Structural Steelwork Inspection

Southport Pier
Promenade
Southport
PR8 1QX

Contract No: LV1255

Dated: June 2023

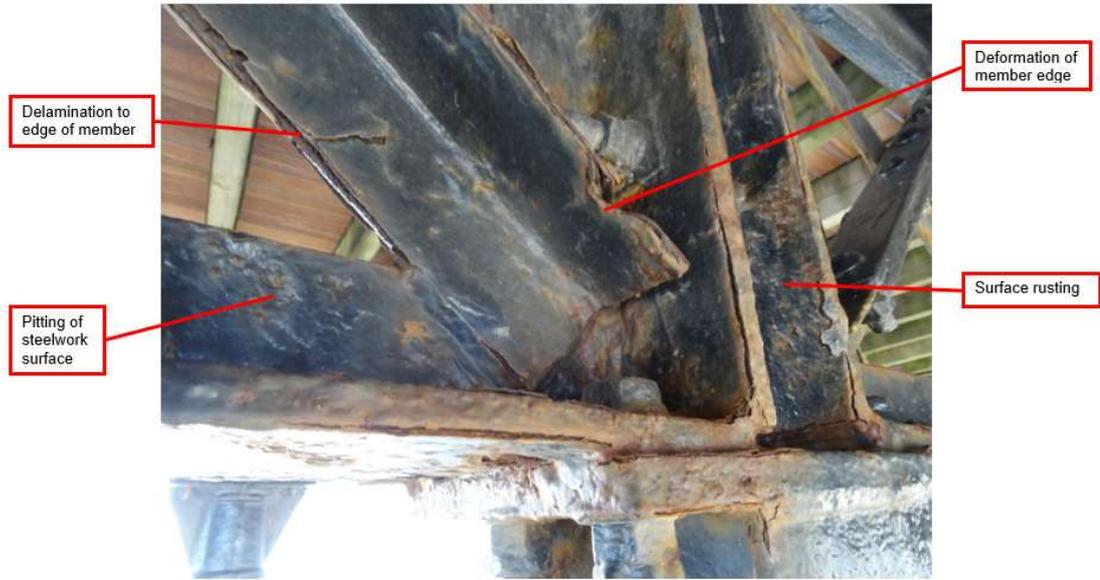
Photograph 5 – Typical defects found along steel frame

2.9 Typically, the extent of any corrosion and delamination is noticeable at the edges of the steel members highlighted in Photographs 5 and 6 above. The thickness of the steelwork was difficult to ascertain due to the uneven surfaces, previously removed rust and pitting, and the paint thickness and unevenness, due to the paint and any corrosion under the paint, along the member.

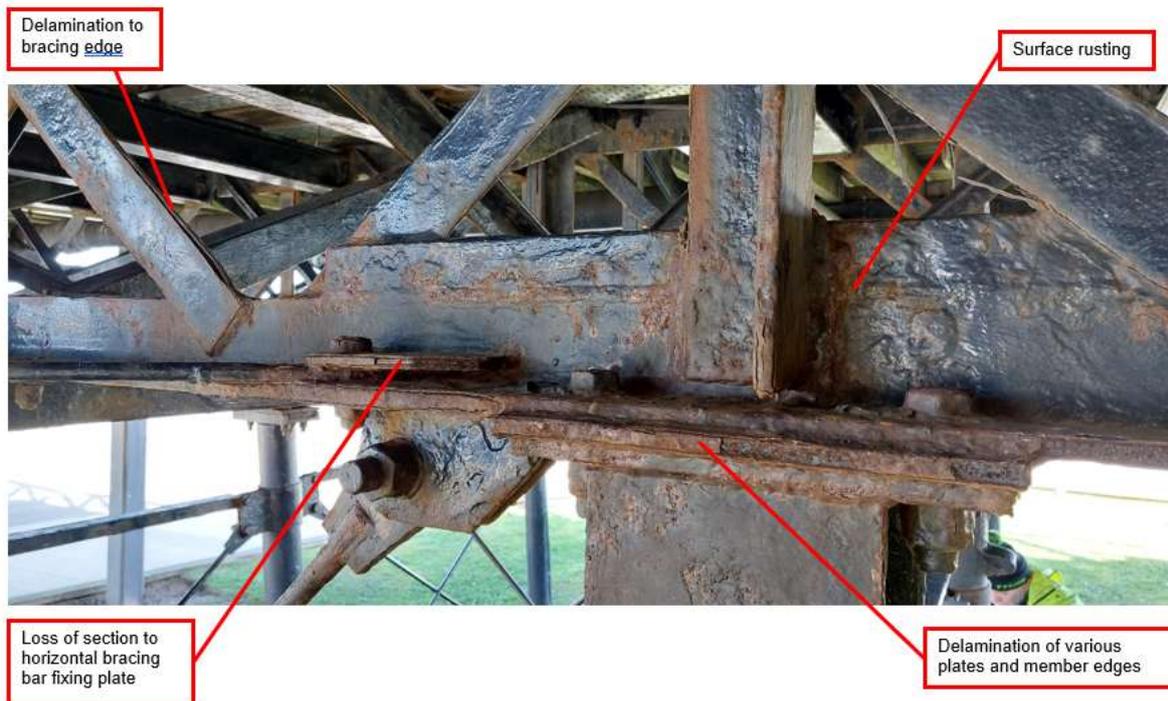
Photograph 6 – Typical defects found along steel frame

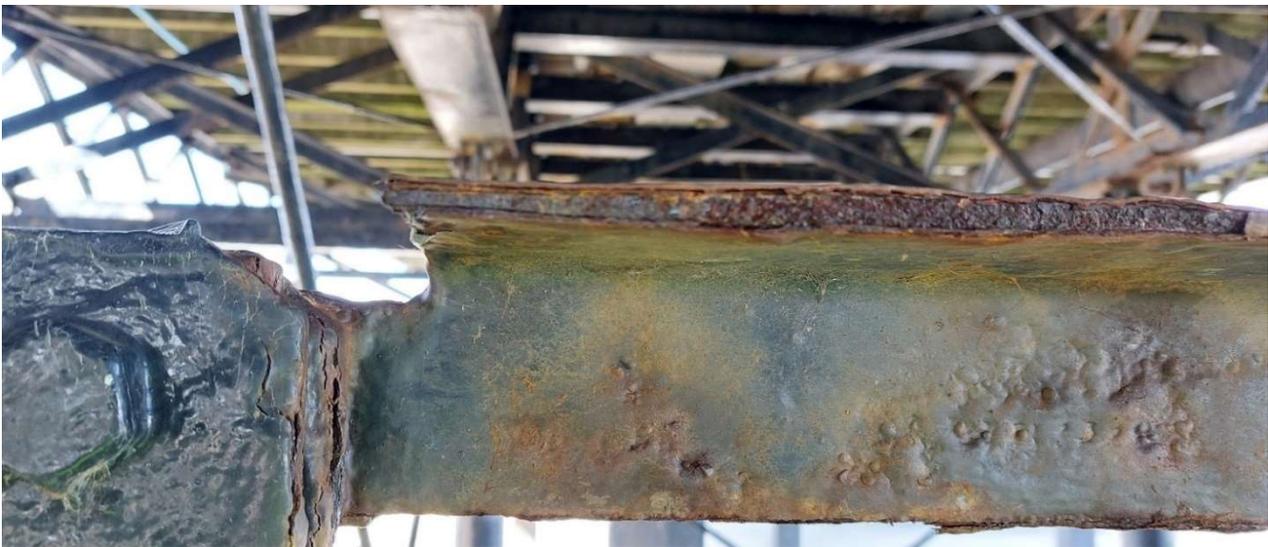
Photograph 7 – Exposed member edge and pitting to vertical web.

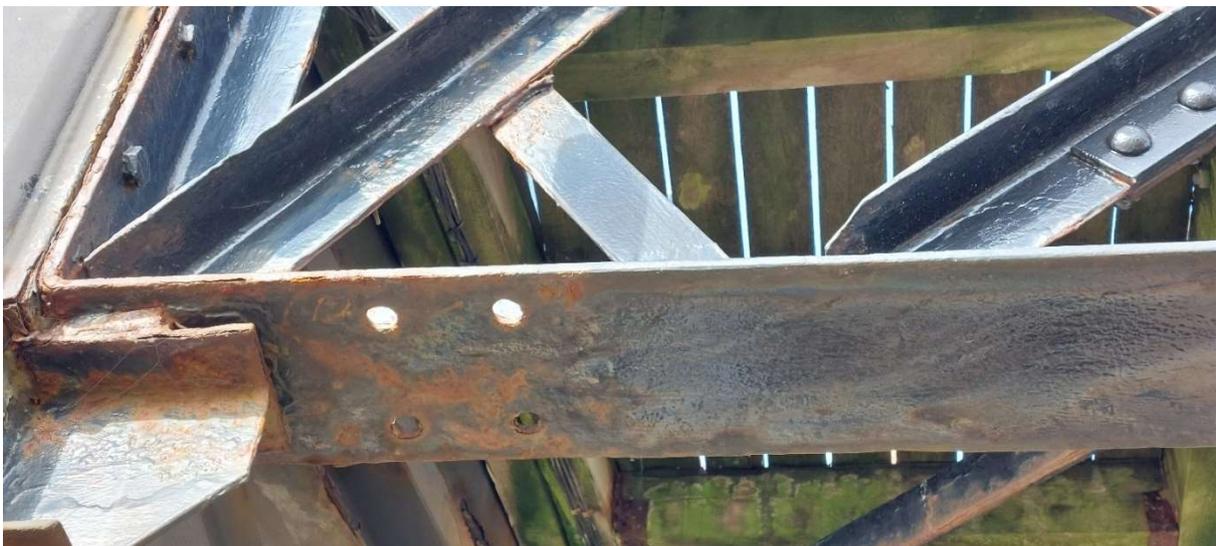
Photograph 8 – Rust present to the underside and around the bolt holes of the truss member.

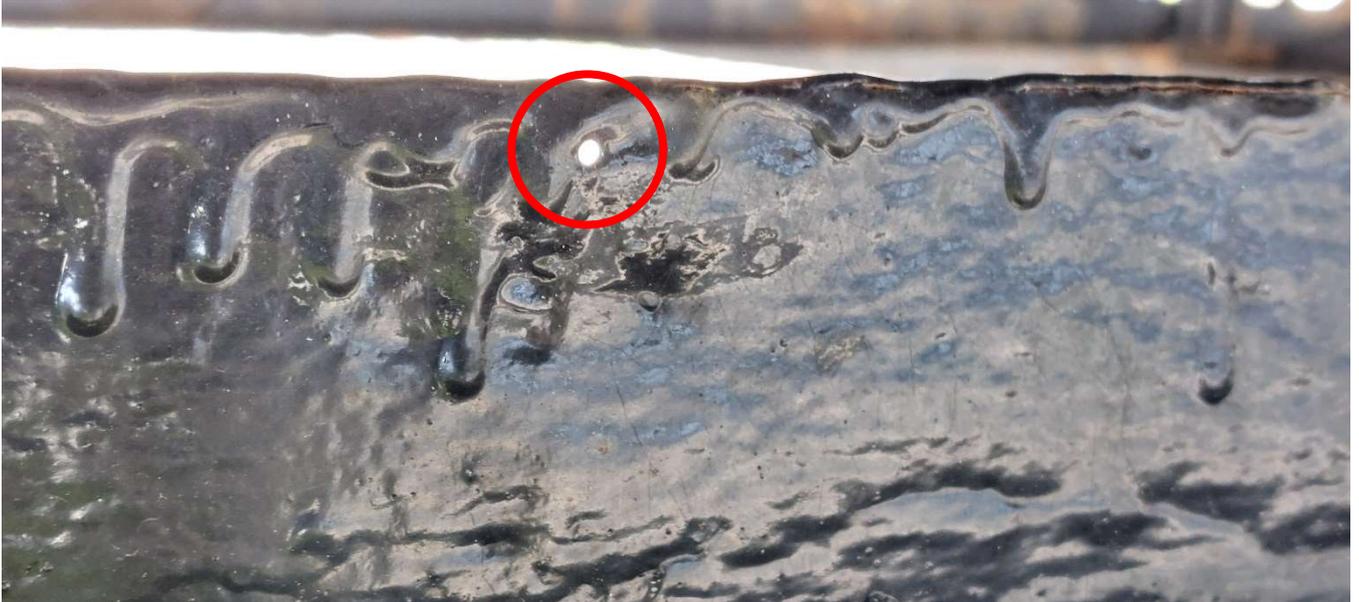
Photograph 9 – Uneven paint application, and hole in web highlighted.

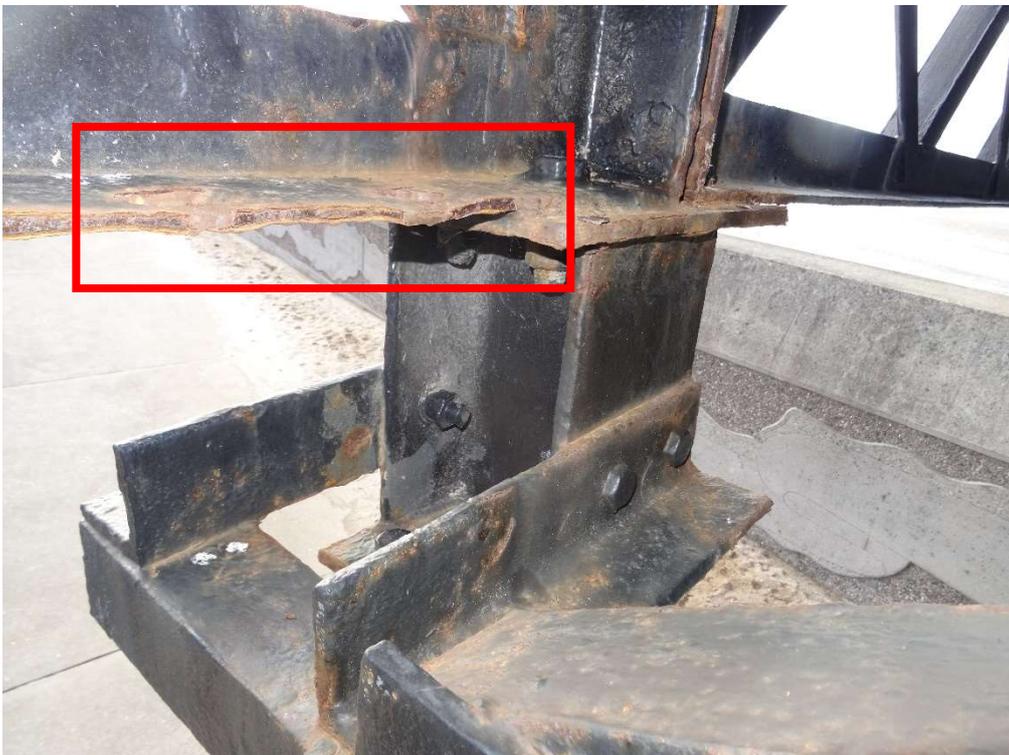
Photograph 10 – Buckling/deformation of member edge, highlighted for clarity.

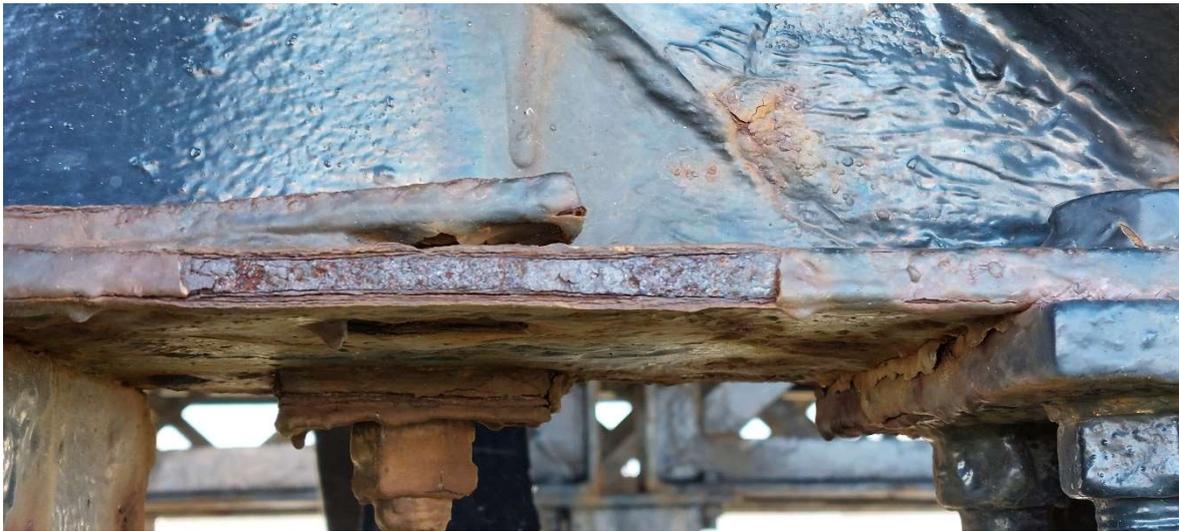
Photograph 11 – Delamination to top and underside of flange and indication of varying thickness in section.

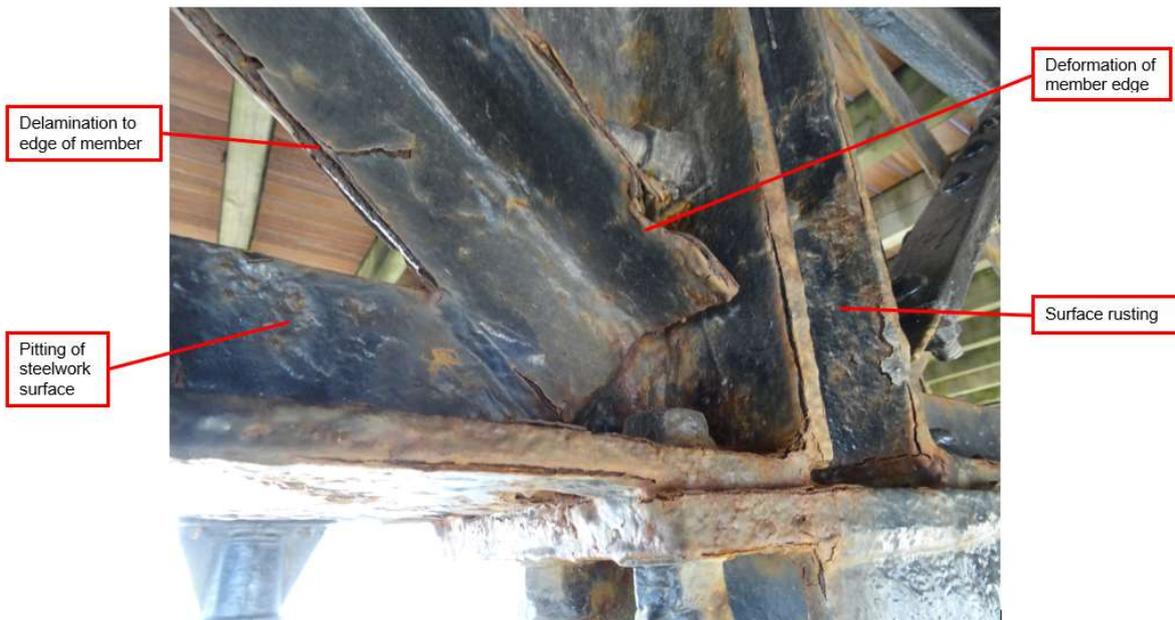
2.14 Photograph 12 shows the column head that supports the incoming South Mid trusses, it highlights some of the typical defects that were observed to this frame.

Photograph 12 – Trusses on support post, indicating defects present.

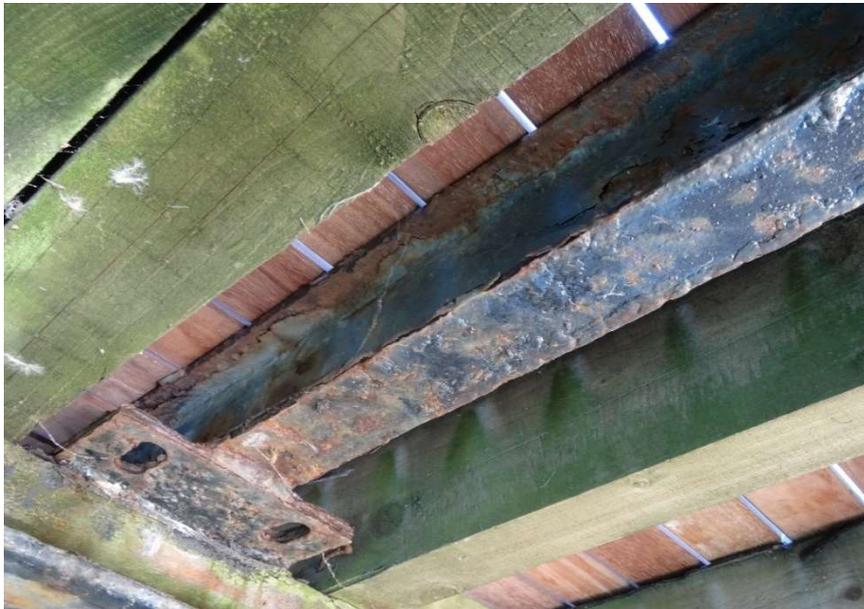
- 2.15 The steelwork directly under the timber decking had the most significant areas of localised damage including reduction in section size, delamination and rusting. Photograph 13 shows an example of one of these beams this is a typical and reoccurring issue with numerous of other examples observed in other areas along the pier. The beam shown is a 127mm deep beam that spans between the top of the South Outer and South Mid trusses, and similarly between the top North Mid and Outer trusses. It would appear as part of the replacement boards this beam has been raised off the steelwork below and now supported off timber packing or has been a redundant members re-used in this area.

Photograph 13 – Damaged 127UB located to underside of new decking

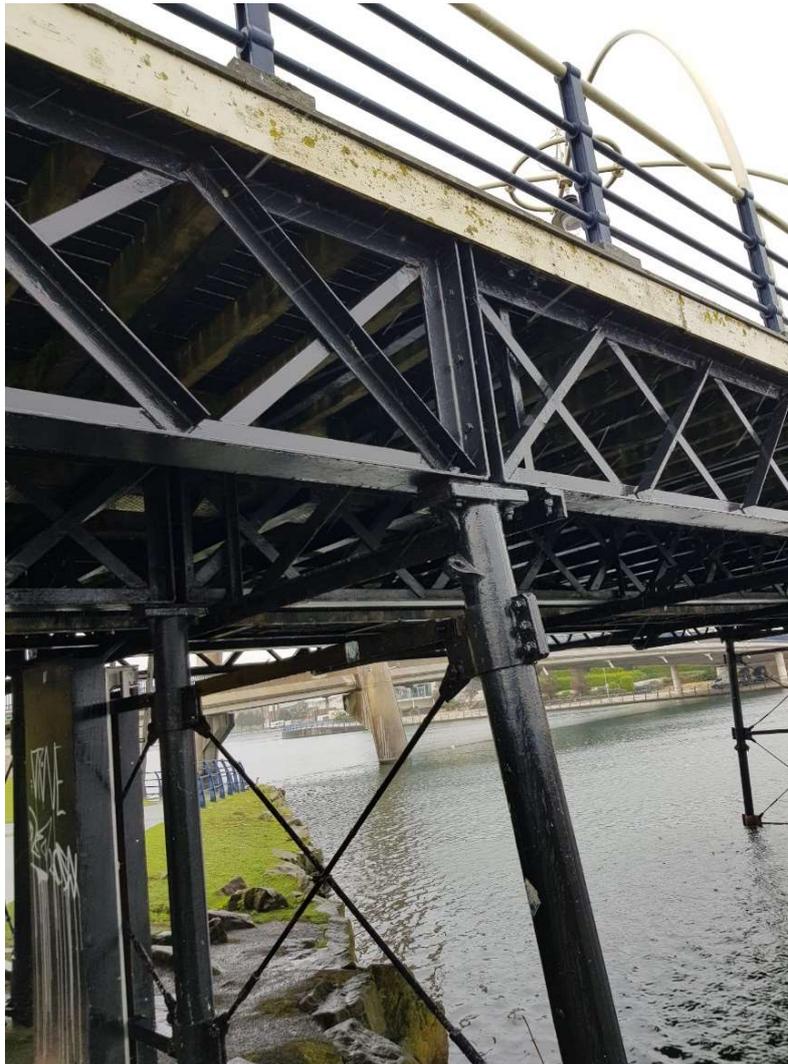
2.18 The frame in this area appears to be in better condition than other areas surveyed. Photograph 14 below, shows the frame adjacent to the lake edge, and the paintwork appears untarnished. Closer inspection revealed localised delamination to the bottom edge of the high-level bracing collars, and to the underside of the transverse frame angles, this is evidenced in Photograph 15. We cannot confirm if this section was replaced as part of previous remediation works.

Photograph 14 – View on support frame in Area 2, and incoming Trusses

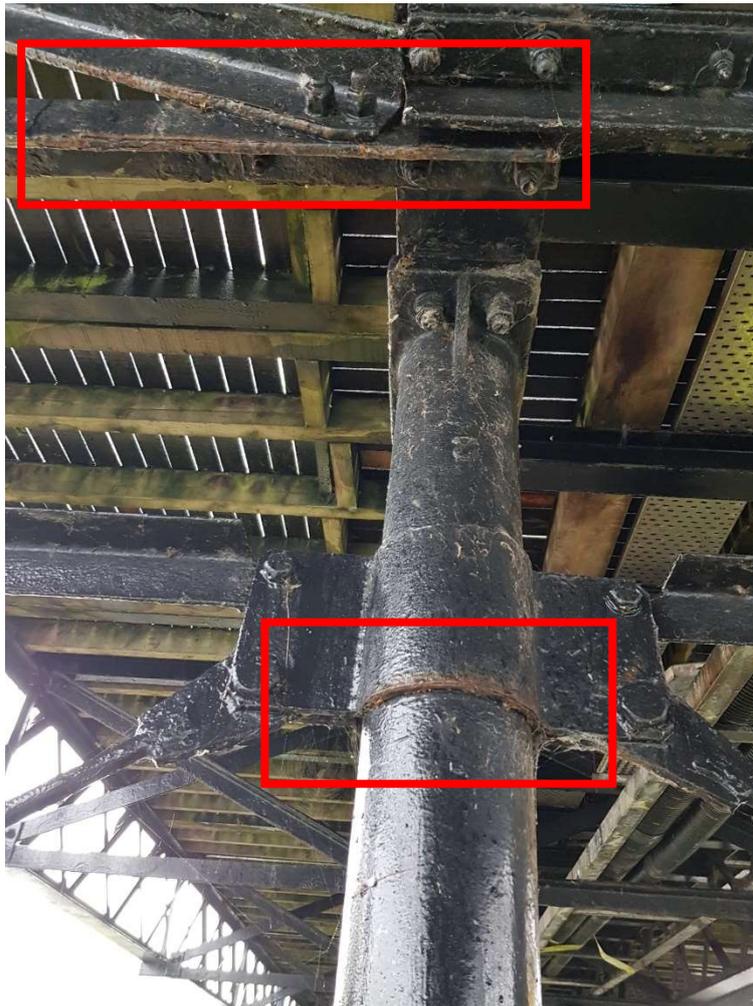
Photograph 15 – Highlighting delamination to underside of members and bottom edge of the bracing collar

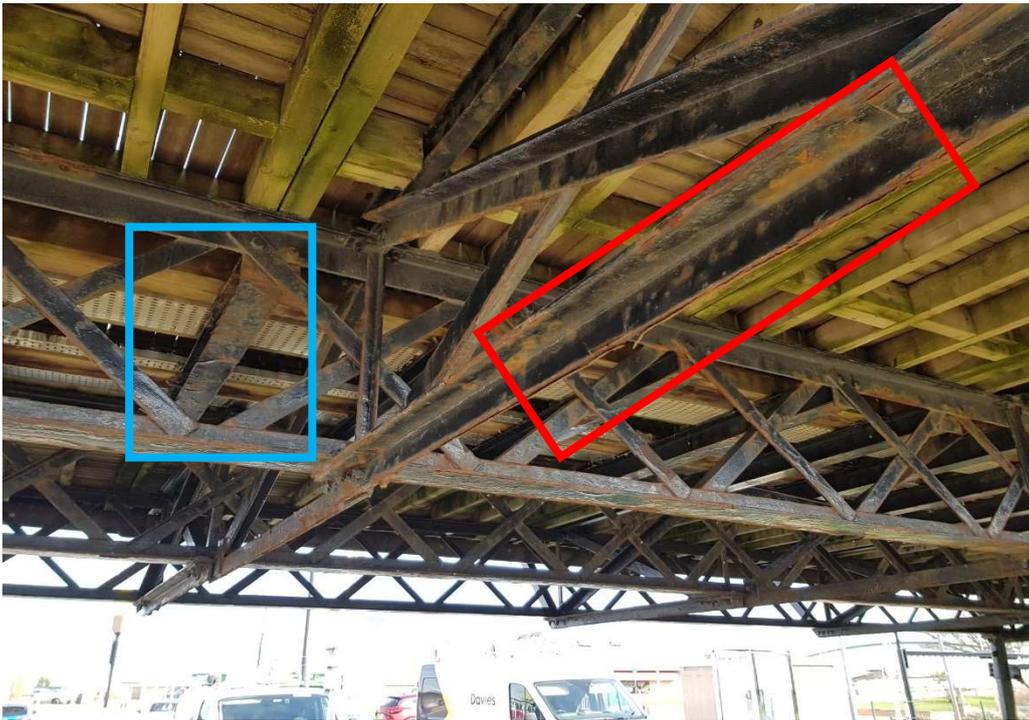
2.21 Photograph 16 shows a transverse frame adjacent to the survey area with highlighted evidence of delamination and rusting to the members. The paint on the underside of the rail support beam is peeling and delamination to the flange edges in this area are highlighted in blue.

Photograph 16 – A transverse frame adjacent to the support frame in the survey area

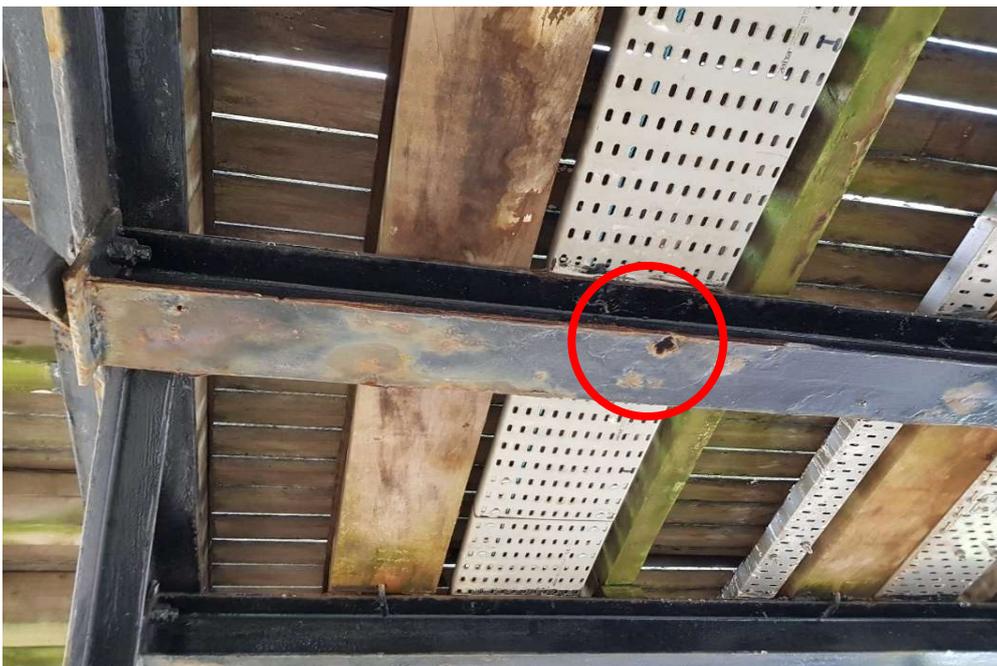
- 2.22 Some of the 152mm deep cross beams spanning between the Mid trusses, have visible evidence of corrosion, rusting and delamination to the top flange. In some locations, as shown in Photograph 17, additional corrosion localised around existing holes in the bottom flange is present.

Photograph 17 – Damaged 152UC located to underside rail support beams

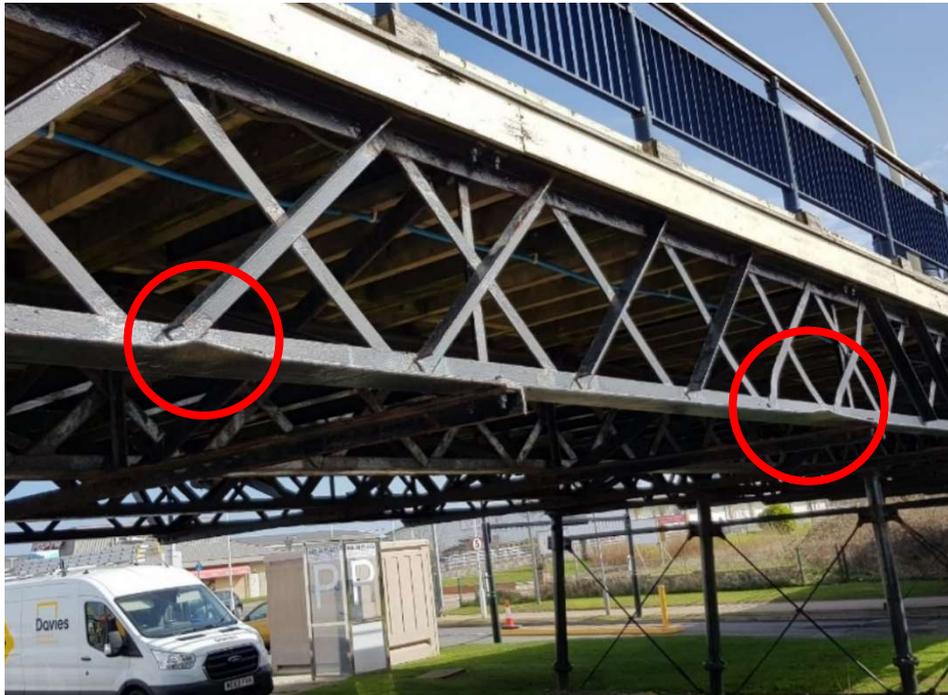
- 2.23 Photograph 18 highlights where the base of the South Outer longitudinal truss may have been impacted causing the localised buckling of the bottom flange. Similarly this may have occurred during propping of the trusses during previous inspections/remedial works.

Photograph 18 – Impact damage (highlighted) to the underside of the South Outer Truss

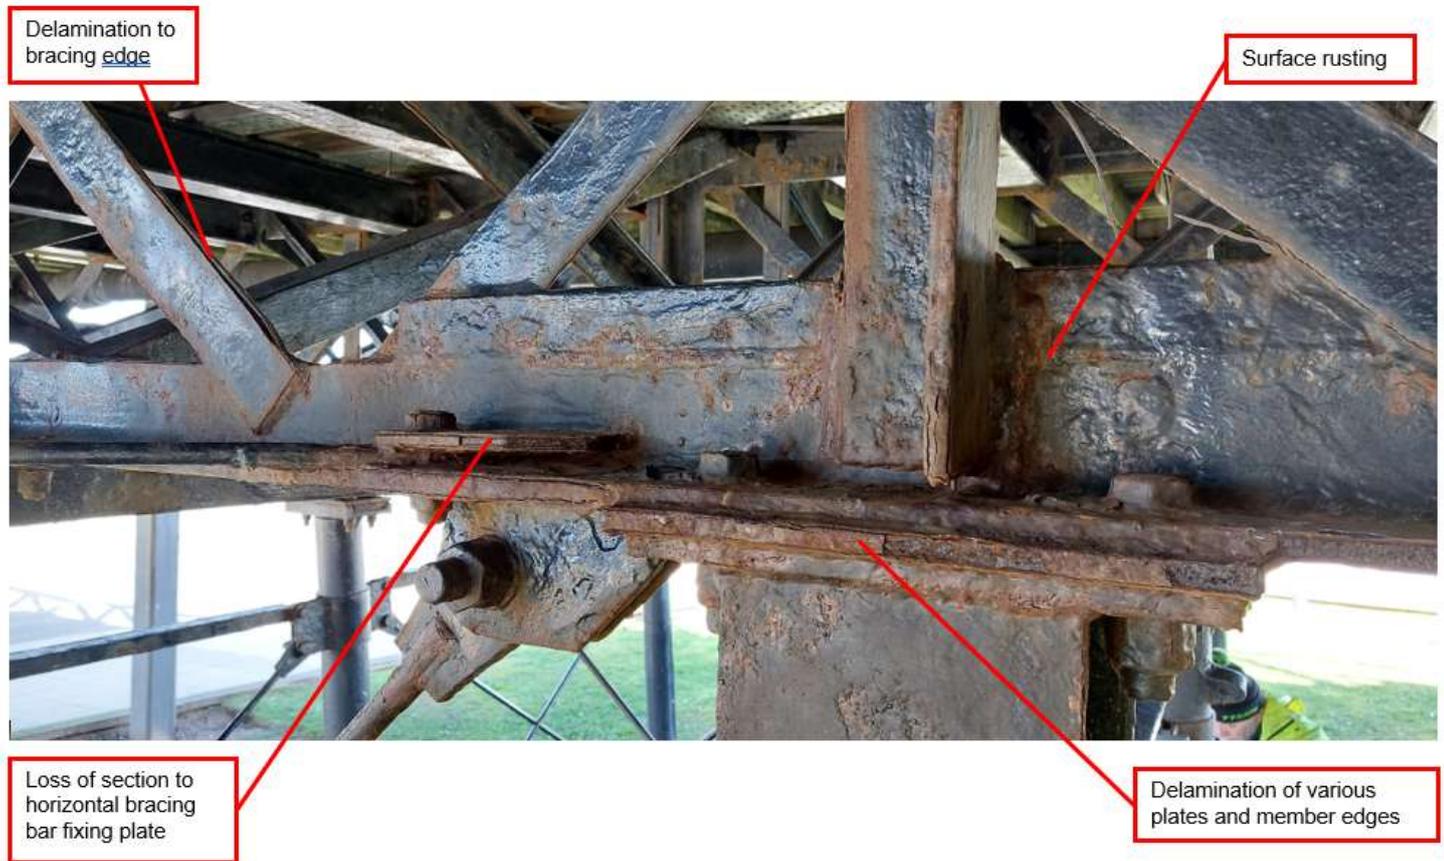
2.27 In Photograph 20 numerous defects, including the horizontal bracing bar connection plate thickness, highlight some of the similar problems observed to this area.

Photograph 20 – Various defects around surveyed frame

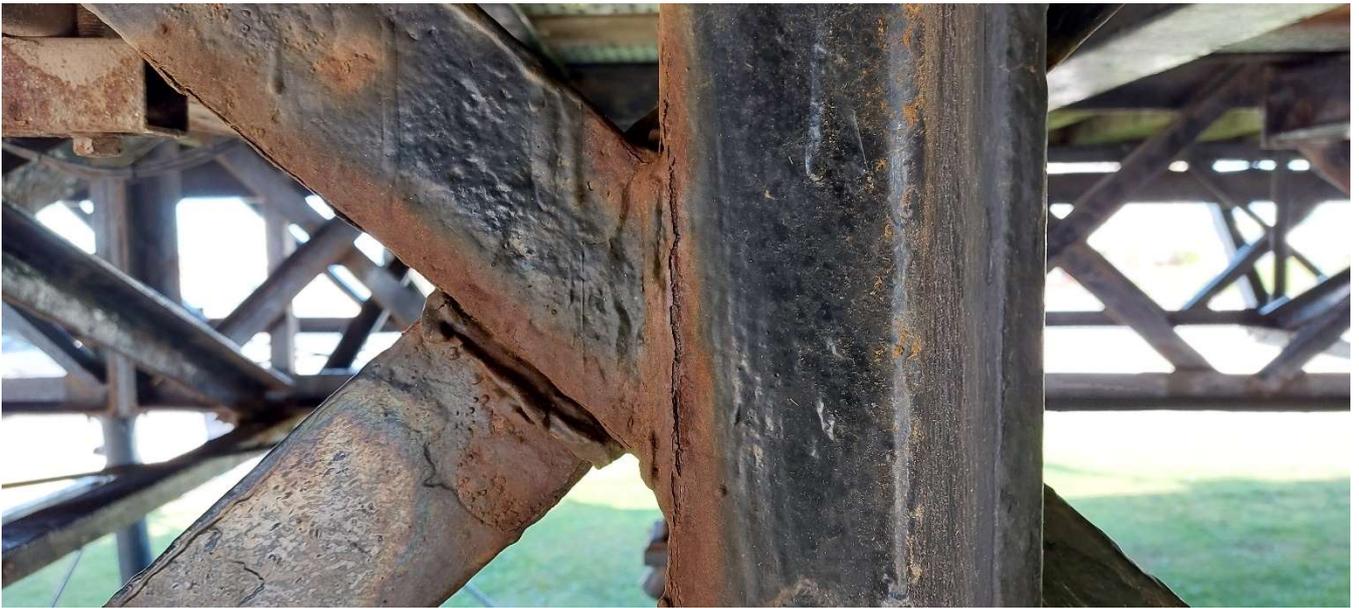
2.28 Photograph 21 indicates the severe rusting and corrosion around the welded connection between the diagonal bracing and vertical truss element.

Photograph 21 – Rusted welds between the bracing members and the vertical truss member

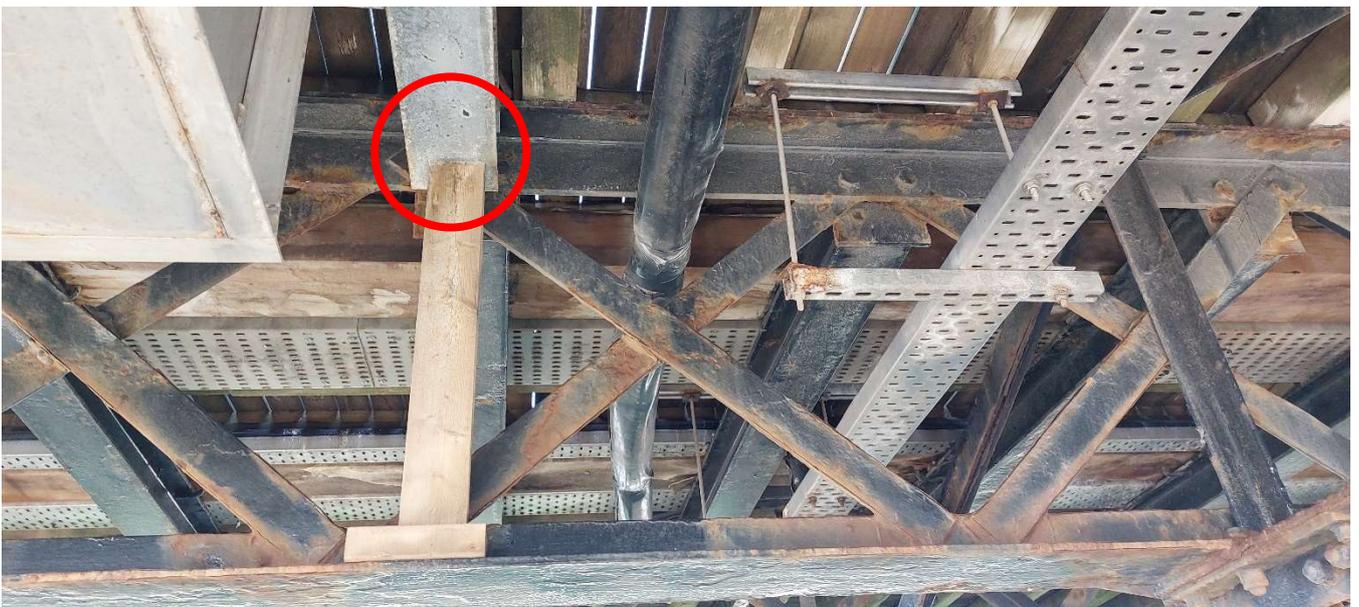
- 2.29 In the area directly below the Donut shop, mechanical equipment has been suspended from the underside of the deck. The supporting steelwork for this equipment has been post-fixed to the existing pier frame. One of these support beams, Photograph 22, has a single bolt connection in the highlighted area, the beam has been propped off the bottom boom of the truss with timber. It was noted that the beam has been drilled for a second bolt, Photograph 23, but not installed.

Photograph 22 – Steel beam with single bolt connection has been propped with timber

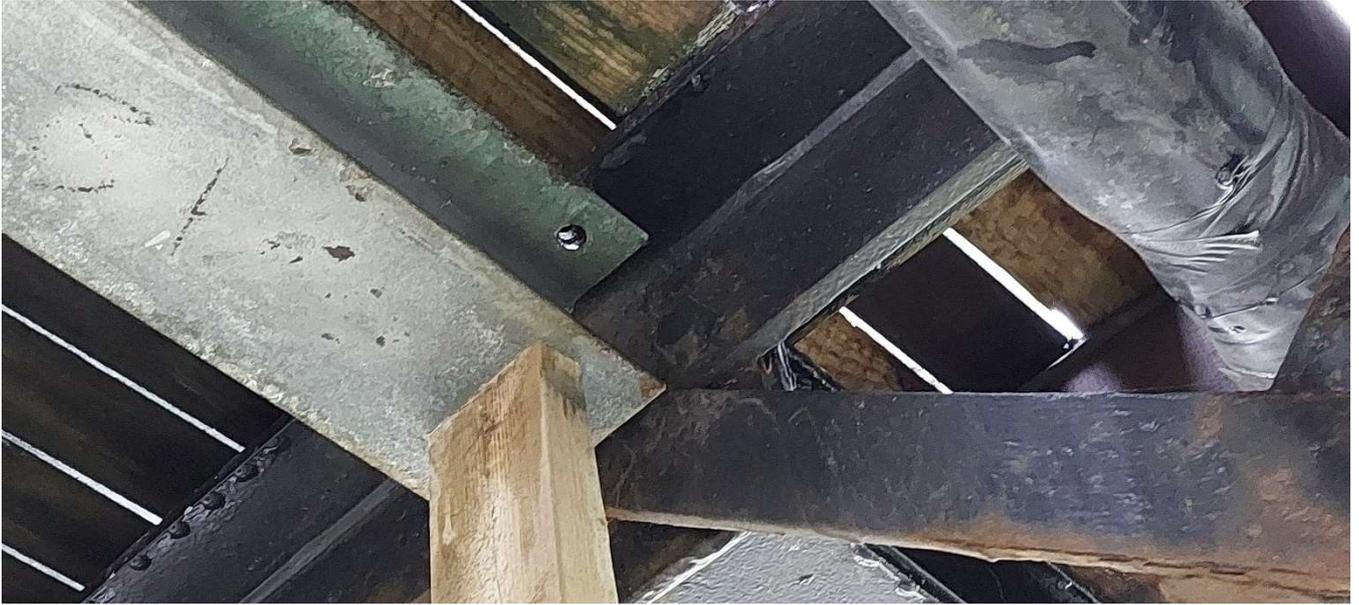
Photograph 23 – Propped steel beam with missing bolt

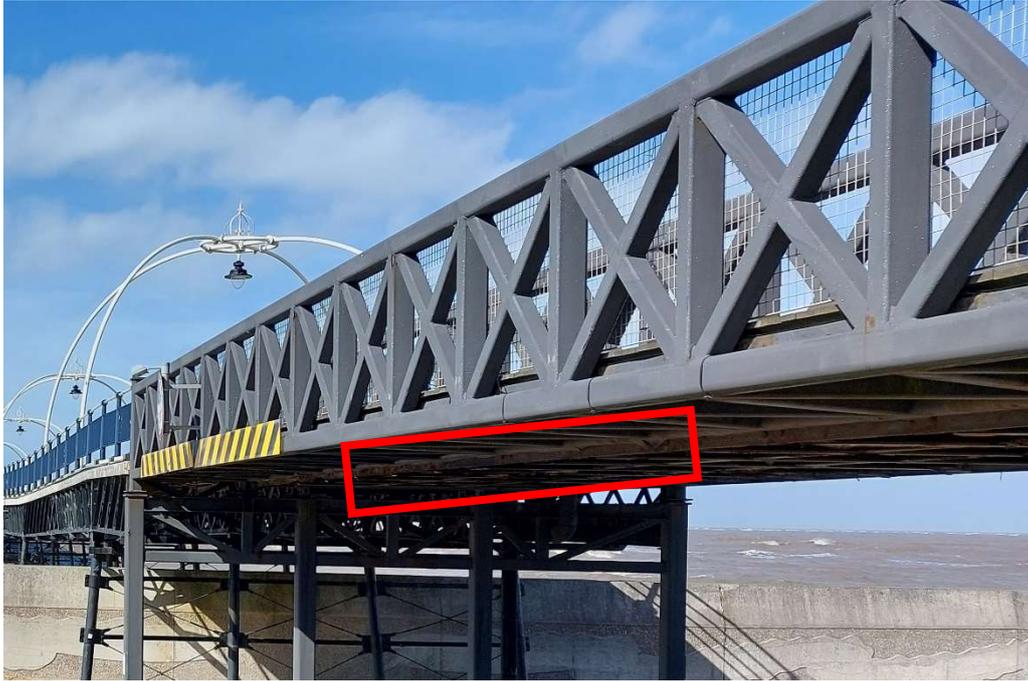
- 2.32 Due to restricted access, Inspection of the bridge deck steelwork was limited to the support frames either side of Marine Drive. Thomasons were advised by Sefton BC that the bridge and its supporting structure are maintained by the Local Authority Highways Department and does not form part of this report. The observation noted in photograph 24 is for information purposes only.
- 2.33 In order to raise the headroom on Marine Drive, the original pier structure was removed and replaced with the bridge. It was observed that there are plates protruding below the underside of the bridge deck members that have been struck by high vehicles, these plates have been highlighted in Photograph 24.

Photograph 24 – View on bridge over Marine Drive, highlighting damaged plates to underside

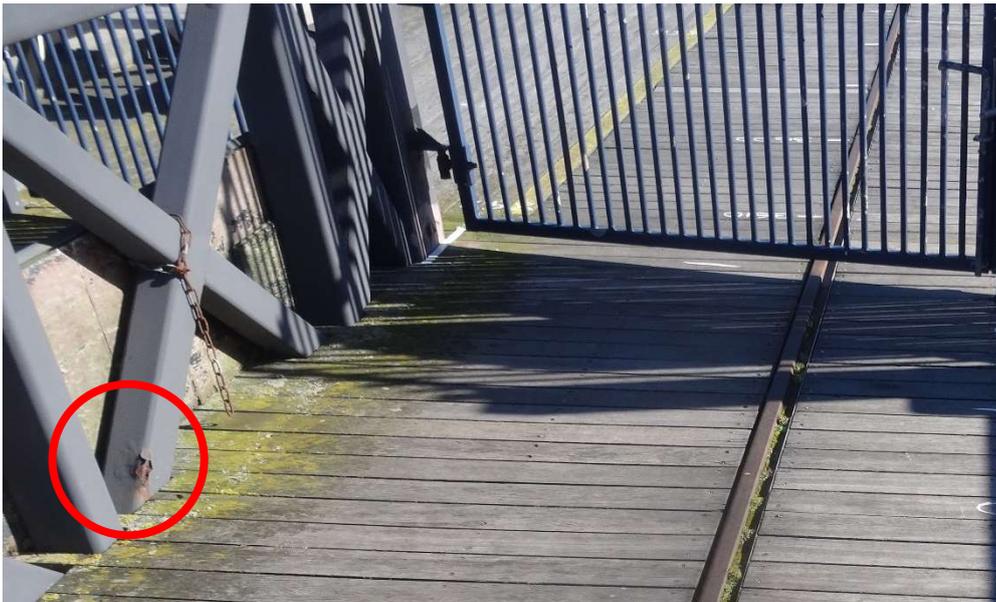
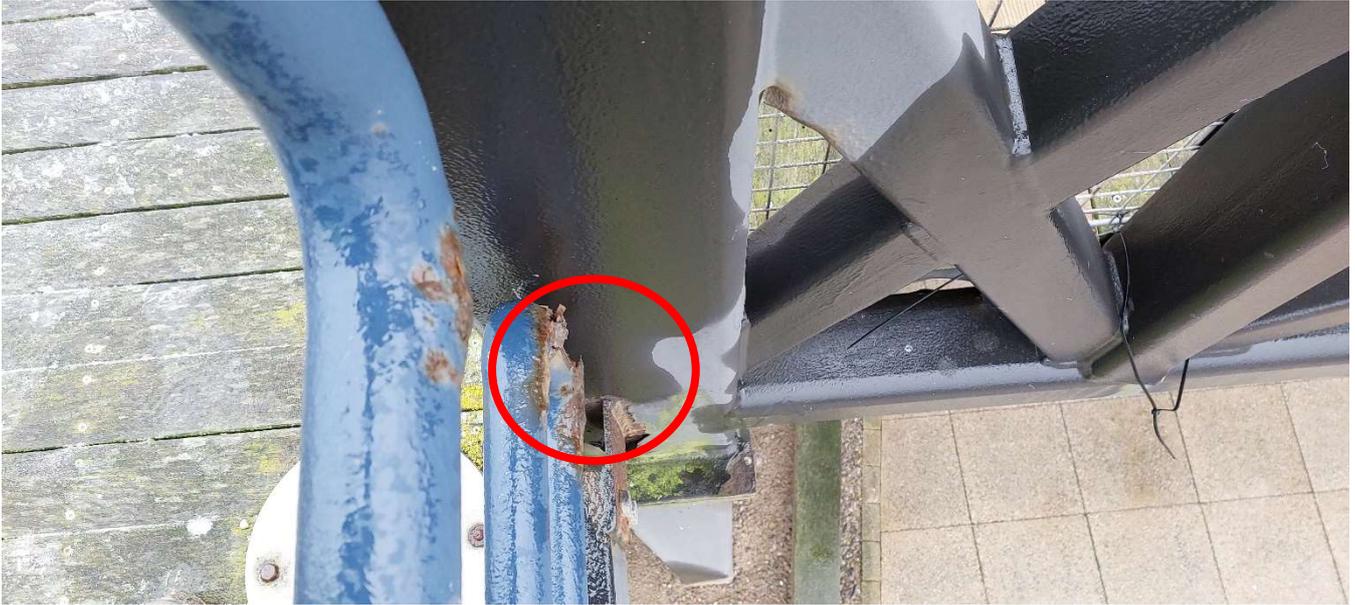
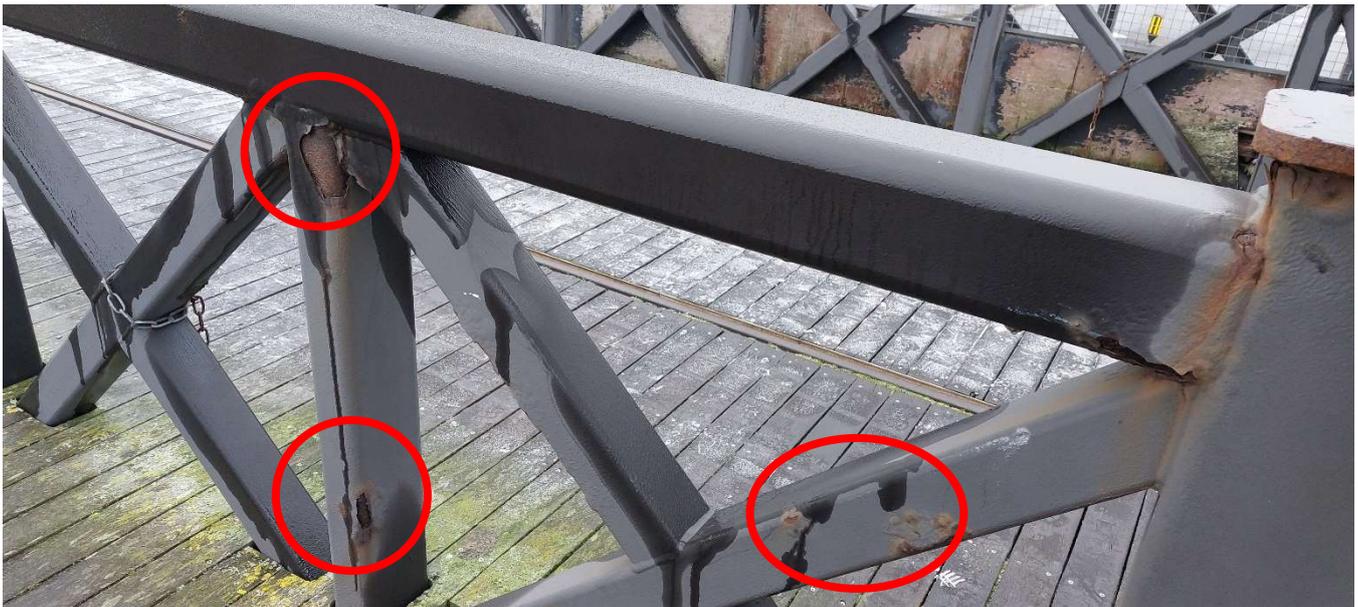
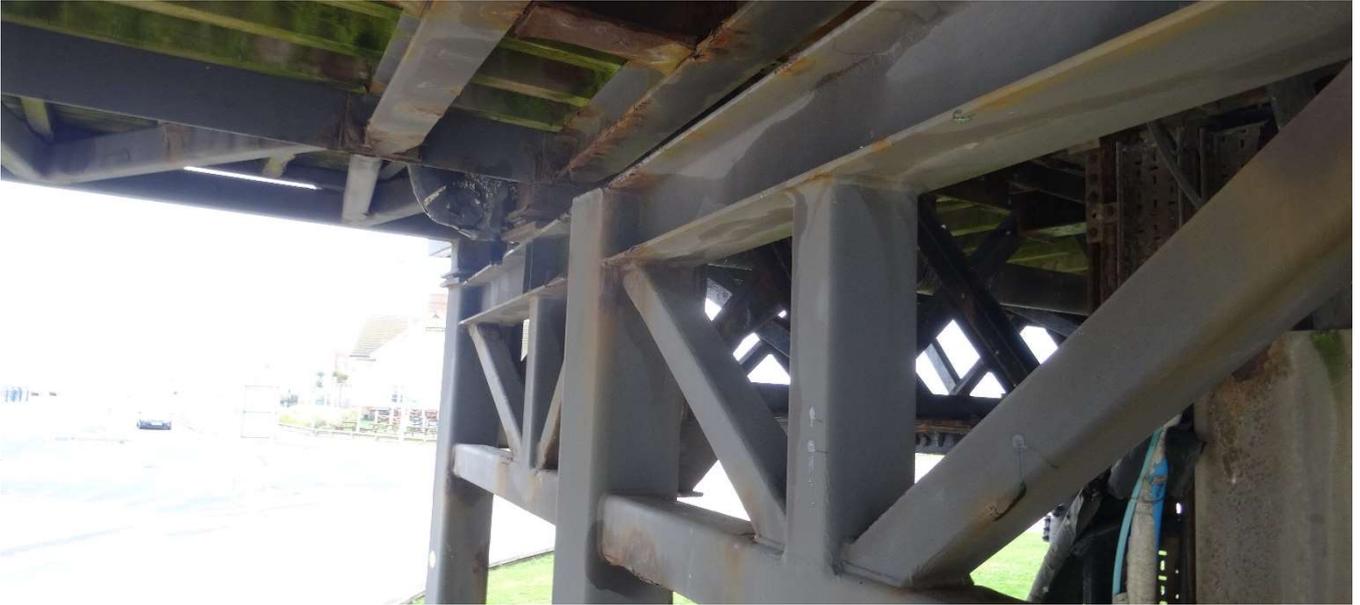
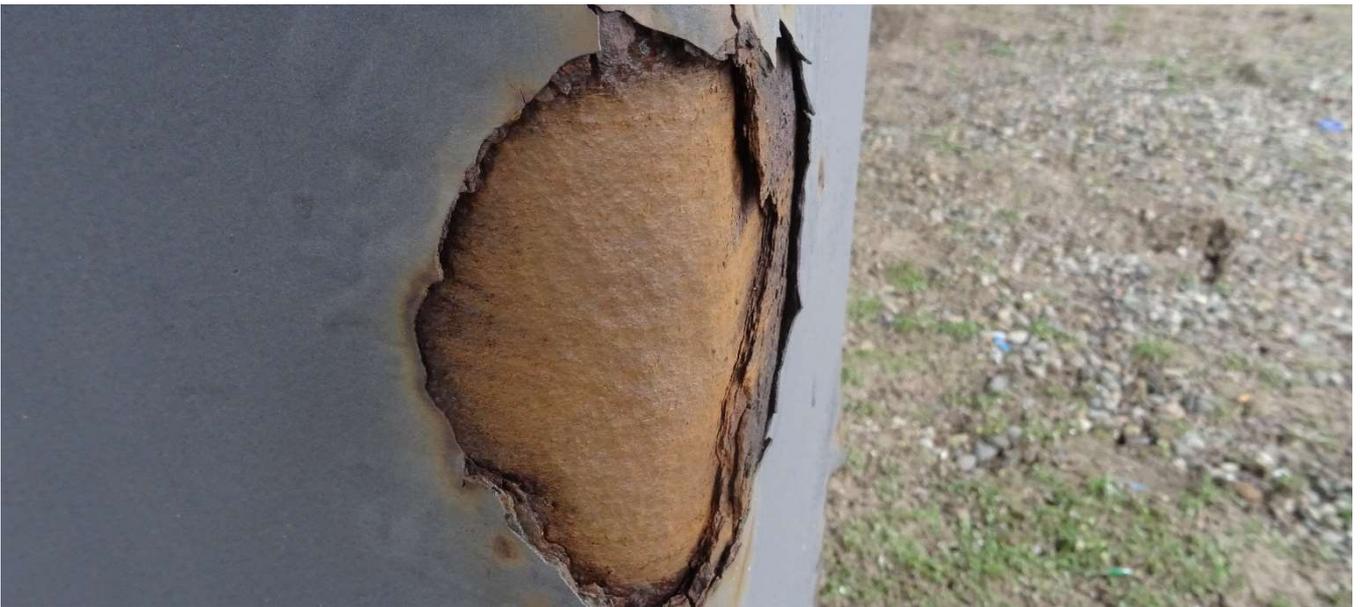
2.34 From a cursory review of the bridge framing above and below, the trusses spanning over the road could be seen to be corroding in areas of peeling paintwork, and examples can be seen in the photographs below. The columns either side of the bridge also had similar visible corrosion of the steelwork within holes in the paintwork.

Photograph 25 – Peeling paint and visible corrosion of frame highlighted on bridge truss member

Photograph 26 – Peeling paint and visible corrosion of frame highlighted on bridge truss member

Photograph 27 – Peeling paint and visible corrosion of frame highlighted on bridge truss member

Photograph 28 – Peeling paint and visible corrosion of frame highlighted on bridge truss members

Photograph 29 – Peeling paint and visible corrosion of frame highlighted on bridge truss column

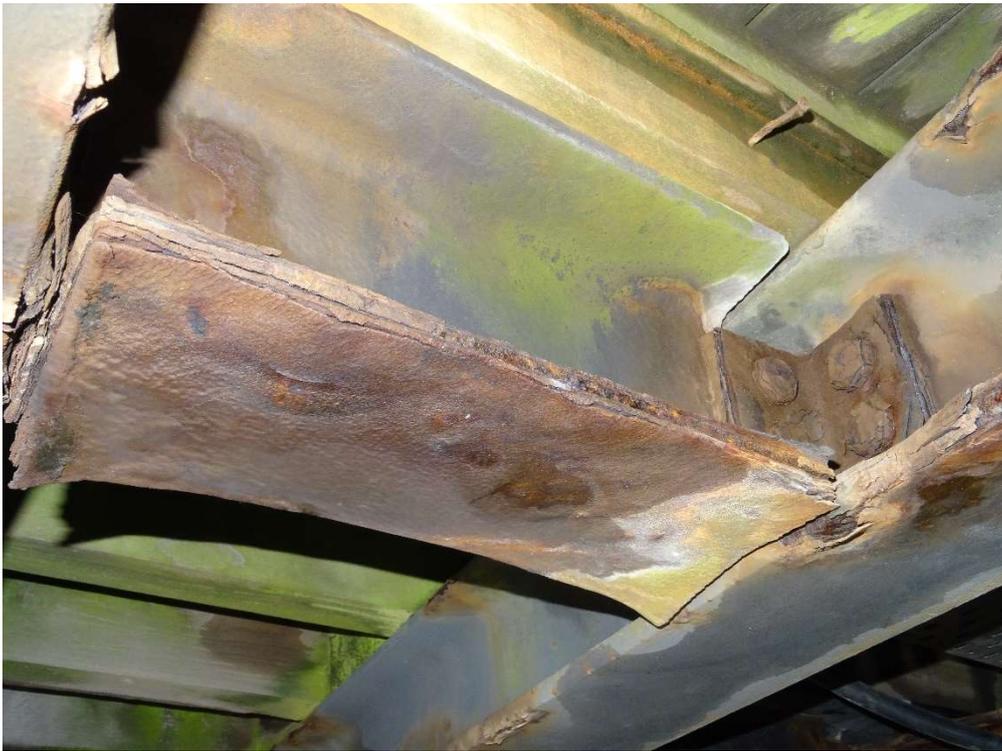
- 2.35 The paintwork and steelwork to the underside of the bridge is in poor condition, with significant corrosion and delamination present, this can be seen in Photographs 30 and 31 below.

Photograph 30 – Condition of steelwork to the underside of Marine Drive bridge.

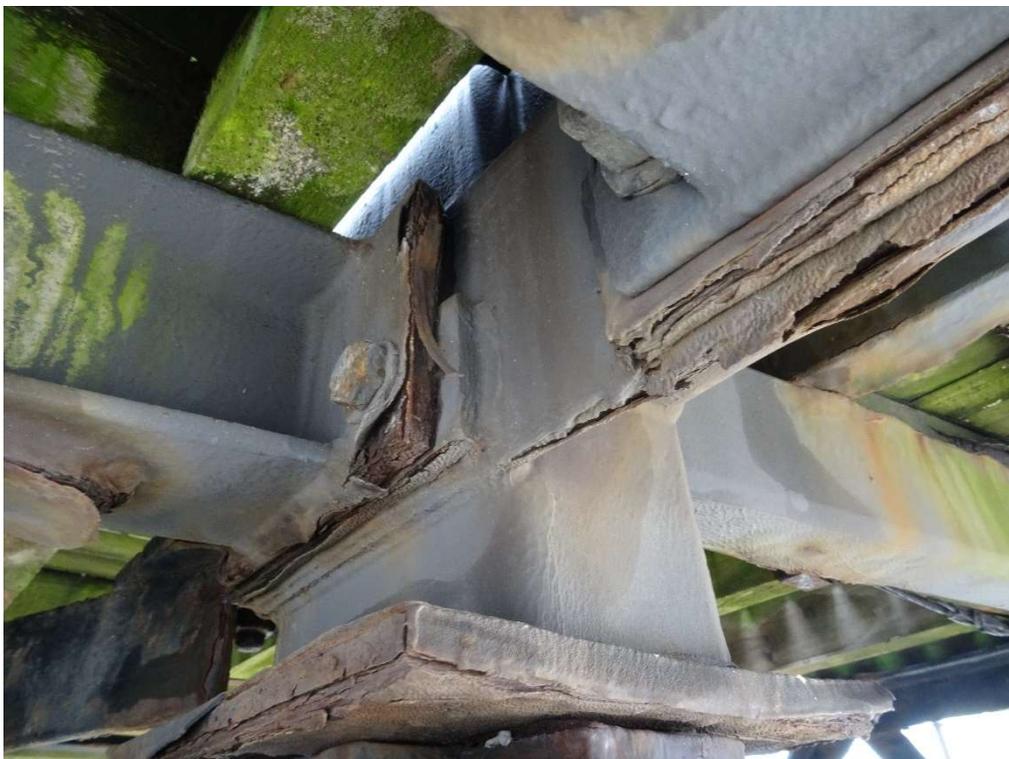
Photograph 31 – Peeling paintwork and delamination of steel members

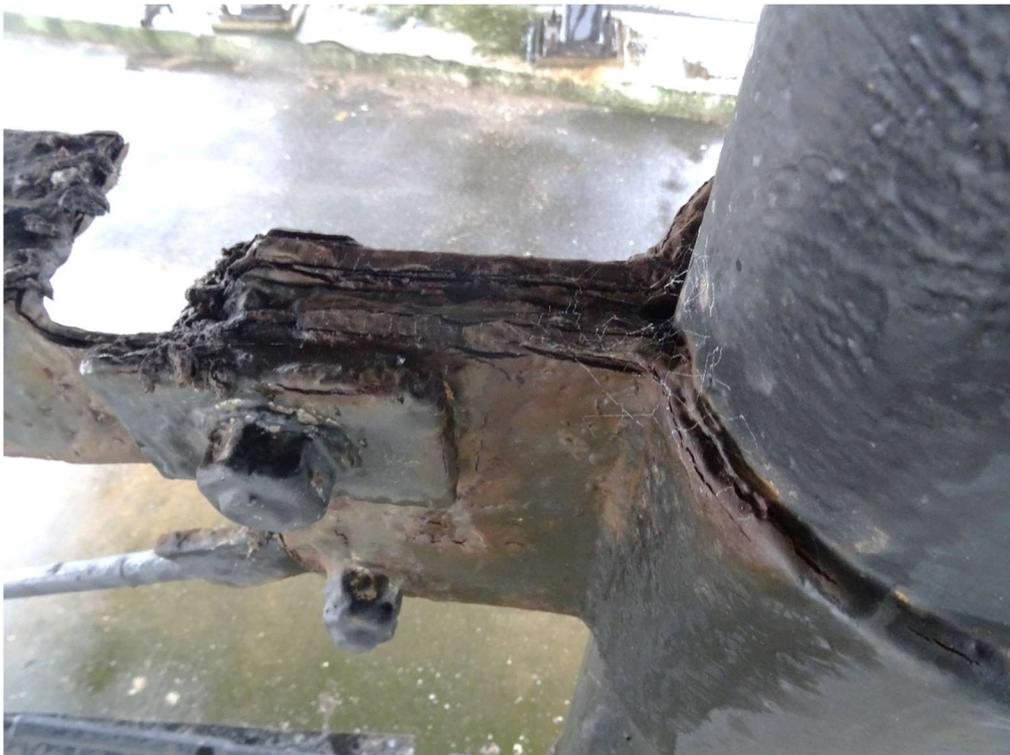
2.38 In Photograph 32, the horizontal leg of the angle, and the single bolt fixing to the collar bracket utilises the vertical leg. The notching of angles forming the horizontal element of the bracing systems at the support post locations, was a typical detail noted in similar fixing locations along the pier.

Photograph 32 – Brace, connection and collar to post are delaminated

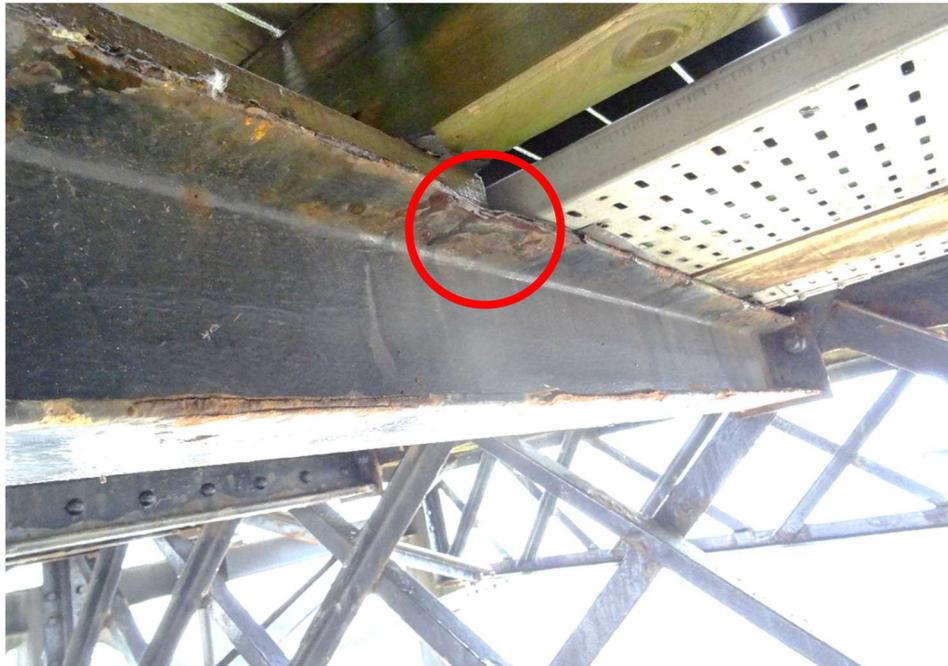
2.39 Within the steel frame spanning over the sea wall, the rail support beams have corroded and as highlighted in Photograph 33 below, part of the top flange has eroded with approximately 15% loss of section width. The beam has a varying flange thickness due to delamination.

Photograph 33 – Damaged rail support beam
