Structural Steelwork Inspection

Southport Pier
Promenade
Southport
PR8 1QX

Contract No: LV1255

Dated: June 2023

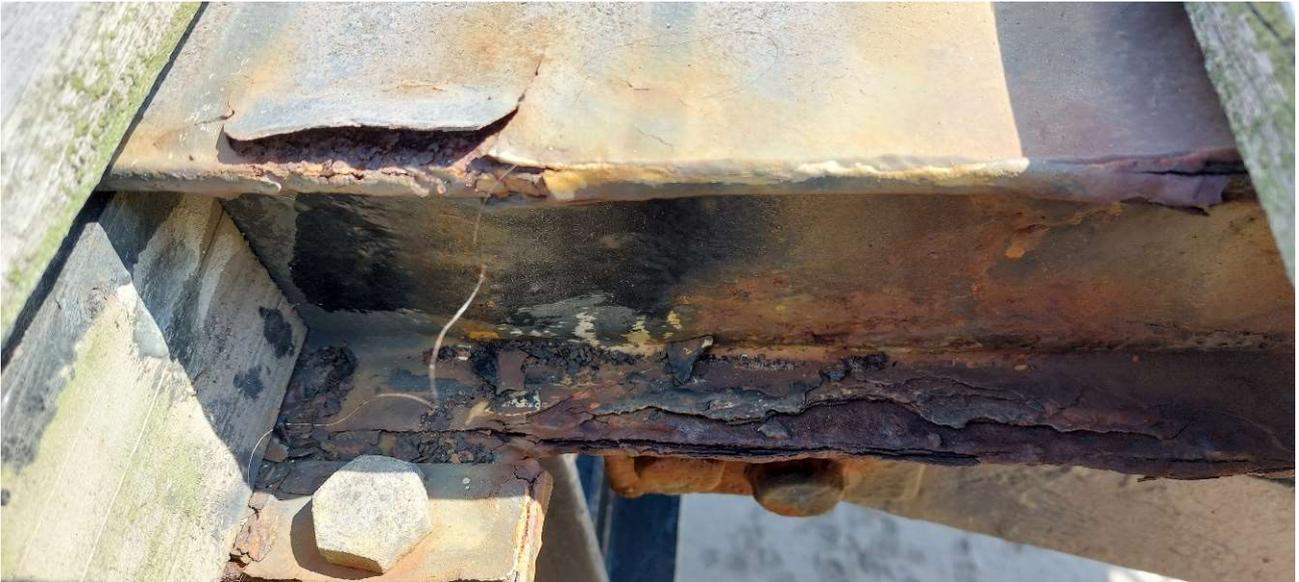
- 2.44 There are similar issues noted to other parts of the structure and this was apparent once decking boards were lifted and the steelwork exposed for review from above. Examples of the exposed beams can be seen in photographs 35 and 36.

Photograph 35 – Detail showing varying section thickness and corrosion to member.

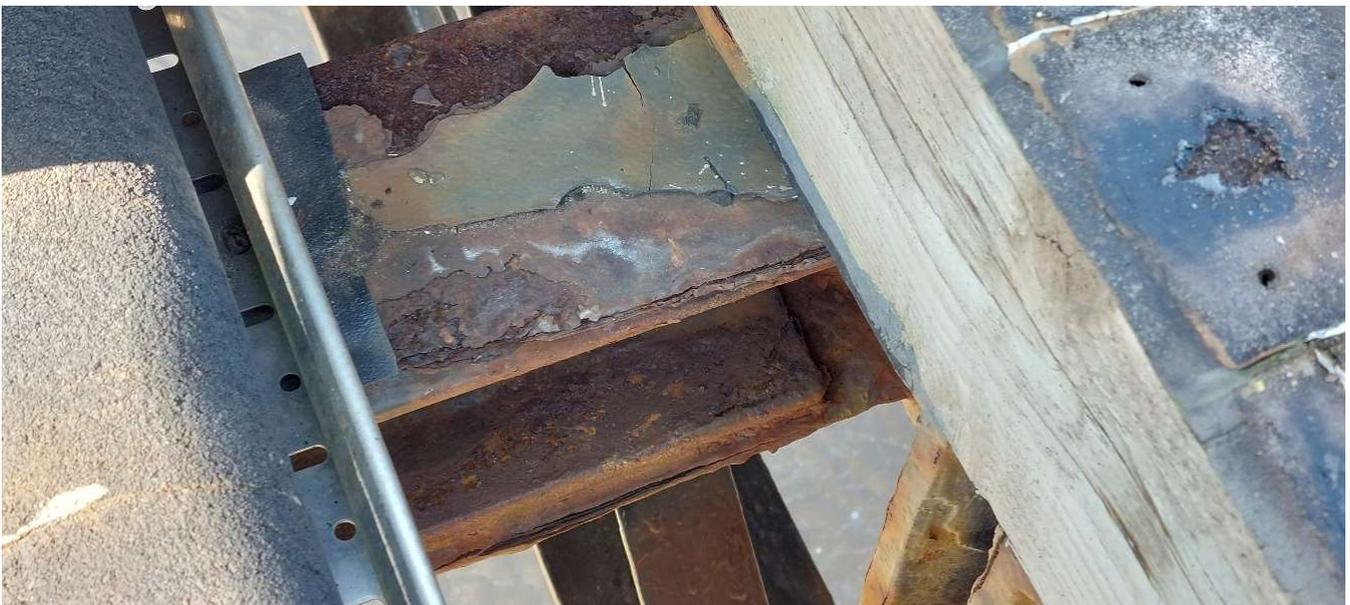
Photograph 36 – Example of delamination to member surfaces and extent of corrosion.

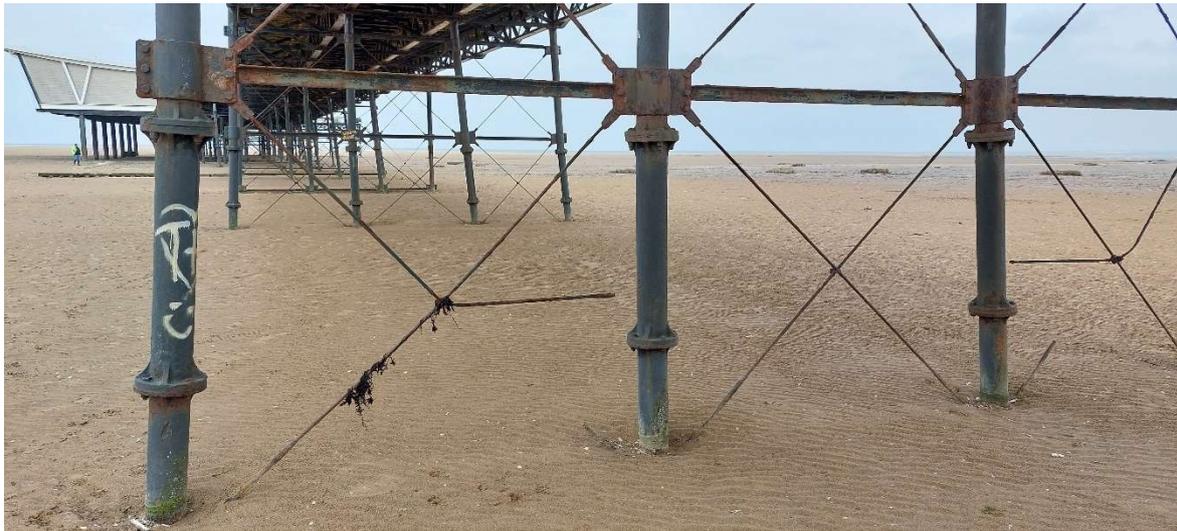
- 2.45 Bracing within the support frames along the beach section of the pier has significant damage in numerous locations. Damage includes snapped and/or bent bracing bars. In some areas, the bracing turn buckles have sheared, evidence of this can be seen in photographs 37 and 38.

Photograph 37 – View on frame with bent and broken bracing bars

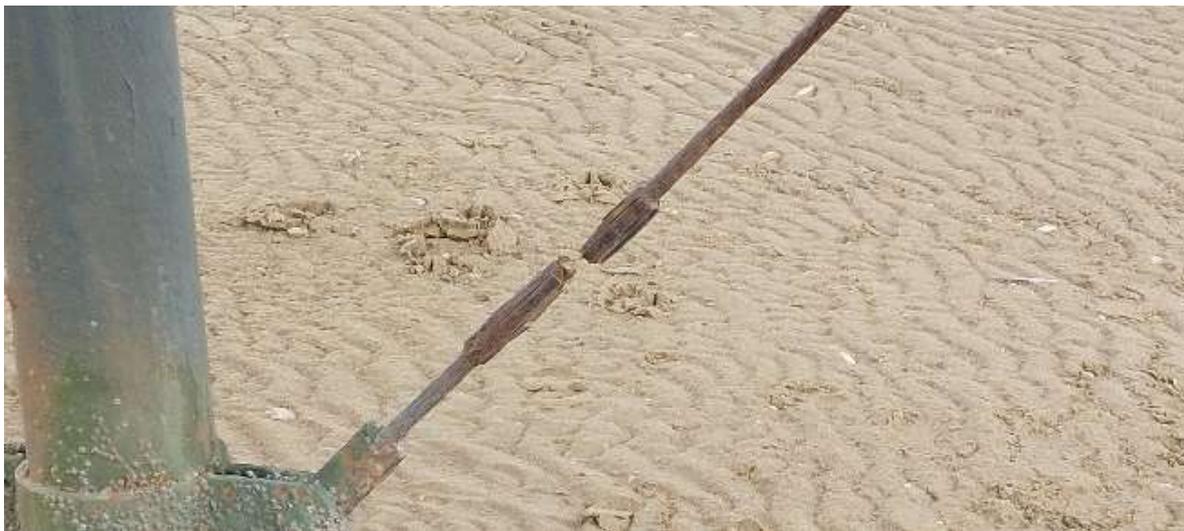
Photograph 38 – Sheared bracing turn buckle.

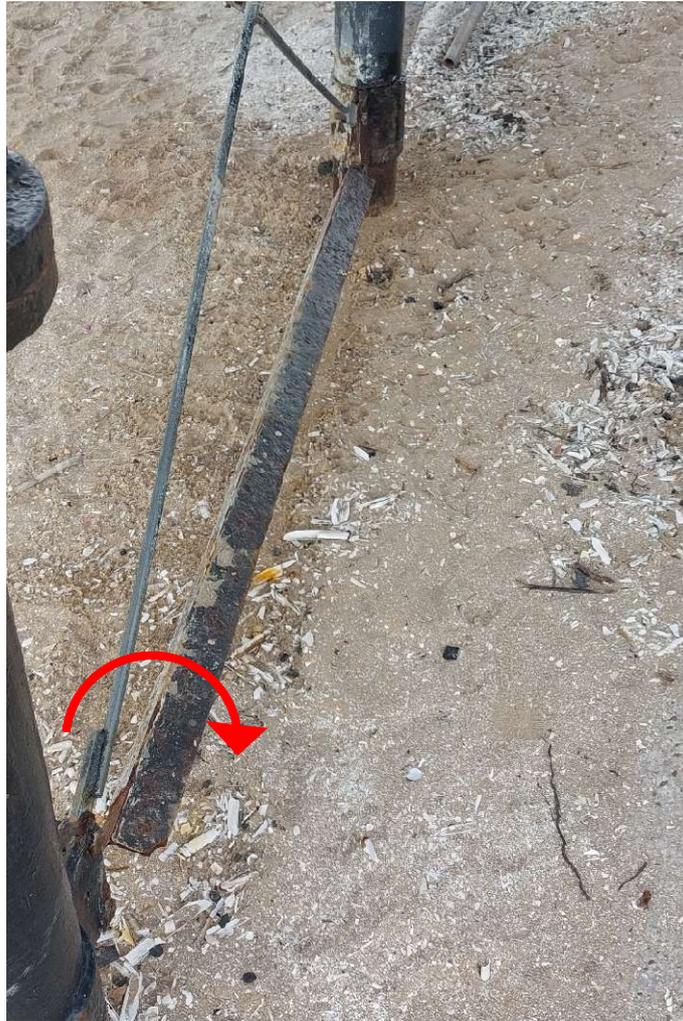
- 2.46 Some of the damage to the beach frames has been caused by the ebb and flow of the tide. Other areas, especially closer to the sea wall, have likely been damaged by members of the public climbing on the frames. This is highlighted by the twisted angle to the base of the frame in Photograph 39.

Photograph 39 – Support frame damaged braced member (arrow indicates direction of twist in member)

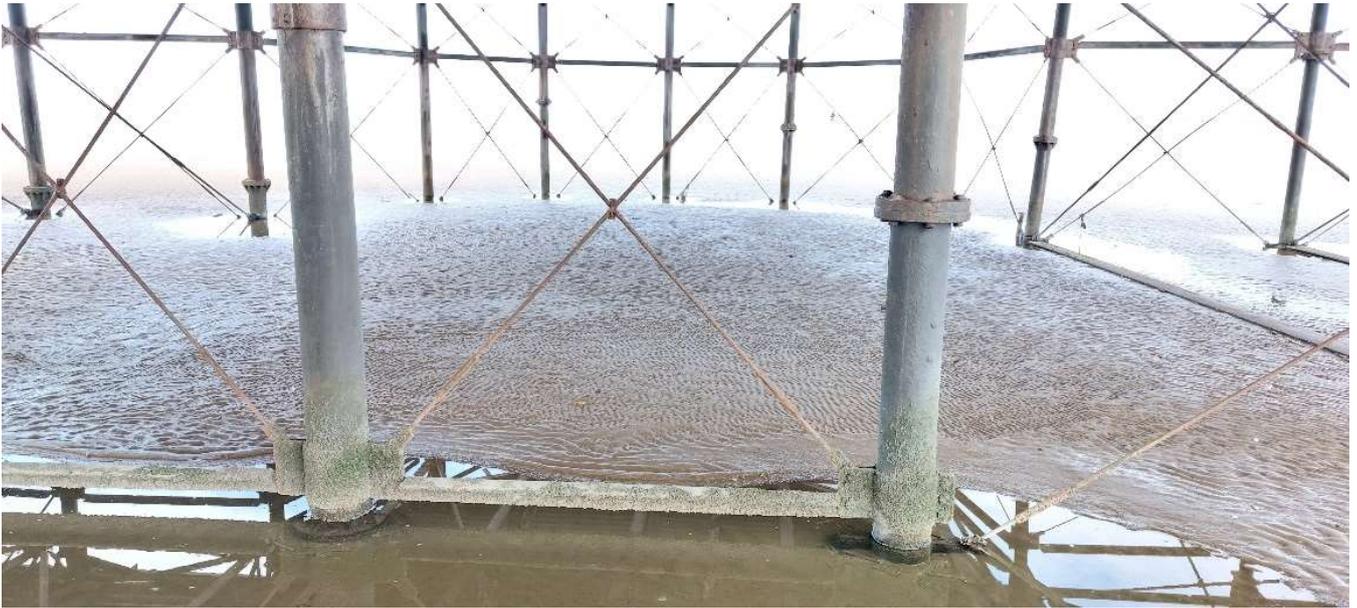
- 2.47 Corrosion of the exposed structural elements at the base of the columns was observed. The corrosion, seen in photograph 40, encompasses the perimeter of the cast iron column, and adjacent steel bracing members at this level. This damage is likely as a result of these members being under repetitive submersion by sea water and any movement in the sands that would also conceal the member.

Photograph 40 – Corrosion to base of seaward pier columns

- 2.48 No testing was carried out on the iron columns, these will need further investigation as part of the remediation scheme to clarify the structural condition, e.g., any internal cracking not externally visible.
- 2.49 The transverse frames that span across the pier deck have a 127mm deep beam that spans between the top flange of the outer and mid trusses either side of the central section. In Photographs 41 and 42, the extent of the corrosion to these members is so severe, there is delamination to all exposed surfaces of the beam making it difficult to determine what structural capacity remains.

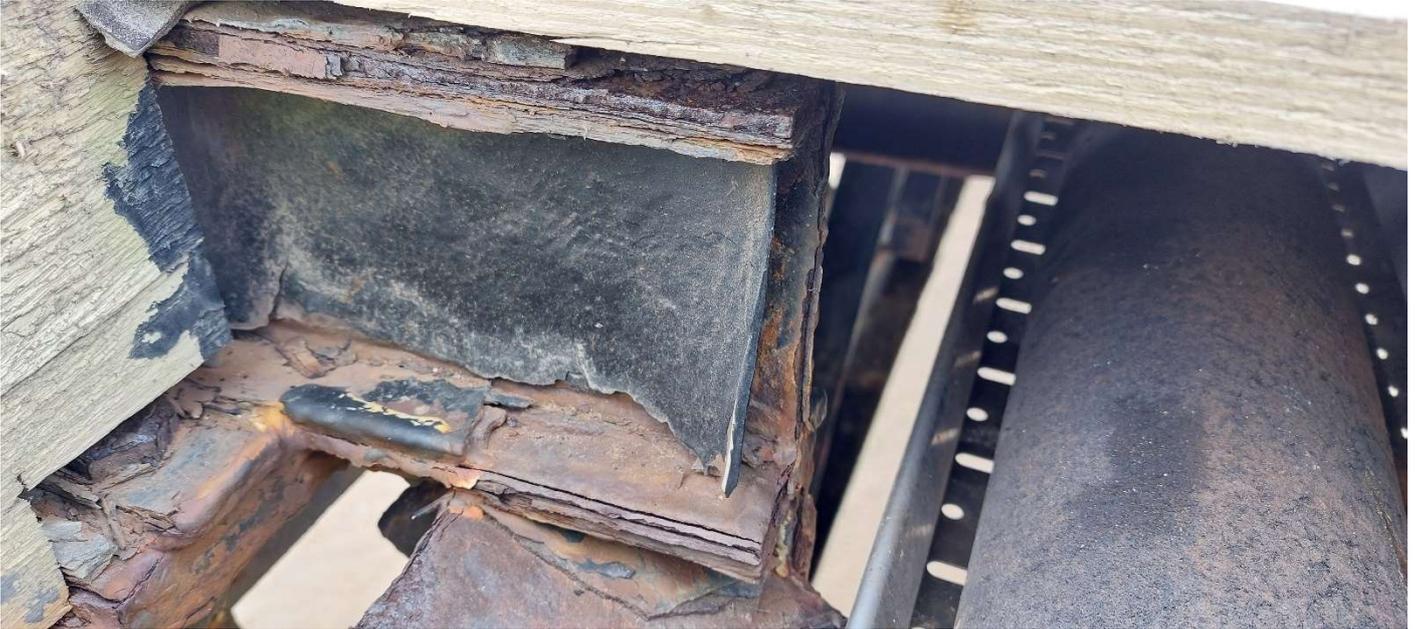
Photograph 41 – View on elevation of damaged 127mm deep Beam

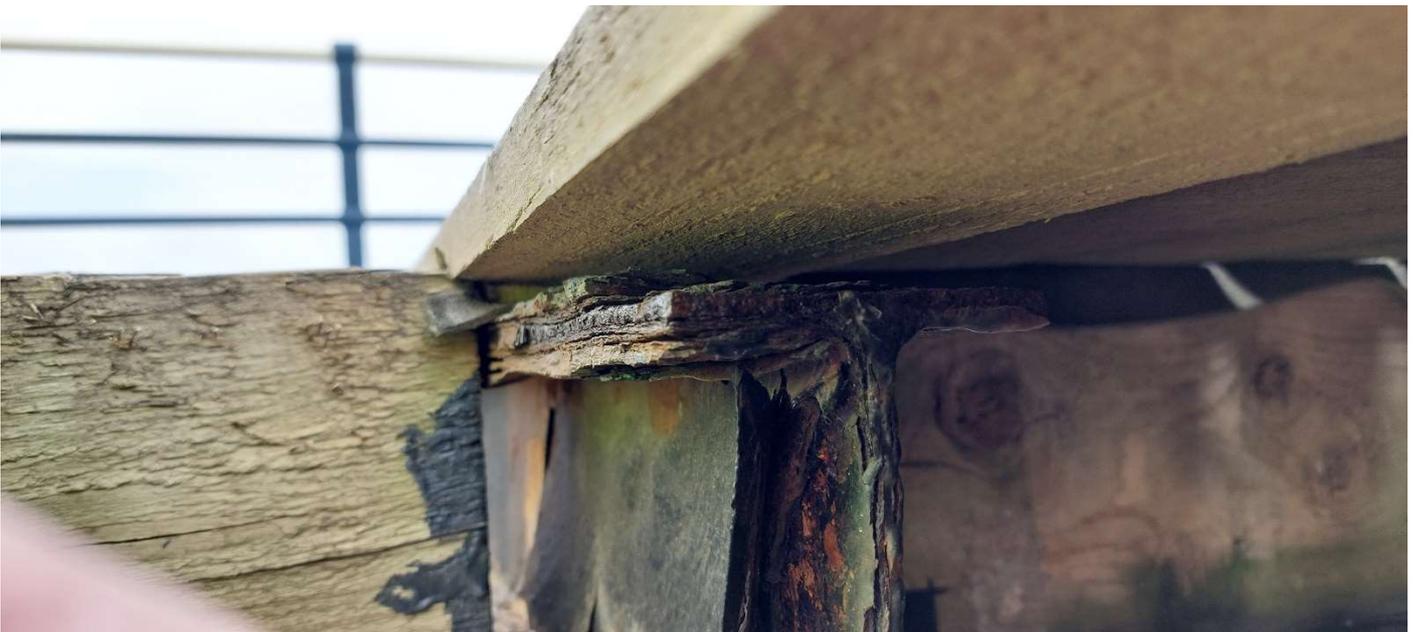
Photograph 42 – View on end of damaged beam in Photograph 36

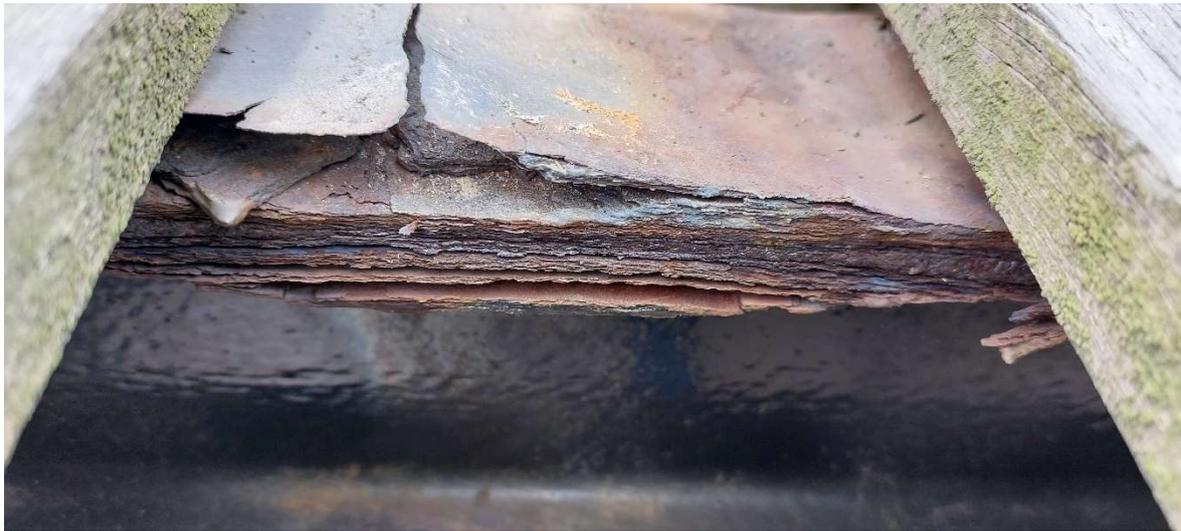
- 2.50 The steelwork supporting the central section of the deck under the existing train rails and the oak beams, was inspected in numerous locations and there was severe damage present. The beams, 152mm deep column sections, can be seen to have corroded and delaminated to such an extent that there is significant loss of the beam flange, there is no structural capacity remaining, this can be seen in Photographs 43 and 44. These will need to be replaced during the next phase of works.

Photograph 43 – Severe delamination of the top flange there is no remaining steel section

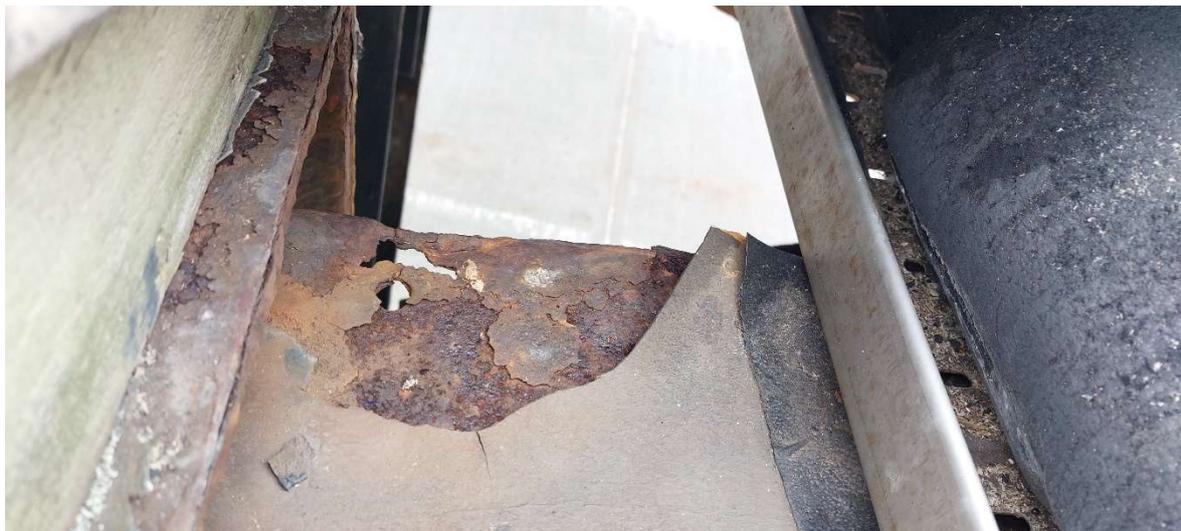
Photograph 44 – Holes caused by delamination and corrosion in the top flange of the steel beam

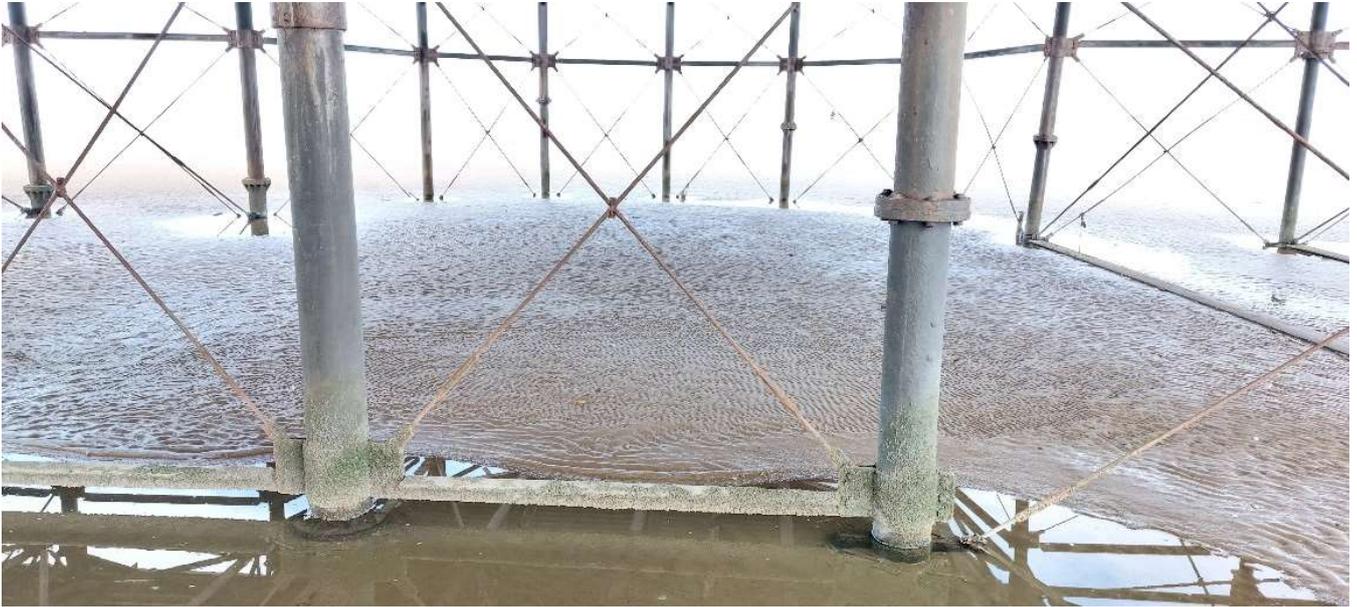
- 2.51 A visual survey to the underside of the pier over the beach, recorded similar damage at a number of locations. The true extent of damage to the beams directly under the timber decking is difficult to quantify at this time and would require lifting of the decking along the full length of pier.
- 2.52 An issue observed at the base of the columns along the beach section was corrosion of the exposed structural elements. The corrosion, seen in photograph 45, encompasses the perimeter of the cast iron column, and adjacent steel bracing members at this level. This damage will likely be caused by these members under repetitive submersion by sea water and any movement in the sands that would also conceal the member.

Photograph 45 – Corrosion to base of seaward pier columns

- 2.53 No testing was carried out on the iron columns, these will need further investigation as part of the remediation scheme to clarify the structural condition, e.g. any internal cracking not externally visible.
