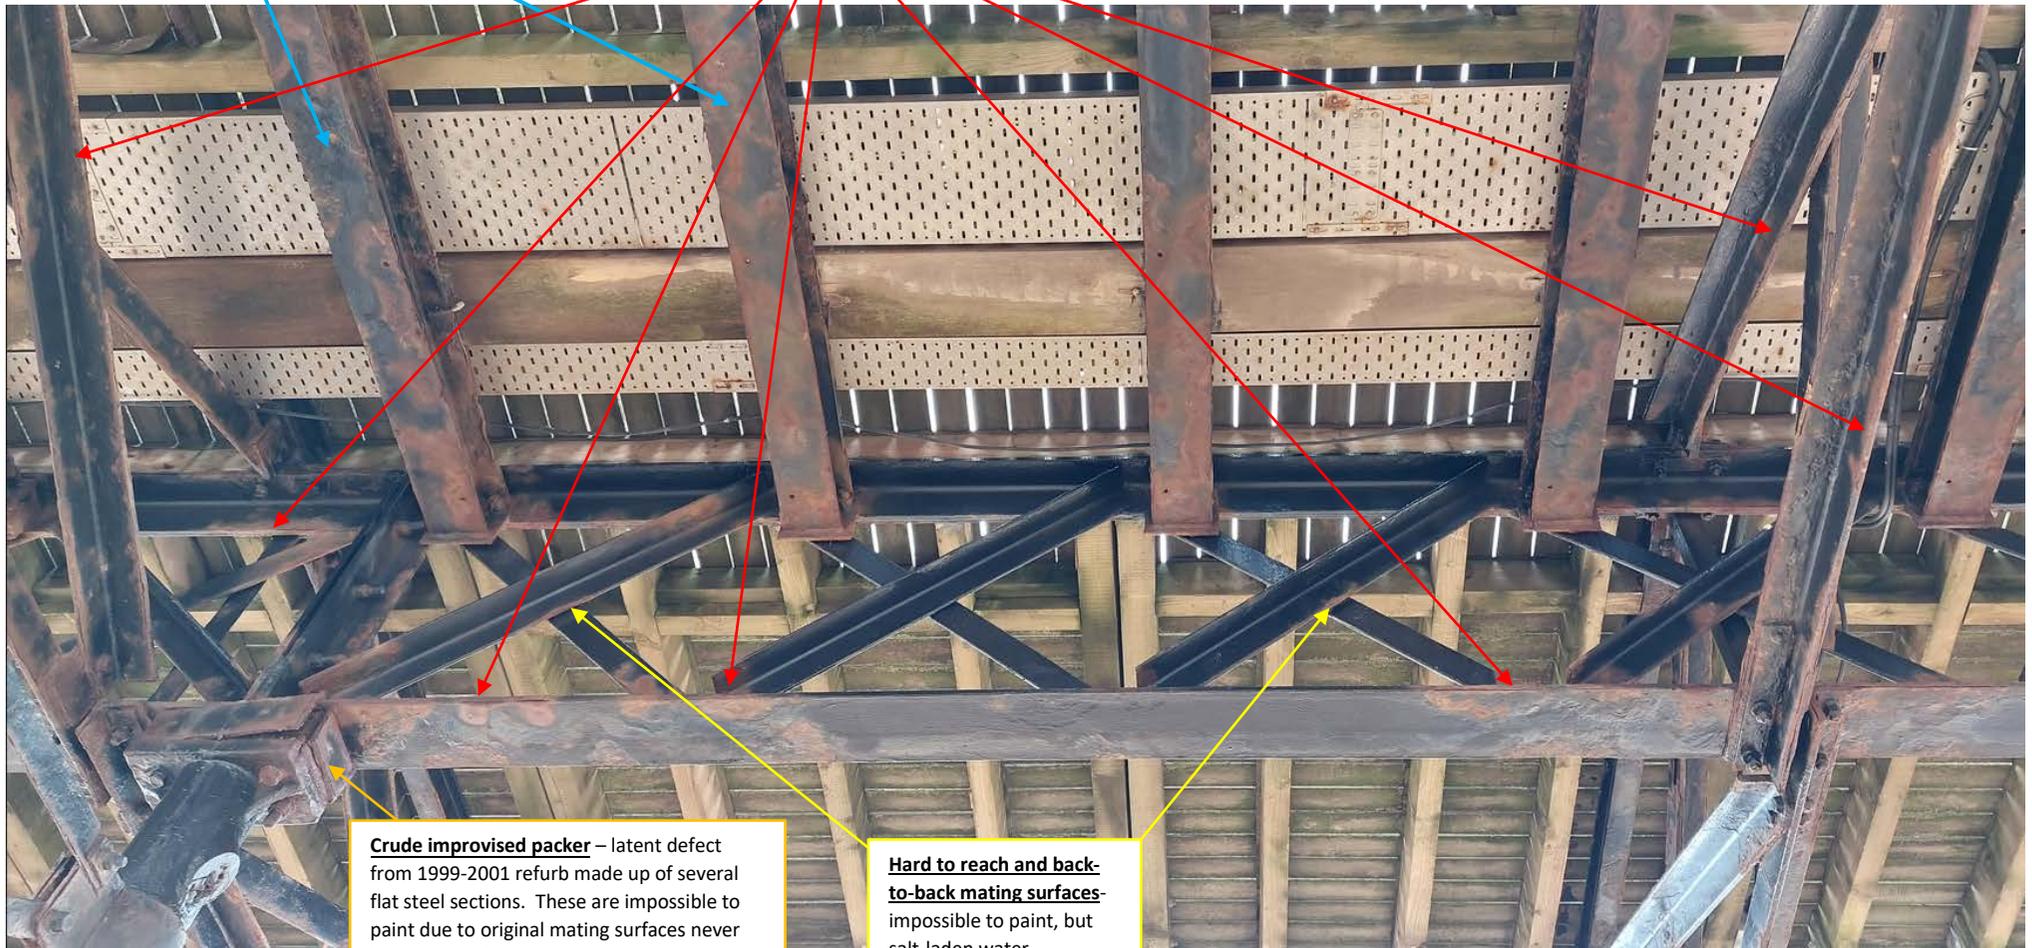
**6" UB's** – these support disused tram tracks and are effectively redundant.

Tops are not properly painted due to lack of access and salt water pools on the flange and runs down the beam causing staining.

**Multiple areas of Edge failure** due to lack of radius edges – another latent defect from 1999-2001.

Its calculated there are 100,000 linear metres of defective edges (with insufficient radius). These need to all be individually ground to a 3mm radius.

**Crude improvised packer** – latent defect from 1999-2001 refurb made up of several flat steel sections. These are impossible to paint due to original mating surfaces never being painted. These need to be removed and replaced with pre-formed stools.

**Hard to reach and back-to-back mating surfaces** – impossible to paint, but salt-laden water penetrates causing corrosion.
