## Structural Inspection

Southport Pier  
Promenade  
Southport  
PR8 1QX

Sefton Metropolitan Borough Council  
Magdalen House  
Trinity Road  
Bootle  
L20 3NJ

Dated: April 2023

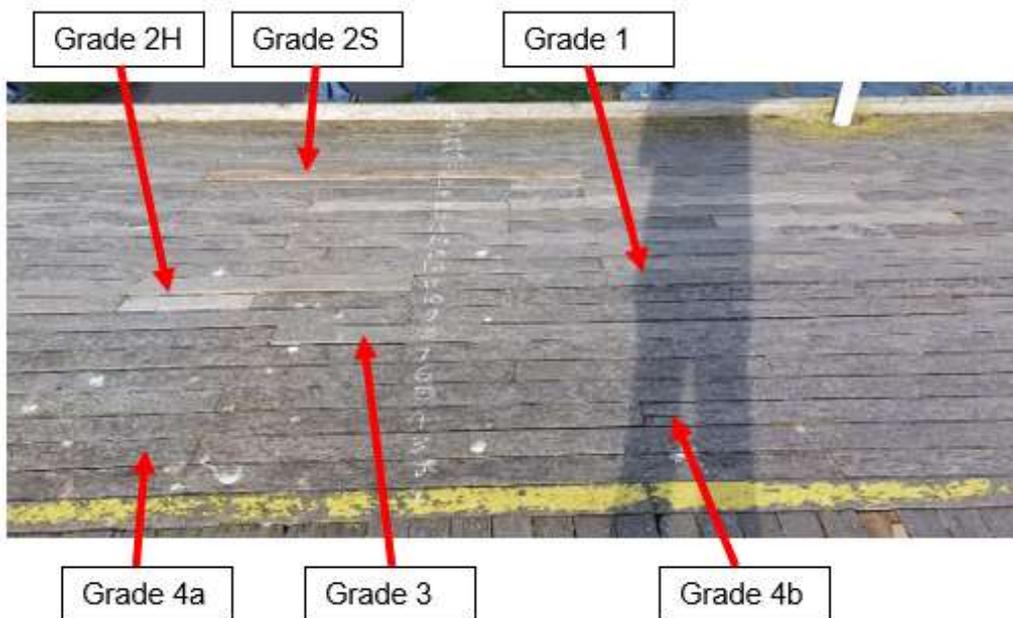
1. Good condition
2. Previously replaced boards (recorded as Softwood (S – assumed to be temporary) or Hardwood (H))
3. Loose Board
4. Damaged Board (sub-split into minor (a) and major (b) damage)
5. Board needs replacing

Photograph 4 – Typical examples of board grading criteria.

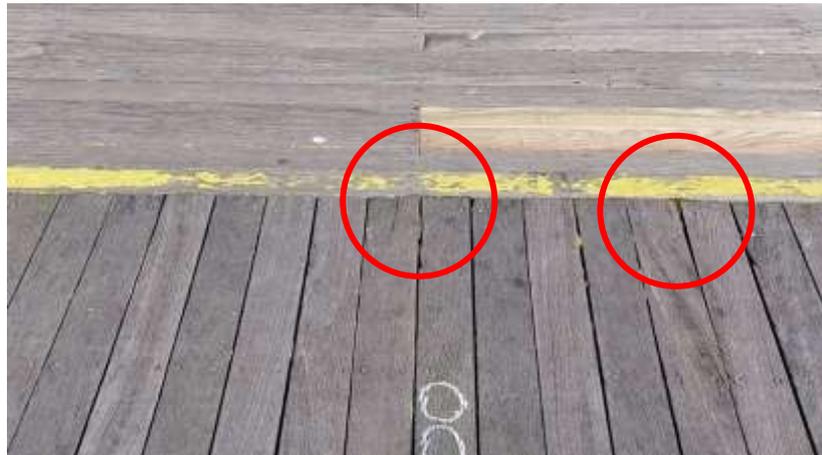
2.11 It could be seen at the noggin ends of the boards, that to the top of the joists in the north and south sections of the pier that moss or vegetation is forming on the top of the joists causing the central deck boards at these locations to displace by being pushed upwards. This is creating inverted vee's over the joists, or solitary raised boards, this is highlighted in photograph 5 and figure 3 below. This issue is creating trip hazards along the pier, due to the uneven surface. Where this occurs, and any additional trip hazards, their location was added to the notes taken.

Photograph 5 – Indicating the inverted “vee” caused by movement of boards.

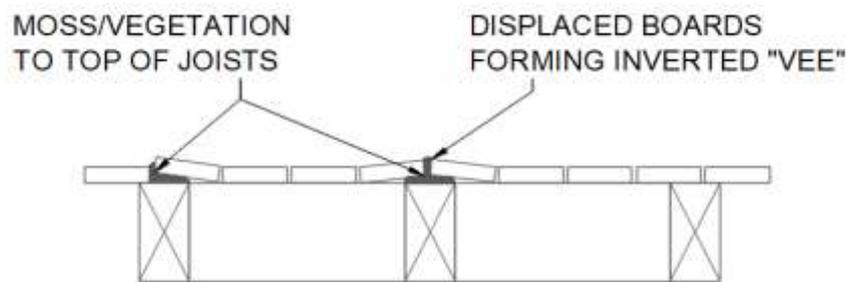
Figure 3 – Detail showing displacement of boards.

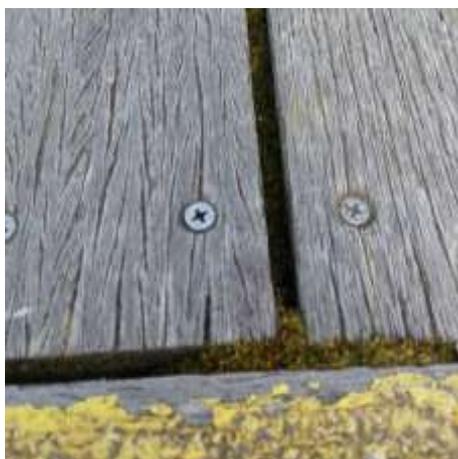
2.12 A typical observation along the deck was the moss growing on or between the boards occurred mostly over the land-based section rather than the seaward side. Some examples of the moss and fungi present between the boards can be seen in photographs 6 and 7 below.

Photograph 6 – Evidence of vegetation/moss growing in board joints.

- 4.4 Following any remediation or replacement of timbers on the pier, Thomasons recommend an appropriate maintenance plan be set up to ensure the deck is maintained regularly and removal of any organic growth, moss etc, is maintained to prevent areas of constant saturation to reduce the likelihood of similar damage to the boards re-occurring.

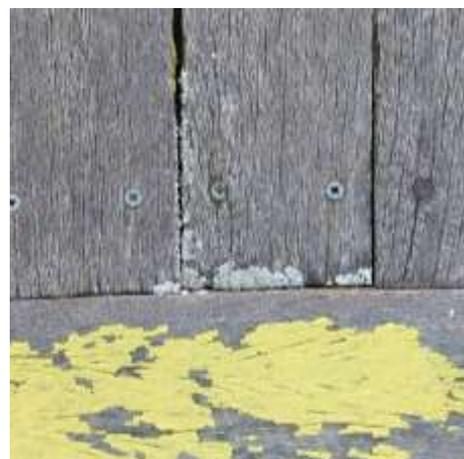
Photograph 7 – Evidence of vegetation/fungi growing in board joints.

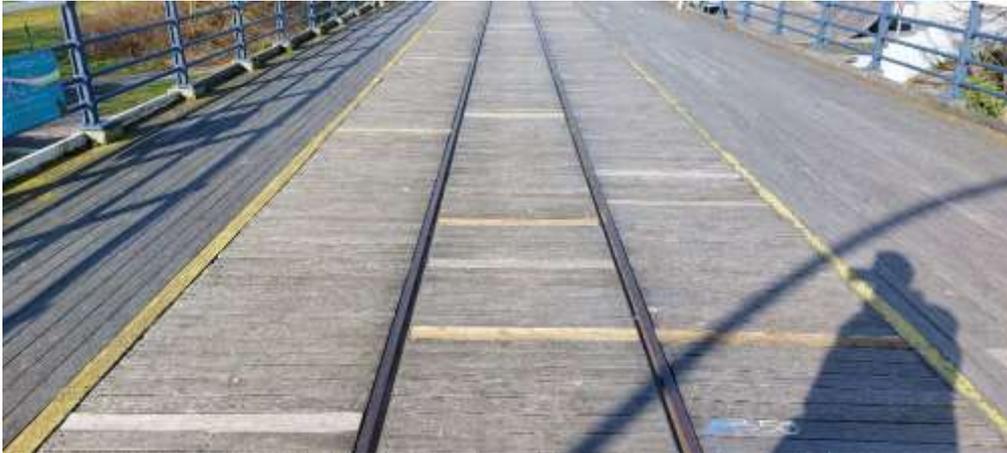
- 2.13 Boards that have been replaced previously were also noted. From the photograph below, the replacement boards are lighter than the original boards, and the variation in colour highlights if the boards are unweathered softwood (brown – assumed to be temporary) or hardwood (grey).

Photograph 8 – Highlighting boards that have previously been replaced in the centre section.

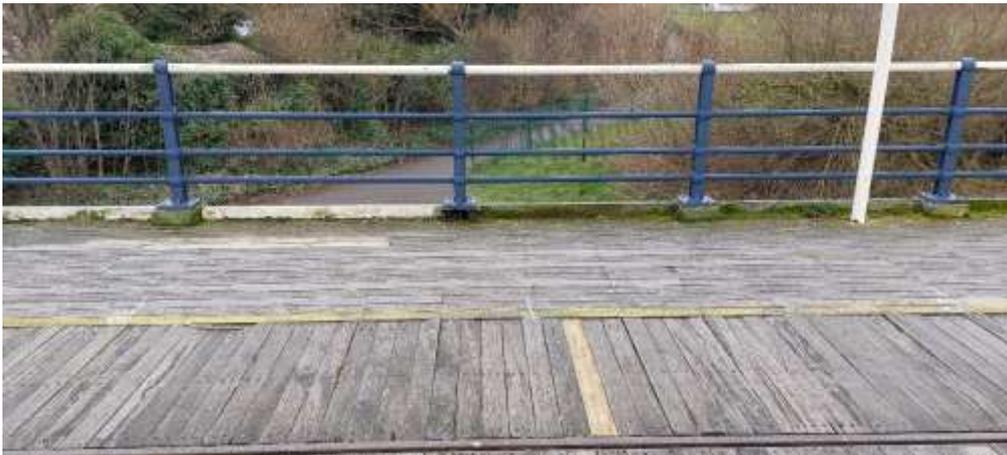
- 2.14 The outer edges of the central boards show evidence of movement in the noggins to the underside. This movement has likely been caused by the train that runs up and down the surface of the pier. Since the train doesn't require rails, it can use the full width of the deck. The noggins to the underside have deteriorated along the pier loosening any fixings, therefore the wheels from the train will gradually push them down. This has caused the decking boards to become loose, forming an uneven surface, and created trip hazards between adjacent decking sections. This is evidenced in photograph 9 below and highlighted by figure 4. It has been advised that the current road train weighs 9.81kN (1000kg) and the passenger carriages when fully loaded weigh up to 11.28kN (1150kg), both running on four wheels with an axle width of 1220mm. Appendix B includes calculations that indicates the maximum loading a typical 6"x3" joist can withstand has been determined to be 2No. max point loads of 2.84kN (290kg), when spaced 1.22m apart along the span of a joist, this capacity is greater than the force imposed by the Road Train engine, 2.45kN (250kg) and the passenger carriage 2.82kN (287.5kg).

Photograph 9 – Highlighting movement in timber noggins to underside of centre section.

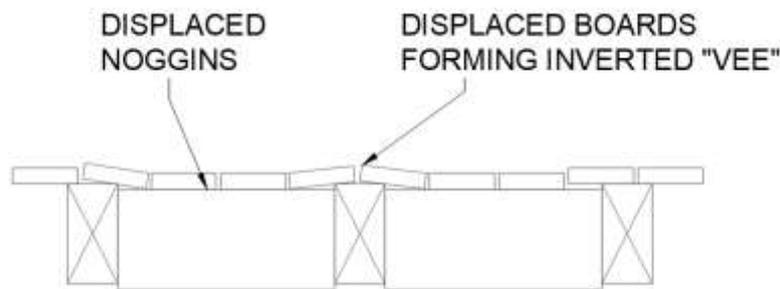
Figure 4 – Detail showing displacement of noggins.

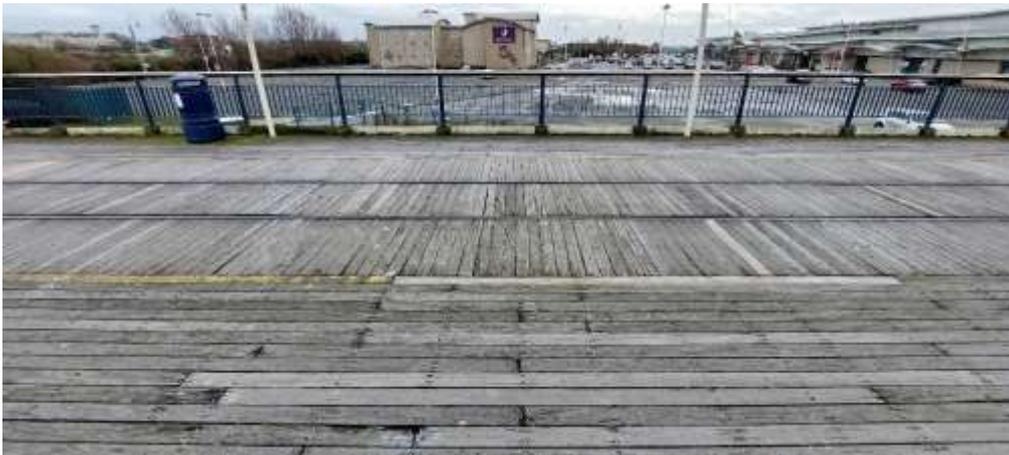
2.17 Inspection of the longitudinal boards found any damage present was typically at the board ends. Any damage along the board was found located at a natural defect in the board, such as knots or the orientation of the wood grain. These defects have allowed water ingress, and due to exposure to the elements, a constant saturation and drying out process will cause cracking at these natural defect locations. This will also have been aided by the constant pressure applied by pedestrian footfall and the train. There is evidence of uneven decking boards due to loose or missing screw fixings, and where insufficient repairs have been carried out.

Photograph 10 – North (shown near side above) boards indicating damage at ends or fixing points.

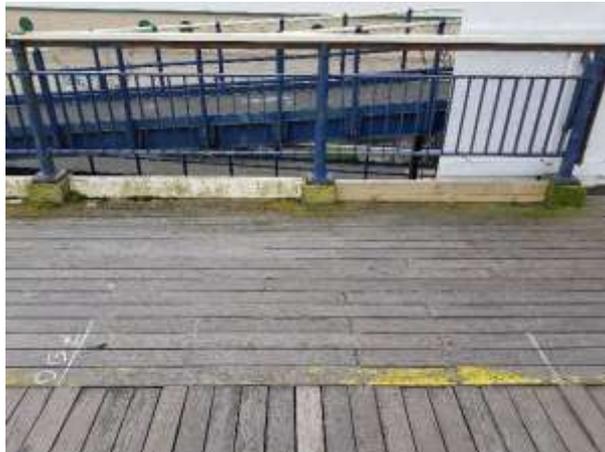
Photograph 11 – South boards indicating damage at fixing points.

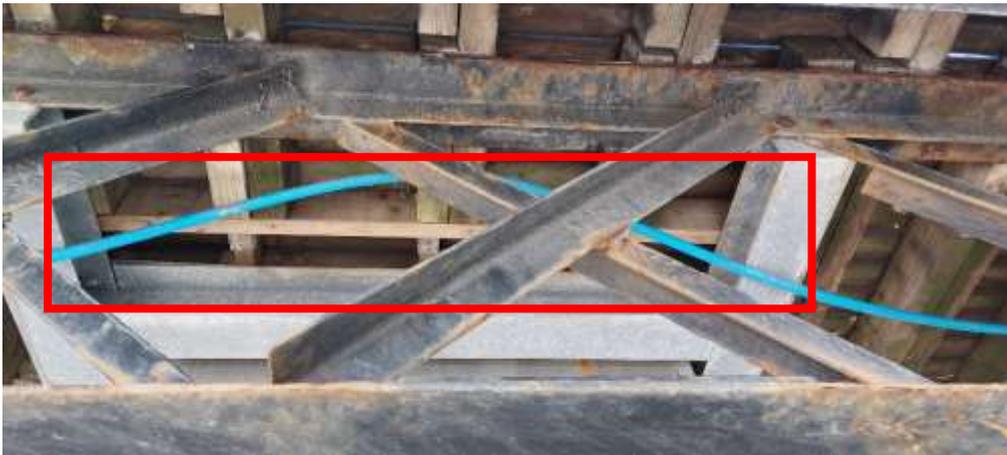
- 2.18 At the first shop unit, a rectangular section of decking has been cut away to allow the installation of mechanical plant to the underside of the deck. When the decking has been replaced, smaller section joists have been utilised, these can be seen through the boards and in photograph 12. There is a lot of movement under foot of the decking timbers when walking across.

Photograph 12 – View on smaller replacement joists (highlighted) to underside of cut-out outside second shop.

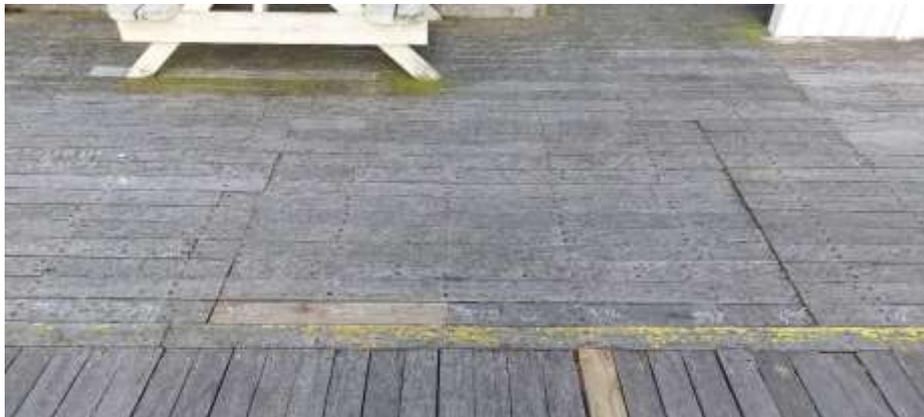
- 2.19 When reviewing the boards above the area on photograph 12 the decking boards are dipping, as seen in photograph 13, and have settled at the edges creating a trip hazard to members of the public. There is also a similarly cut section to the front of the second unit along the pier, seen in photograph 14. It is understood these modifications leading to the cause of the dipping is due to alterations undertaken for Mechanical and Electrical installation works in 2017.

Photograph 13 – Decking cut out and replaced outside first shop.

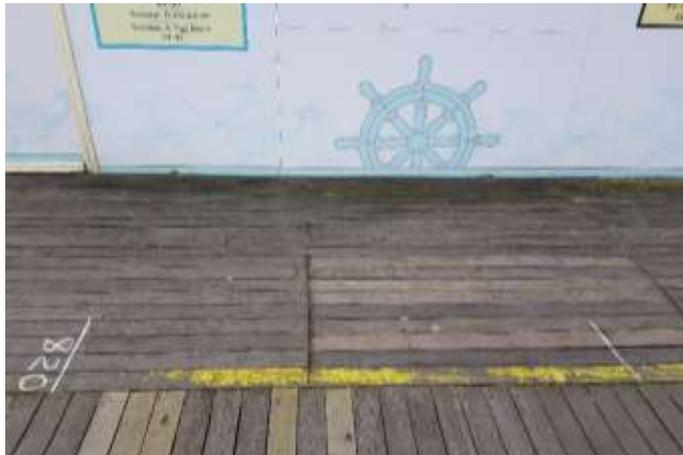
Photograph 14 – Decking cut out and replaced outside second shop unit.

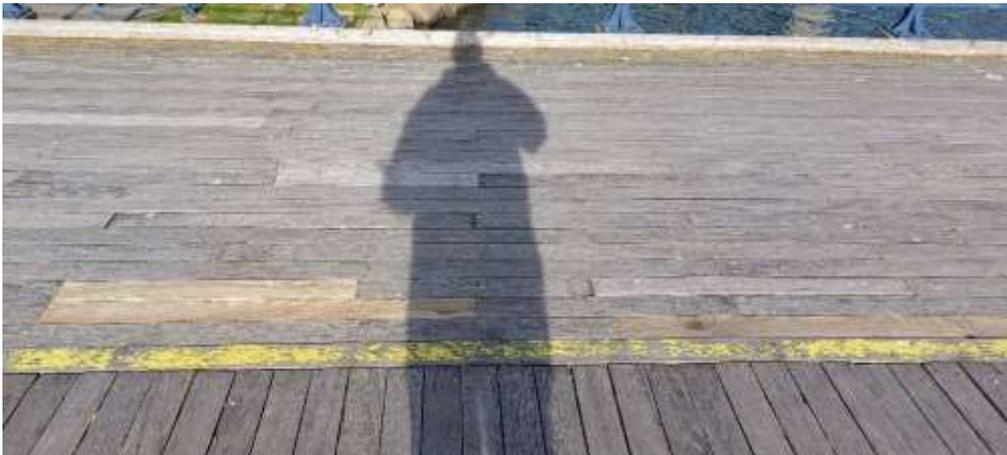
- 2.23 As a general note, along the pier numerous boards have been replaced in the central and side sections. This has been to repair general wear and tear of the decking and where members of the public have had boards break whilst walking over them.

Photograph 15 – Highlighting boards that have previously been replaced in the north section.

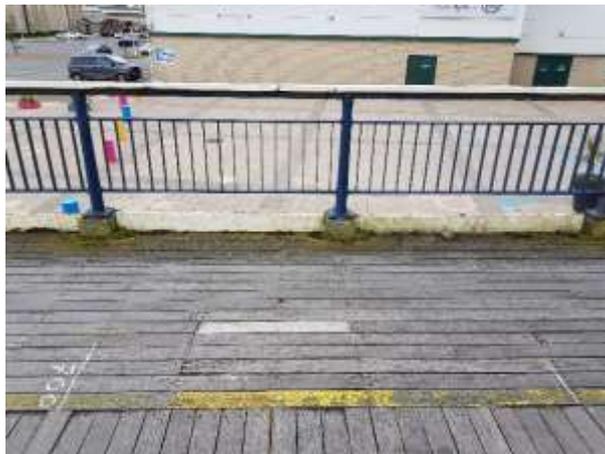
Photograph 16 – Indicating some replacement boards and dropped noggins to the south side of the deck.

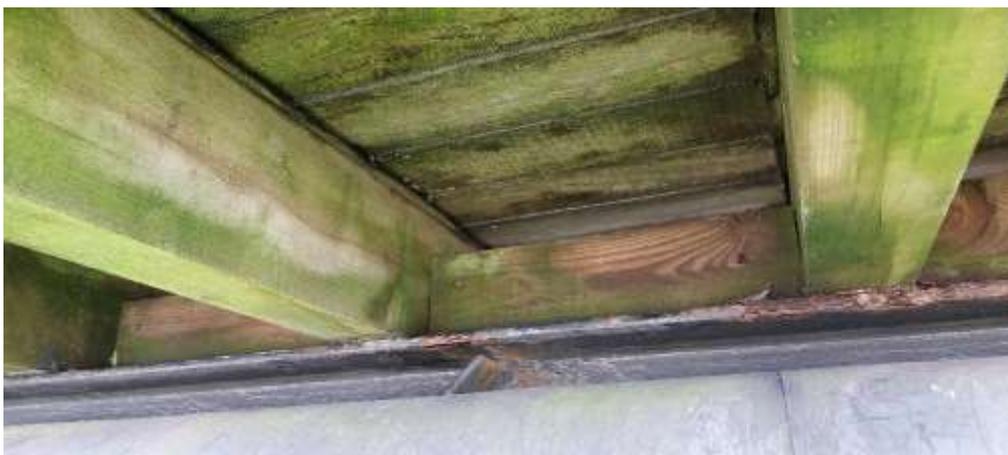
- 2.32 Fixing of noggins was with skewed nails through the ends of the noggins into the joists. Where the noggins sat between joists and steel beams, the noggins were seated into the web of the beam, and skew nailed into the joist at the opposite end. The skew nail fixing is not a controllable structural fixing, penetration depths and edge and spacing distances are erratic and can cause failure in the supported and supporting members which is generally observed throughout the deck.

Photograph 19 – Indicating fixing of noggins over steel trusses.

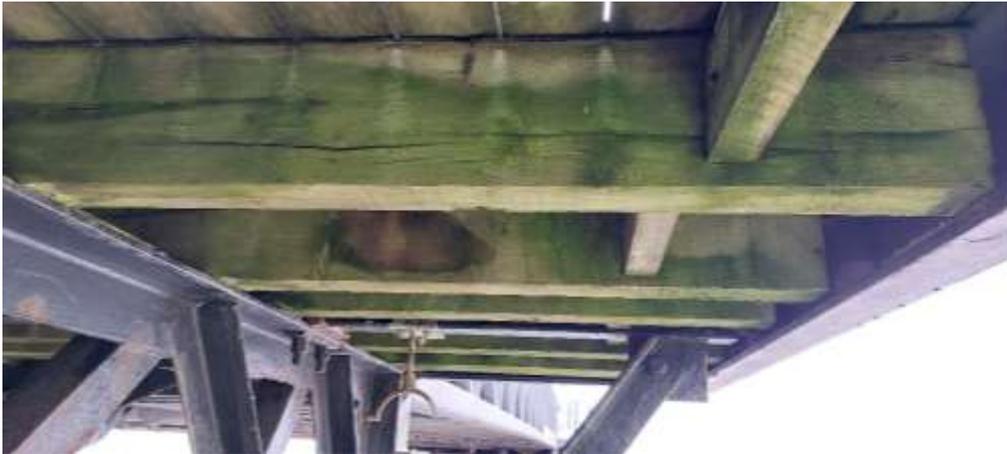
- 2.33 Some of the damage seen in the timber can be seen in photographs 20 and 21 below. Some minor cracking along the sides of the joists are natural splits within the grain where the timber has dried out, this is seen in photograph 20. Other splits in the timber are damage caused by the nails when fixing the noggins to the joist, see photograph 21, and caused shear failures in locations.

Photograph 20 – example of cracking along sides of joists.

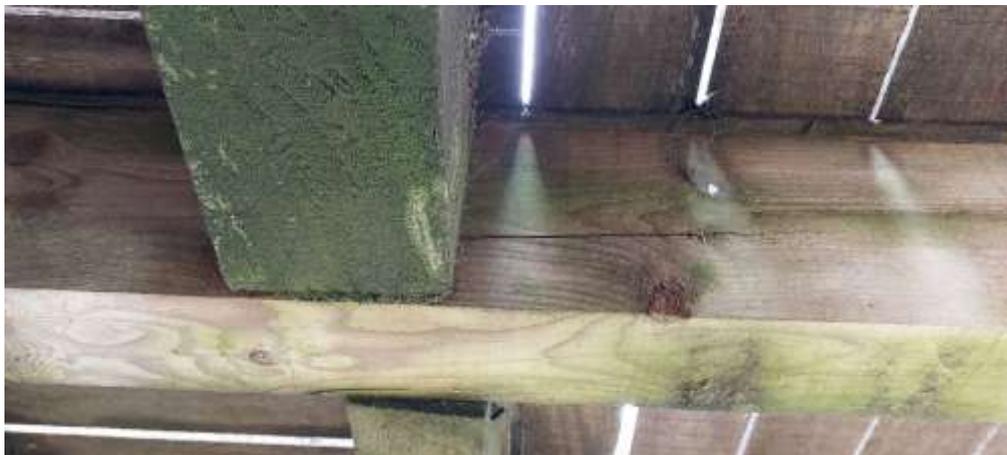
Photograph 21 – example of splitting in joist at fixing location.

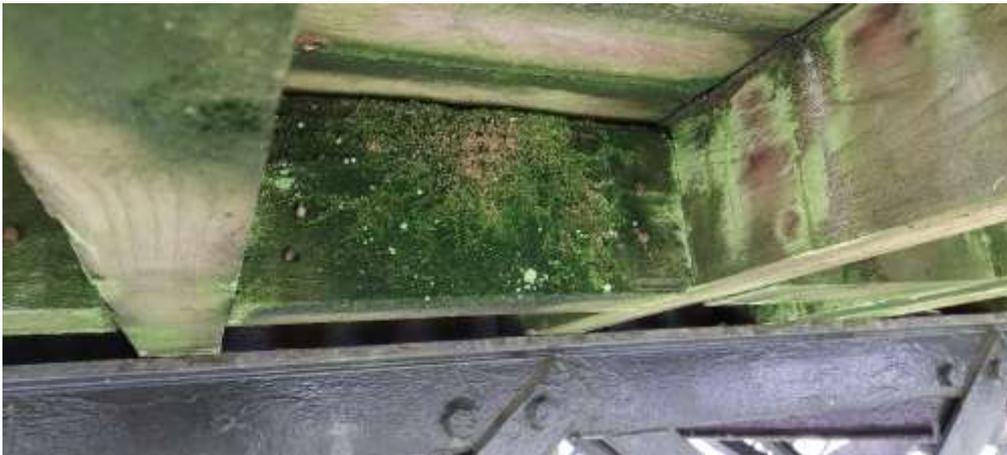
- 2.34 A large amount of moss, vegetation and fungi was present on the deck underside, this is evidenced in photograph 22. In some areas there were ferns growing in the joints of the joists and boards.

Photograph 22 – example of vegetation and moss present on timber.

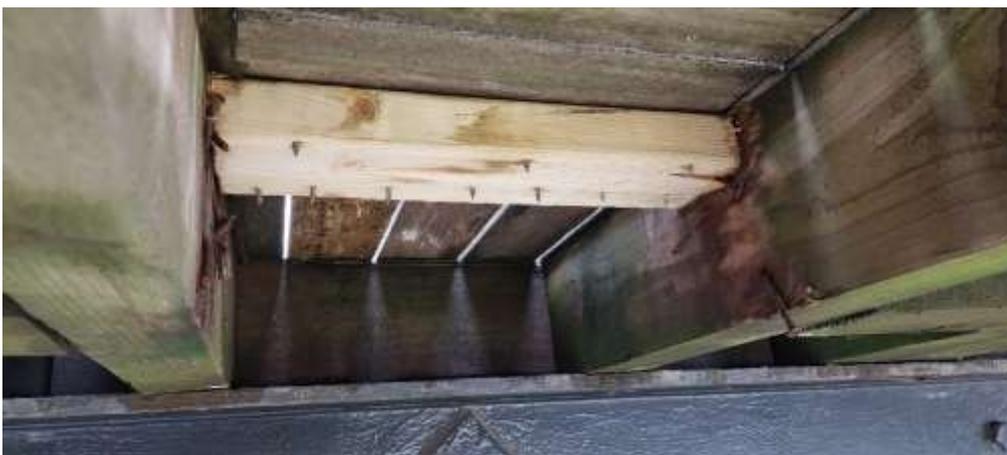
- 2.35 Photograph 23 below shows an example of a makeshift repair to the deck underside, using untreated timber as a replacement noggin. The fixing at the ends of the timber has caused it to split, and in order to provide a new fixing to the decking boards, numerous screws have been installed to the boards. This repair work is suitable for a short term/temporary repair, but long term will have a detrimental effect on the adjacent timber work. The screws are too long for the timber and have penetrated the underside, this creates a point of ingress for water. As noted in paragraph 2.32 the skew nail fixing is not a controllable structural fixing, penetration depths and edge and spacing distances are erratic and can cause failure in the supported and supporting members which is generally observed throughout the deck.

Photograph 23 – example of makeshift replacement noggin.

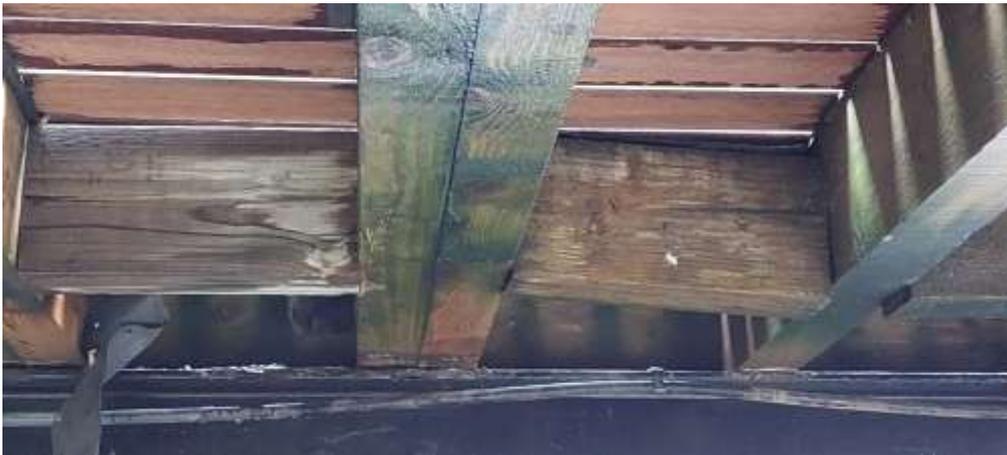
2.40 Noggins to the underside of the deck in this area are typically full depth timber and have been wedged between the joists with no physical fixing noted. Photograph 25 below indicates that the noggins to the right-hand side have dropped, and this detail occurs frequently at noggin positions. At the start of the pier, the decking boards span over the joists, and do not rely on the noggins for support, this happens on the main span of the deck and will be discussed later in this report.

Photograph 25 – Indicating displacement of noggins between joists.

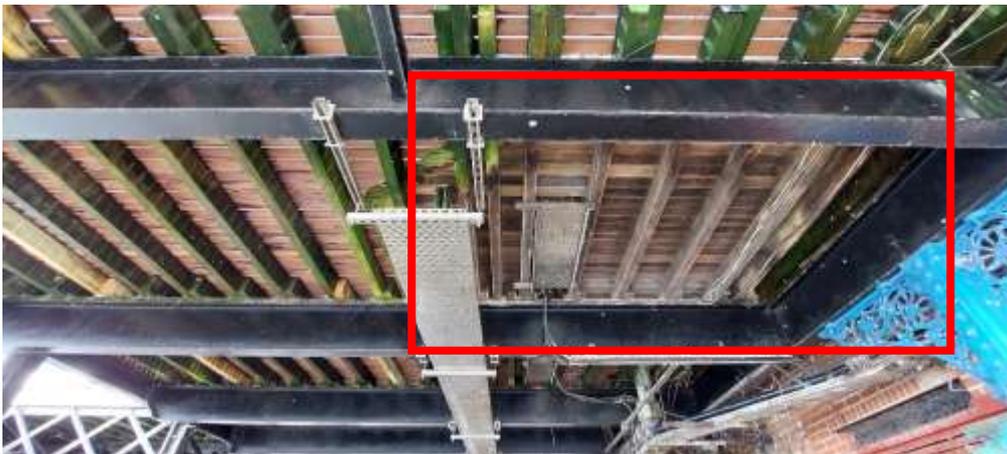
- 2.41 Along the eastern edge of the pier where it butts up to the rear of the chip shop above, there is a section of timber decking that hasn't been replaced as part of the phase 1 of the refurbishment works. This is indicated in photographs 26 and 27 below. The joists to this section also appear to have been left in place. This is likely due to the original ticket office located on the deck above. From our observations on site, it was noted that the deck replacement works had been carried out around the perimeter of the ticket office walls above the deck, and the respective joists below have been left untouched.

Photograph 26 – highlighted area of decking boards not replaced during Phase 1 works.

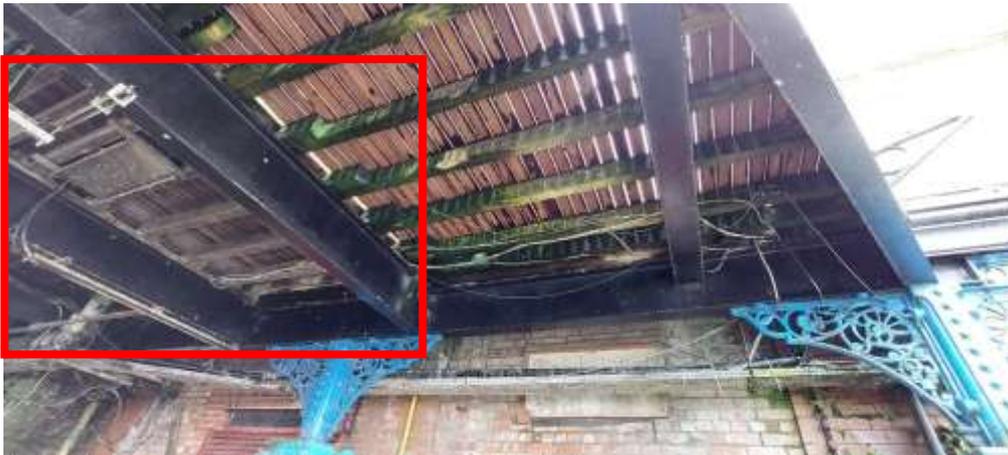
Photograph 27 – highlighted area of decking boards not replaced during Phase 1 works.

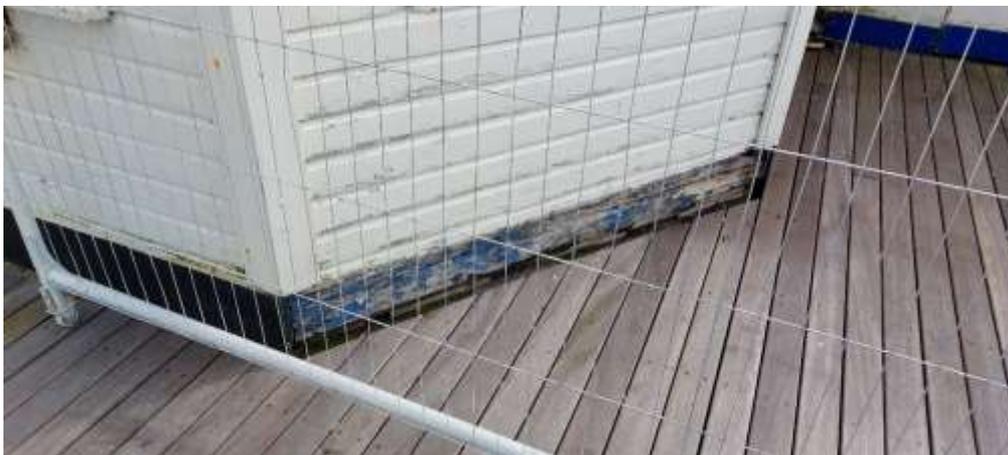
- 2.42 Around the base of the ticket office located over this section of pier decking the timber is rotten. The area of rot present, and seen in photograph 28, appears to have grown to include to the supporting timbers below, and has started to affect the adjacent replaced timbers due to the excess retention of moisture at interfaces, this was observed and noted in the BM Trada reports of 2017 and 2022, Sections 6.0 & 7.0, during which time the estimated number of boards affected grew from 1% to 6%, this has further increase and is verified in Section 3 below.

Photograph 28 – view on base of original ticket office indicating decay of timbers.

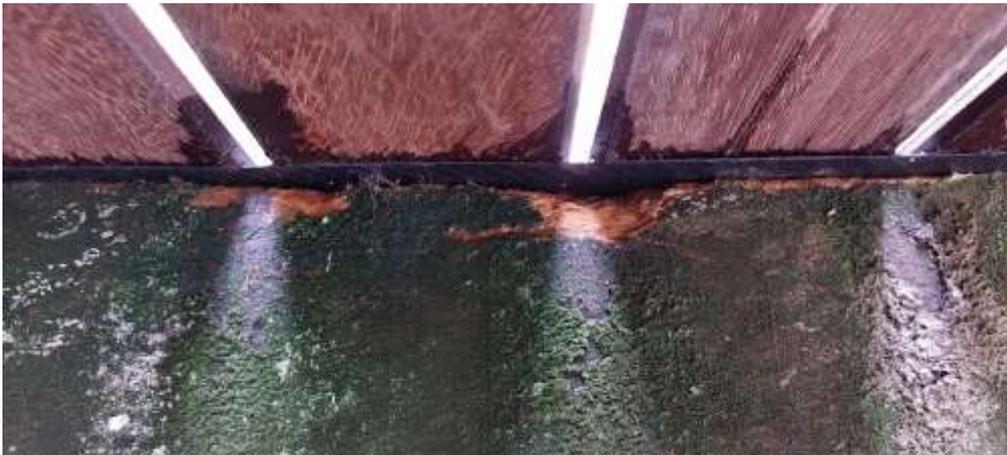
- 2.43 Due to the DPM laid over the existing timber joists the new timber decking appears to be holding moisture for longer than the unsupported section of board as can be seen in photograph 29 below. This will affect, and reduce, the life span of the new decking in the whole southern triangular section of the deck adjacent to the ticket office above due to the retention of this excessive moisture.

Photograph 29 – Indicating example of moisture retention found at the support of new timber decking supported off existing timbers.
