Structural Steelwork Inspection

Southport Pier
Promenade
Southport
PR8 1QX

Contract No: LV1255
Dated: March 2024

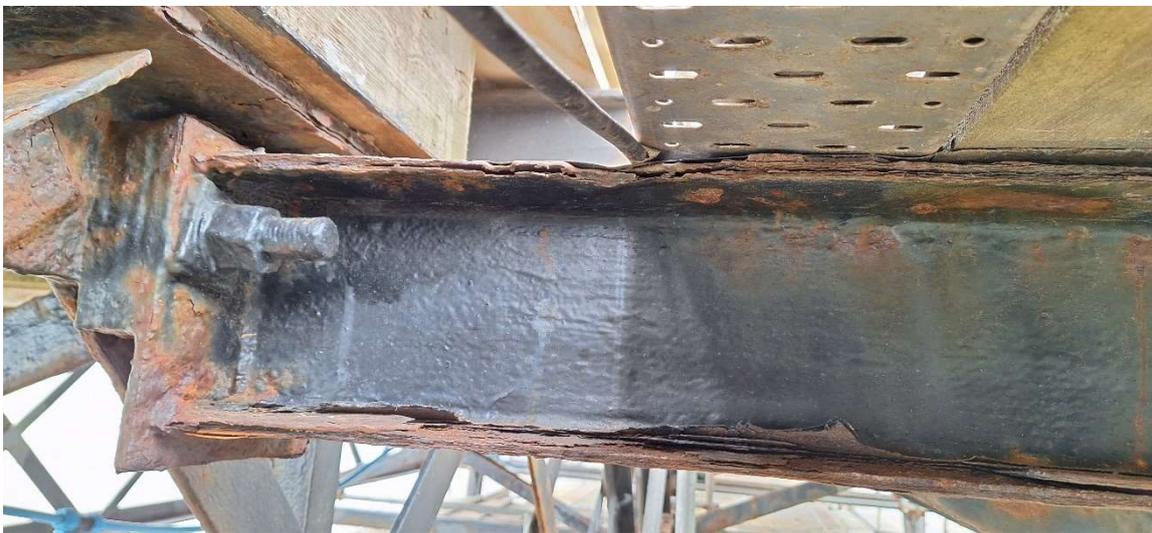
Photograph 05 – Central support Beam Ref 107

3.8 The condition of the central beams varied, with the majority requiring replacing. Beam reference 107 in photograph 05 indicates the typical delamination and section loss noted along the top and bottom flanges. As can be seen, the extent of delamination is such that no solid material of the original steel section remains.

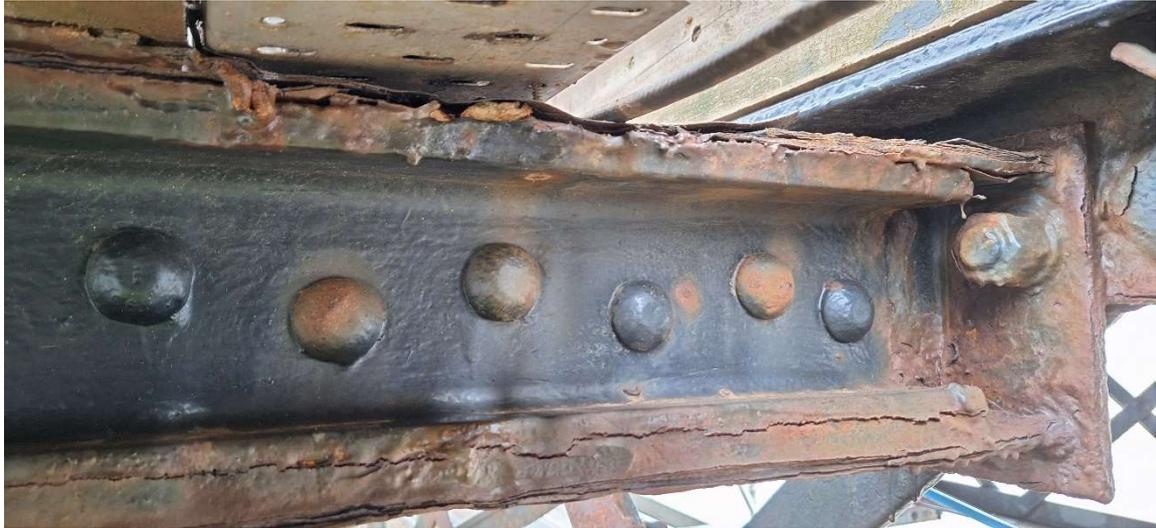
3.9 Photograph 06 below shows a central support beam that has been repaired/strengthened. The 152UC has two 125x65x15PFC's installed back-to-back bolted through the UC web. In addition, full length packing plates, top and bottom, have been installed between the flanges of the UC and PFC's.

Photograph 06 – Central support Beam Ref 120

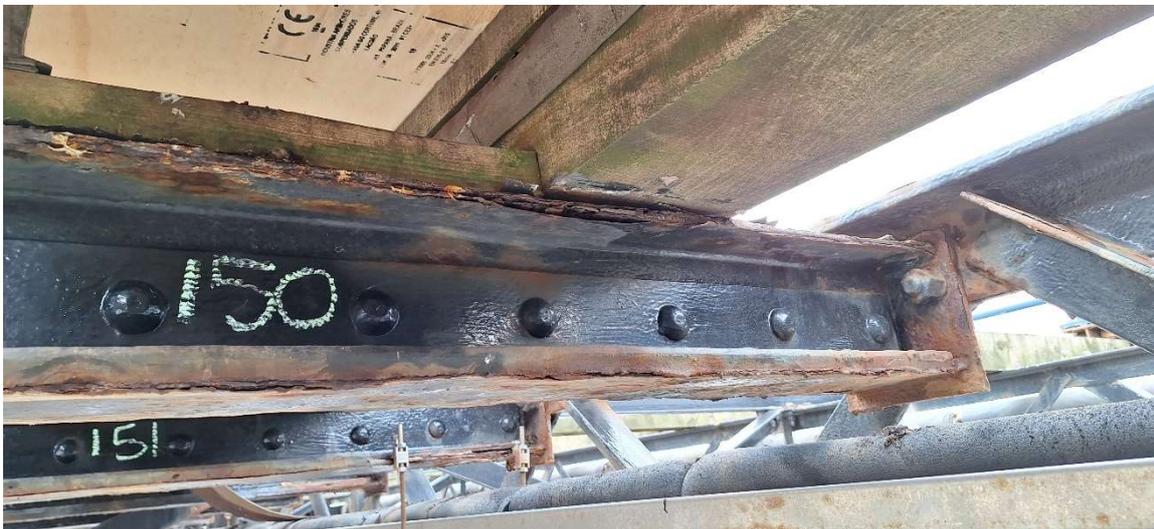
3.10 Historically where the bottom flange has corroded, leaving a shallow depth of section, a remedial repair has been carried out. The remedial detail consists of two steel angles installed either side of the web, seated on the bottom flange, then dome head bolts through the web. At the beam location shown in photograph 07 below, the top flange has also corroded away to nothing at the location of the oak beam.

Photograph 07 – Central support Beam Ref 150

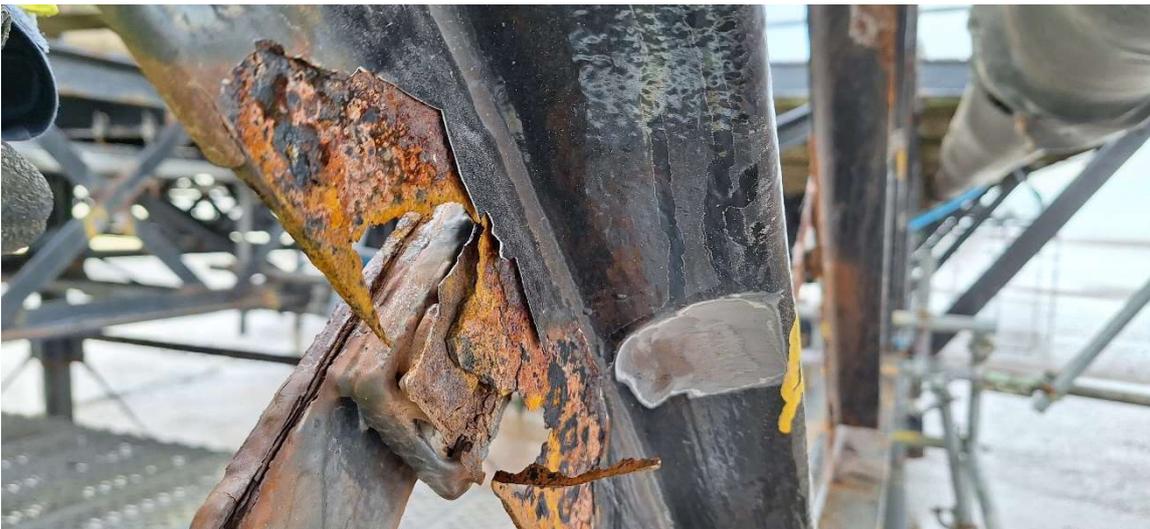
Photograph 08 – Vertical leg of angle brace within Outer North truss in Bay 63

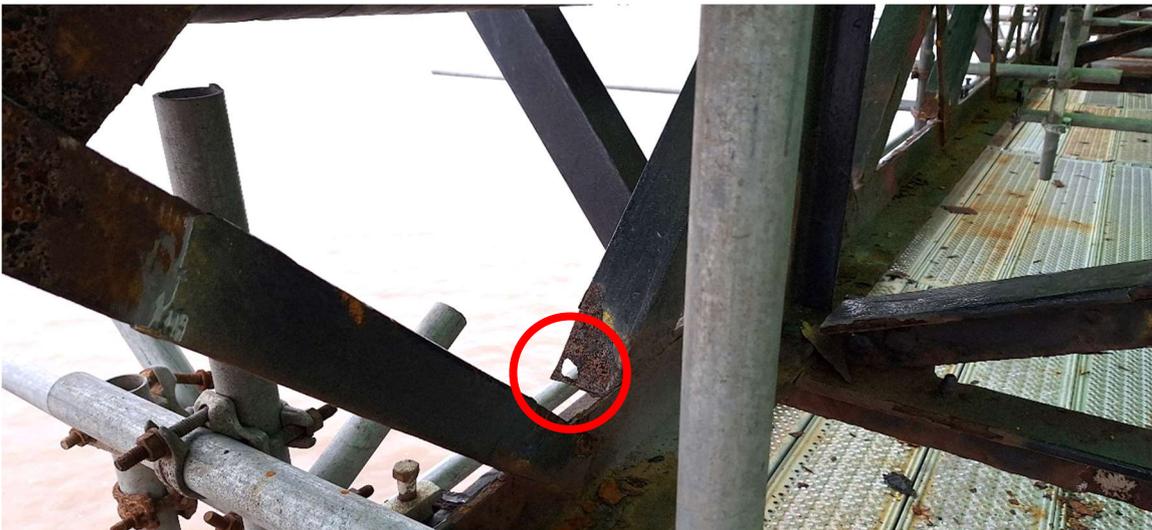
Photograph 10 – Horizontal leg of angle brace within Outer North truss in Bay 62

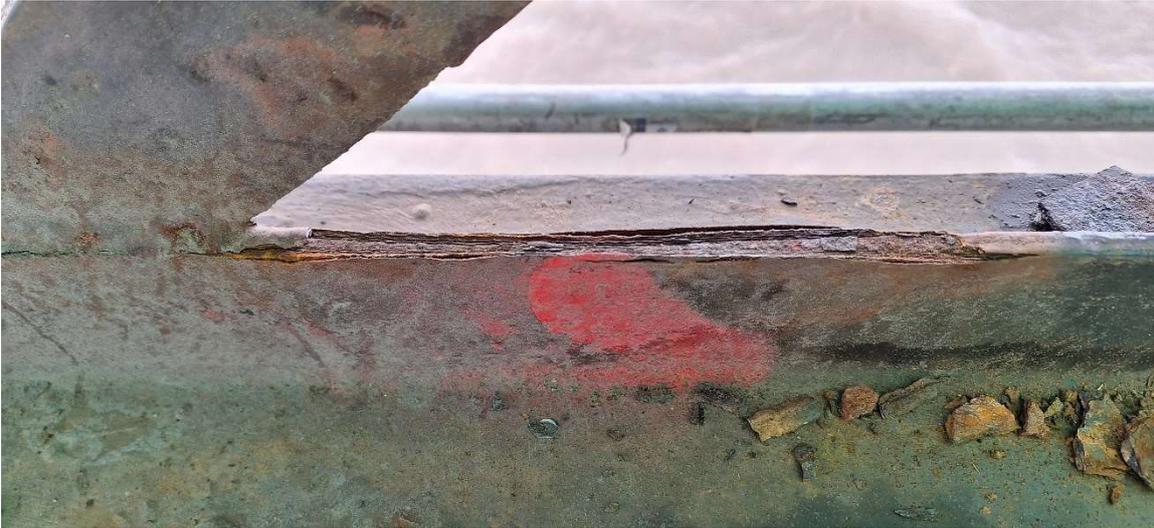
Photograph 11 – Bottom chord of Outer North Truss in Bay 62

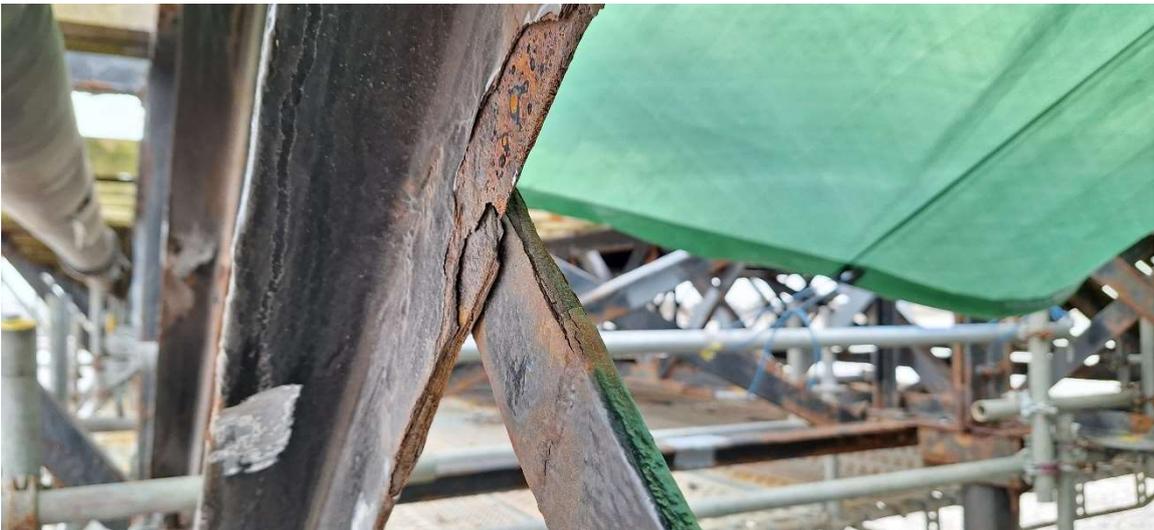
Photograph 12 – Vertical Leg of angle brace within Outer North Truss in Bay 62

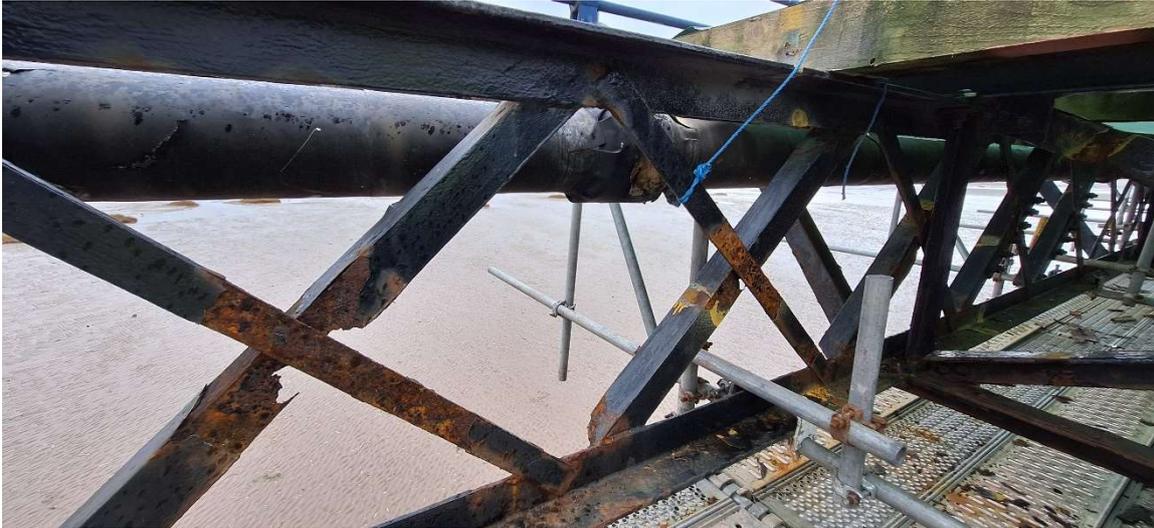
Photograph 13 – View on Outer North truss diagonals in Bay 61

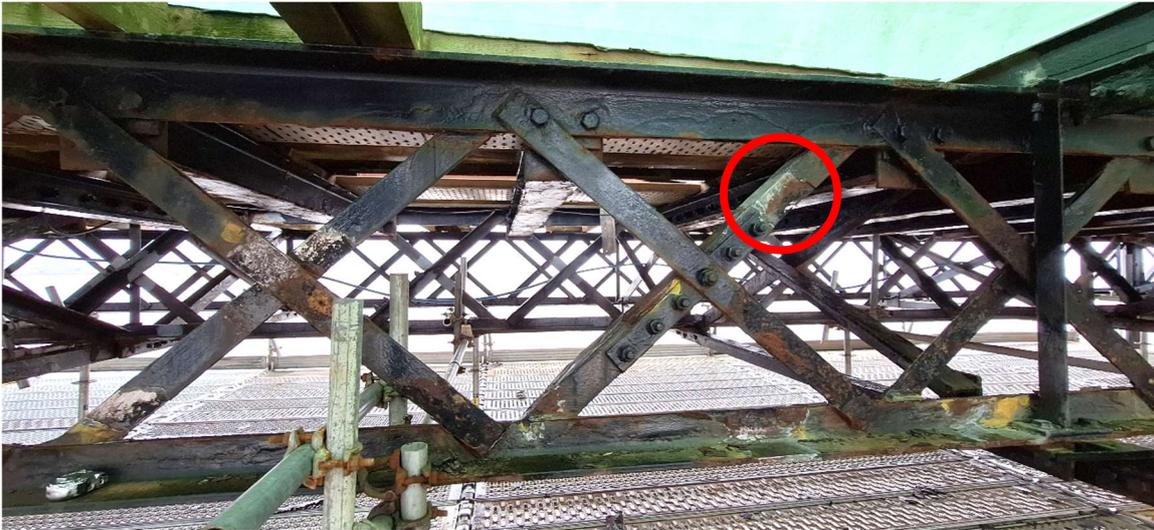
Photograph 15 – Additional loss of section adjacent to previous repair of vertical leg of bracing angle within Mid North truss of Bay

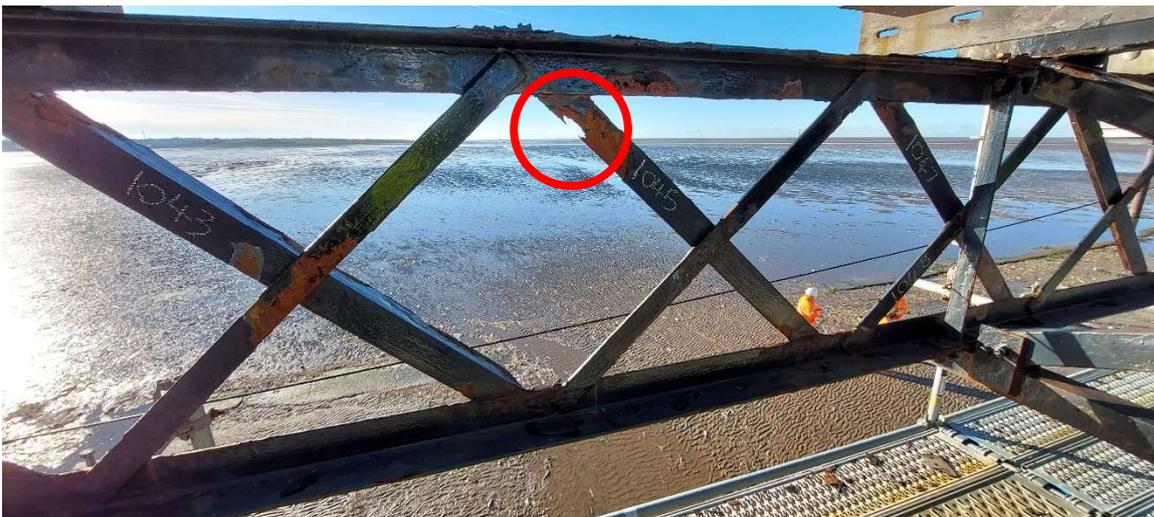
Photograph 16 – Vertical leg of diagonal leg within Outer South truss to Bay 62

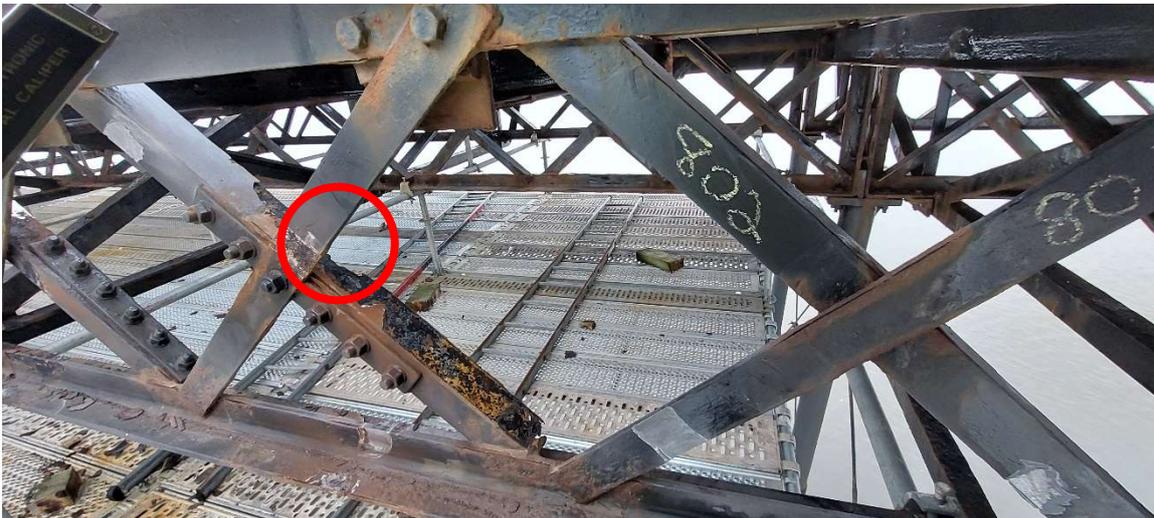
Photograph 18 – Horizontal leg of previously repaired diagonal damaged within Mid South truss in Bay 60

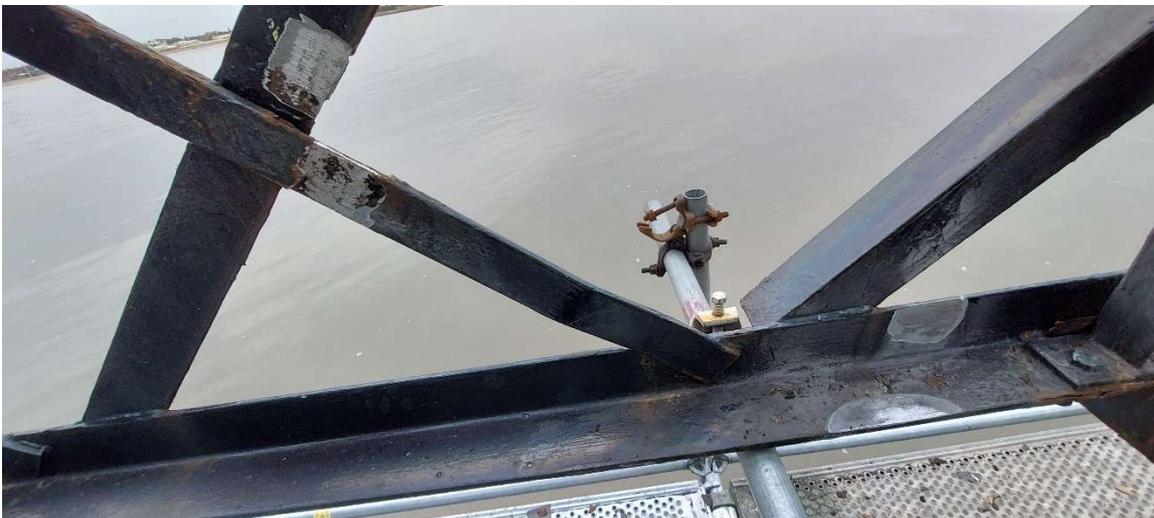
Photograph 19– Buckled flat in Outer South truss in bay 60

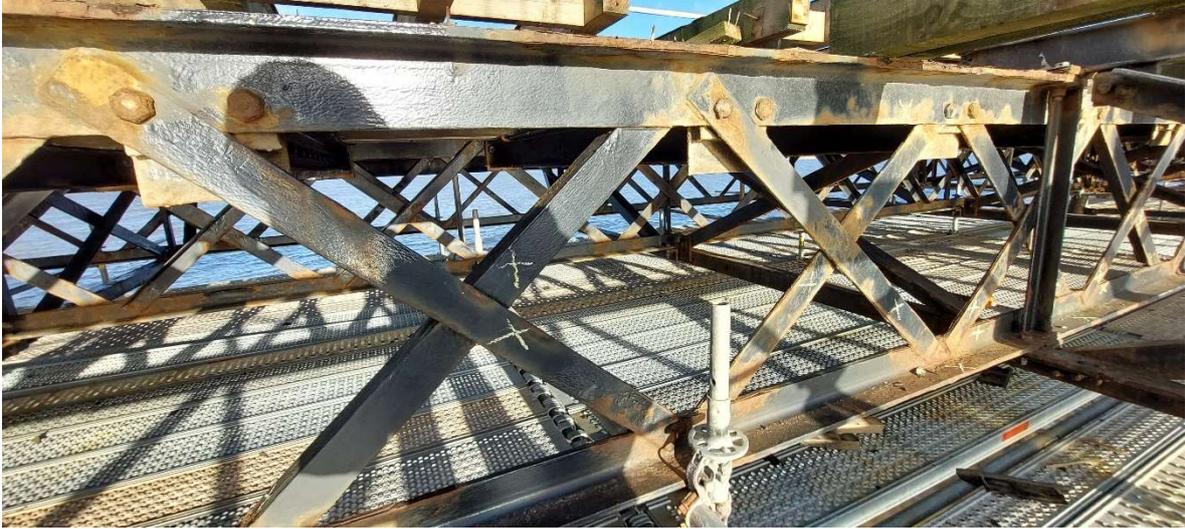
Photograph 20– View on Mid-South truss within Bay 60, indicating corrosion to top and bottom chords

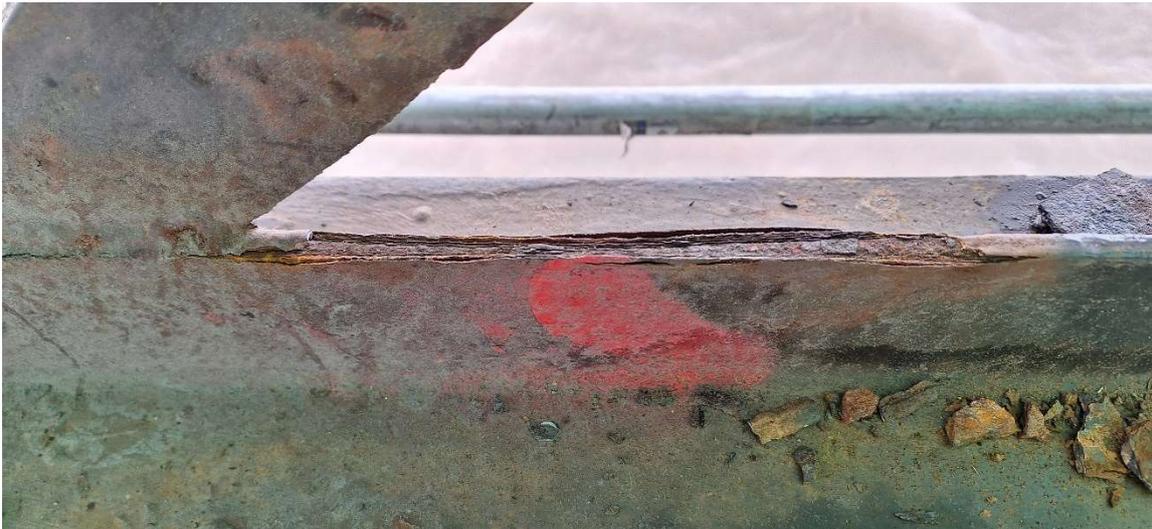
Photograph 21 – Severe loss of section to web of bottom Chord of Outer North truss in Bay 62

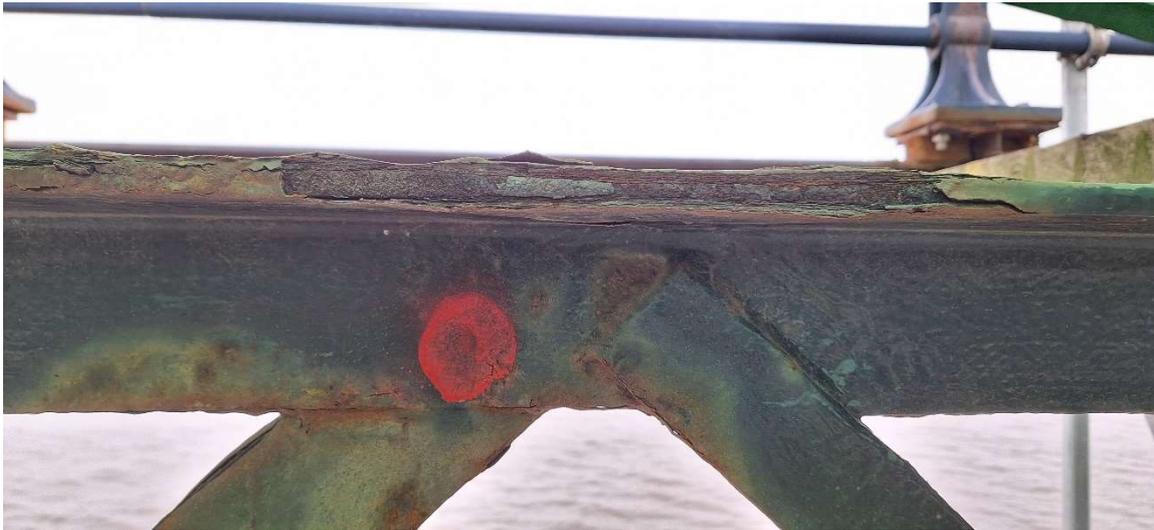
Photograph 22 – Severe loss of section to top Chord of Outer North truss in Bay 62

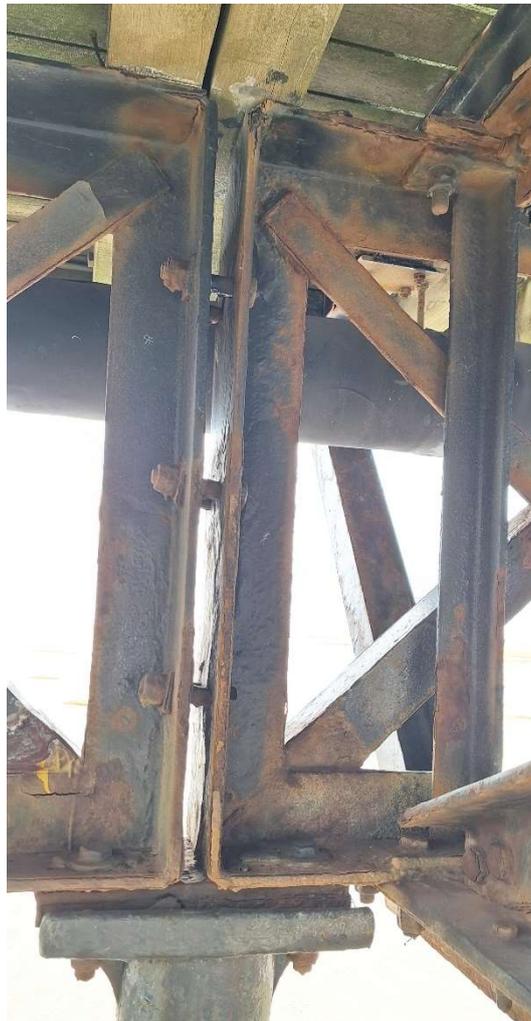
Photograph 23 – Outer North Truss support post on Gridline 59, with noticeable movement in bolts.

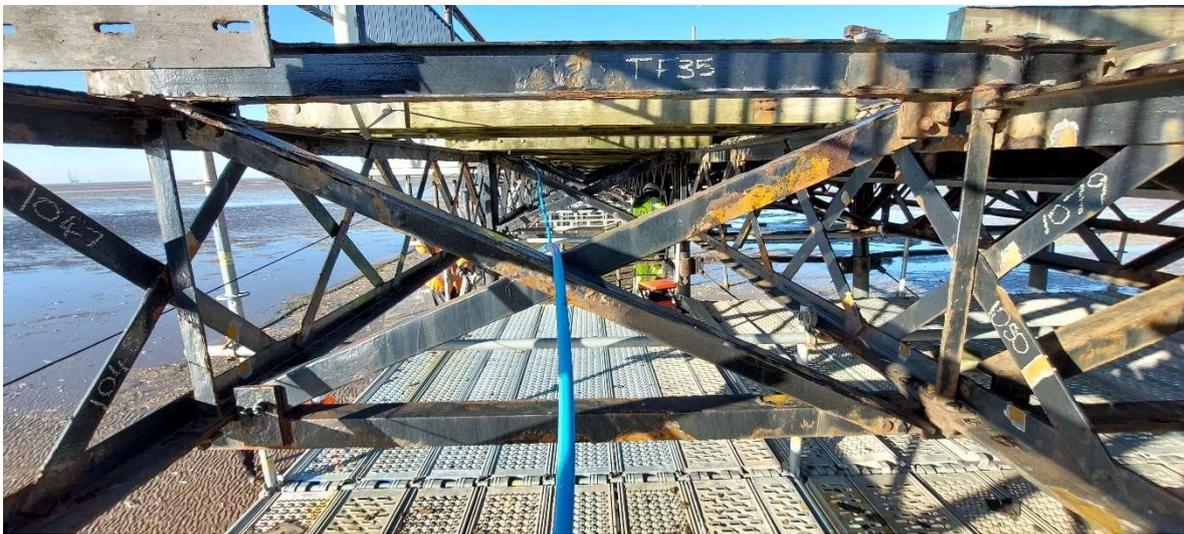
3.17 Photograph 24 below indicates typical condition of the southern section of the transverse frames. Where the paint has been removed prior to any grinding, the exposed steelwork shows the extent of surface corrosion. The top member of the trusses had evidence of severely delaminating flanges with section loss, and the webs, especially at the ends,

Photograph 24 – View on South section of TF35, Bay 62, looking towards sea

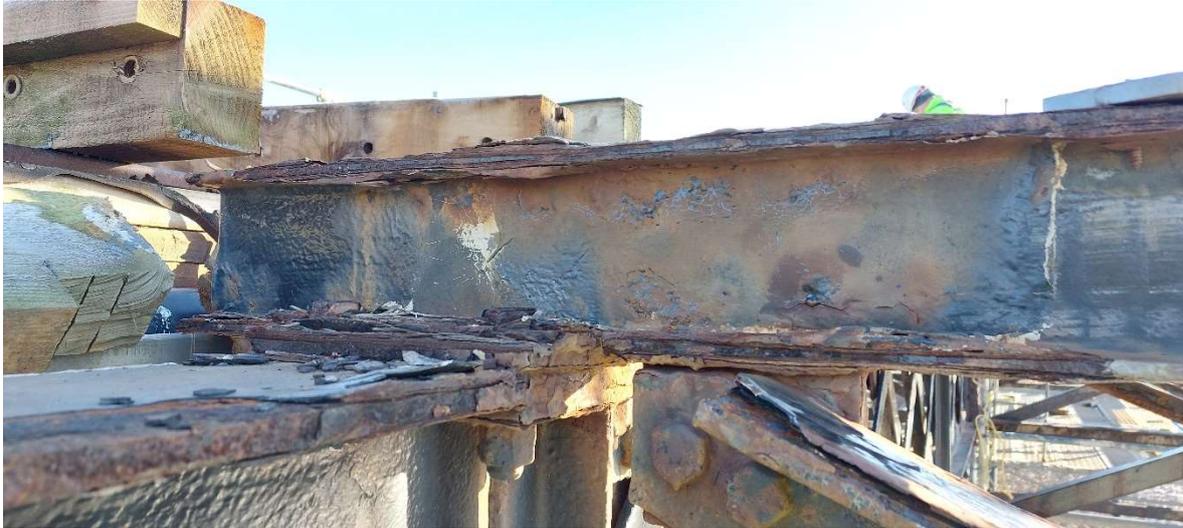
3.18 Photograph 25 highlights the condition to the internal end of the top beam forming the transverse frames. This level of beam damage was noted on both sides of the deck, and at either end of the beams. Along the length of the beam, there was noticeable loss of section, and in some locations had reduced to nothing.

Photograph 25 – View on deteriorated top member of TF34, Bay 63, looking towards land

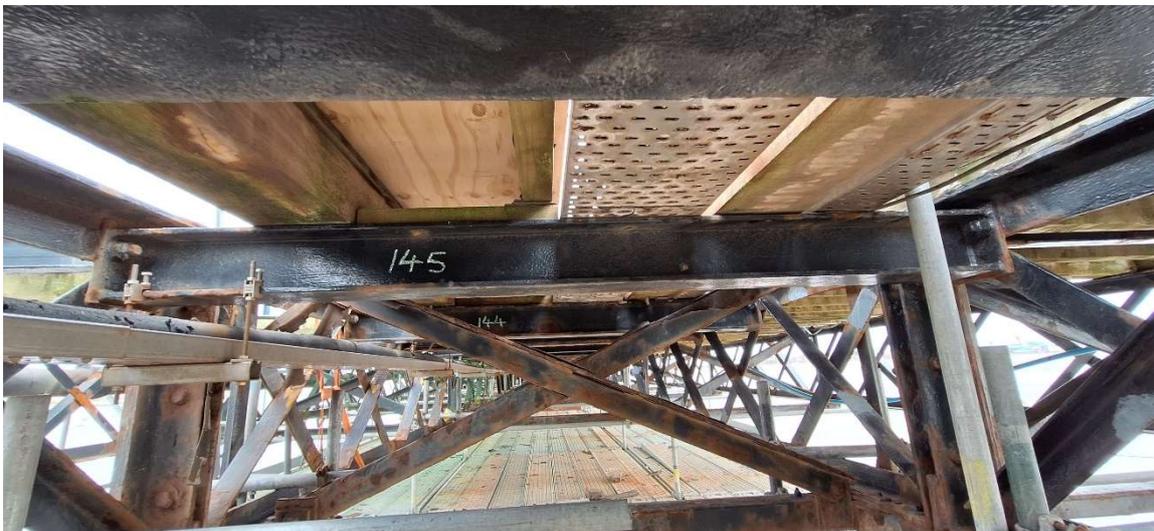
3.19 Along the central section of the deck, the protective paint finishes to the transverse frames have failed resulting in varying degrees of surface corrosion, this is also evident along the surfaces of the diagonal and horizontal members, this can be seen in photograph 26 below.

Photograph 26– View on Central section of TF36, Bay 62, looking towards land

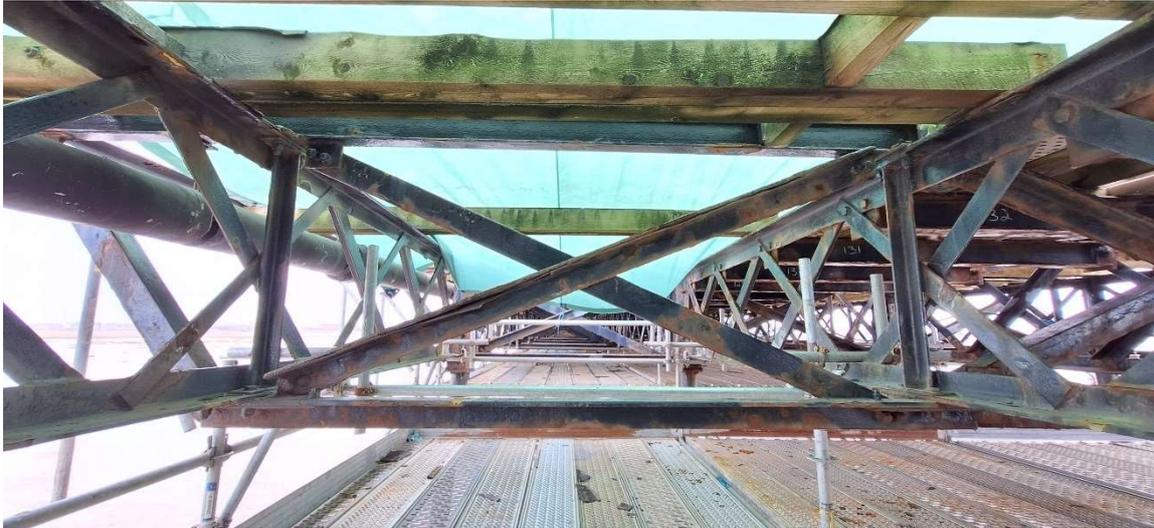
3.20 Photograph 27 below indicates typical condition of the North side section of the transverse frames. Along the edges of the steel members evidence of corrosion could be seen due to the failed paint finish, and surface corrosion was present along the surfaces of the diagonal and horizontal members.

Photograph 27 – View on North section of TF34, Bay 62, looking towards land

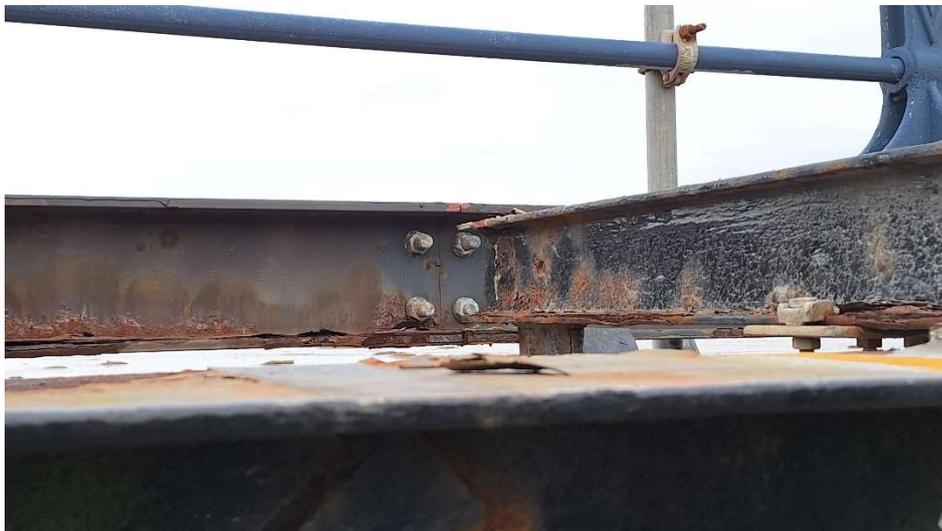
- 3.21 It was noted that a number of the cantilevering top members had no positive fixing to the PFC to the underside of the handrail along the north edge of the deck, an example can be seen in photograph 28, and further locations are noted on the drawings.

Photograph 28 – No connection between PFC and a transverse member within Area 1

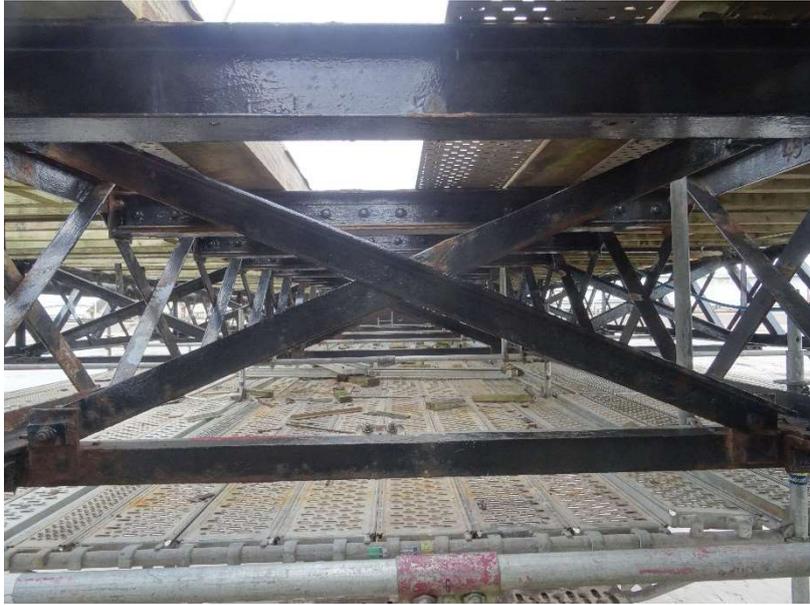
- 4.4 A visual assessment of the central beams was carried out in this area. Notes and commentary have been added to the drawings for clarity.
- 4.5 A view along the central section looking back towards the landward end of the pier can be seen in Photograph 31 below. Some of these beams have had remedial repairs carried out with installation of additional angles.

Photograph 31 – View on Area 2 central section looking landward

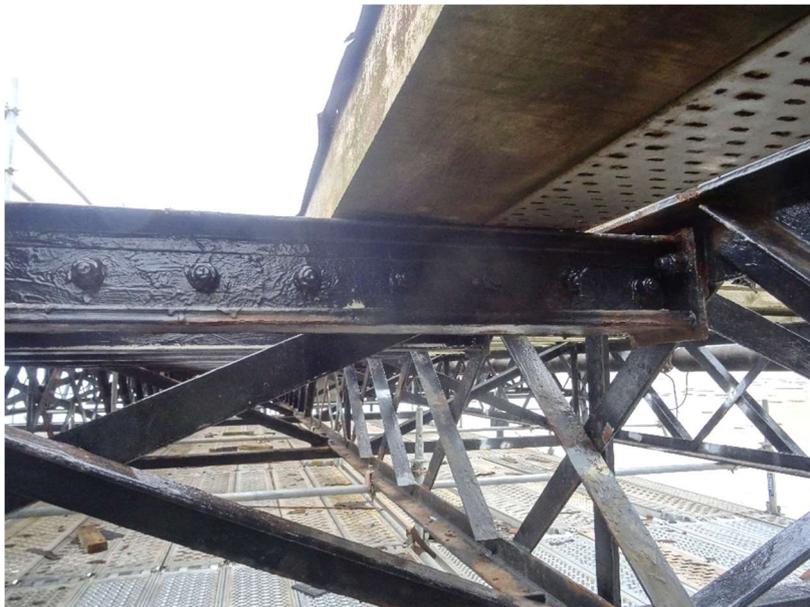
- 4.6 Where the bottom flange has corroded leaving a shallow depth of section a remedial repair has been carried out. The remedial detail is two steel angles installed either side of the web, seated on the bottom flange, then bolted through the web, shown in photograph 32 below.

Photograph 32 – Central support Beam Ref 148 indicating remedial repair.

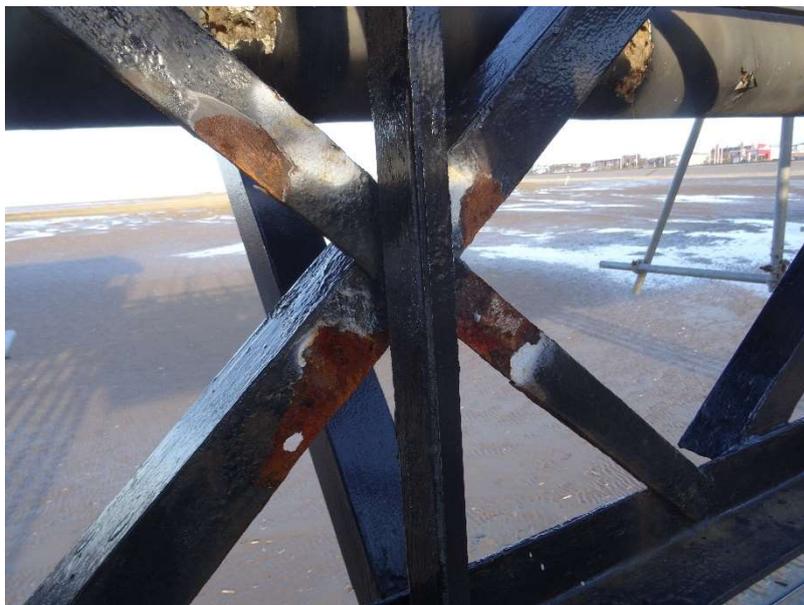
Photograph 33 – Hole in vertical leg of angle brace within Outer North truss in Bay 45

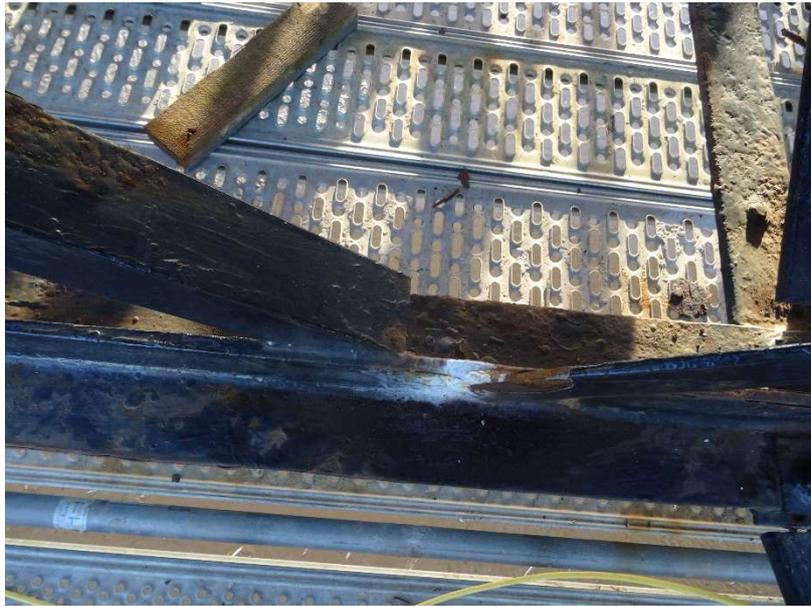
Photograph 34 – Bubbled paint present to bottom chord of Mid North truss in Bay 45

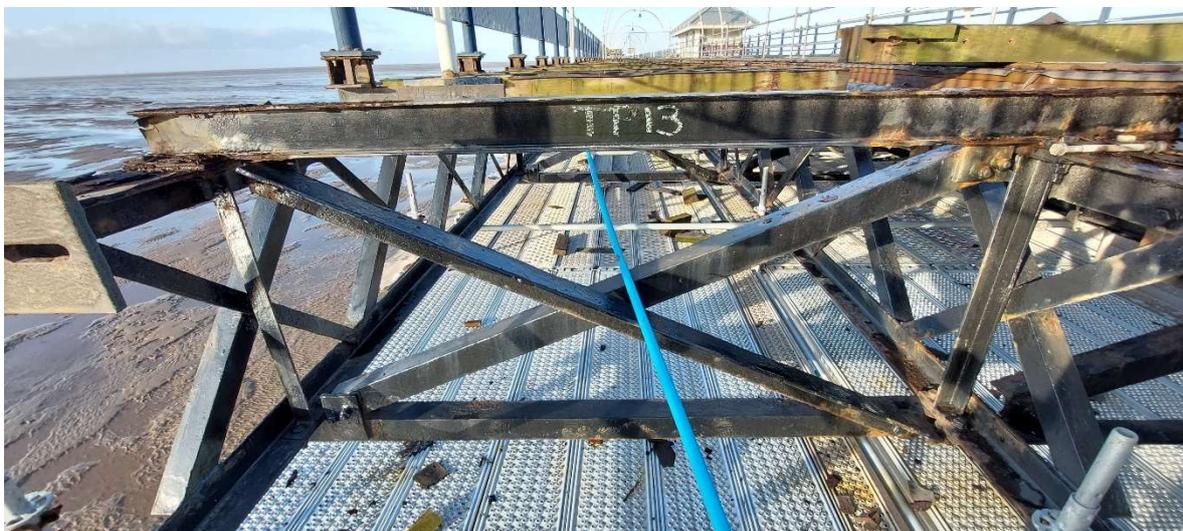
4.13 Photographs 35 and 36 below indicates typical condition of the southern section of the transverse frames. Where the paint has been removed prior to any grinding, the exposed steelwork shows the extent of surface corrosion. The top member of the trusses had evidence of severely delaminating flanges with section loss, and the webs, especially at the ends,

Photograph 35 – View on South section of TF13, Bay 43, looking seaward.

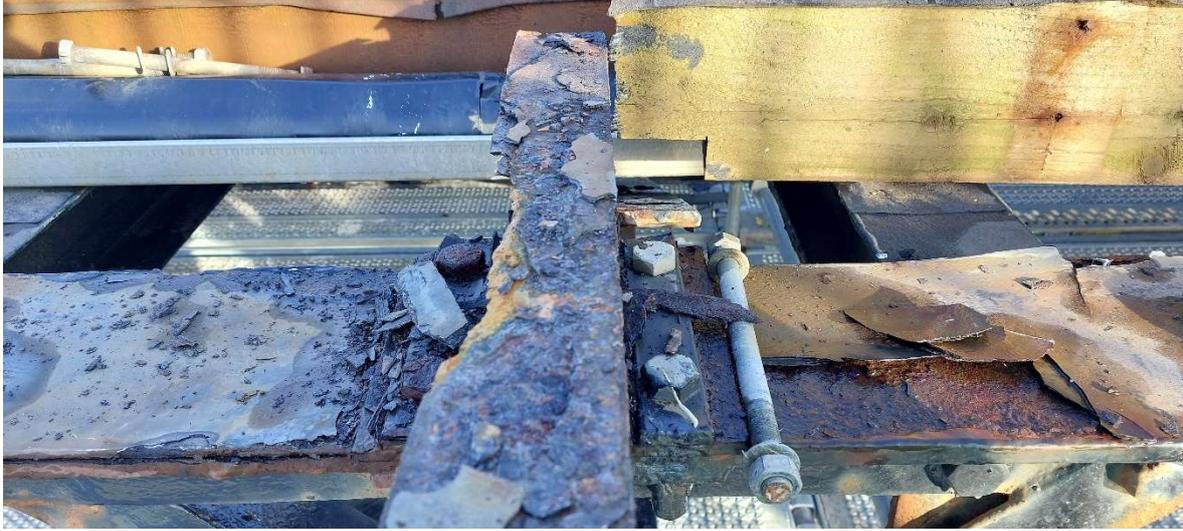
Photograph 36 – View on deteriorated top member of TF13, Bay 43, looking at top of Mid South truss

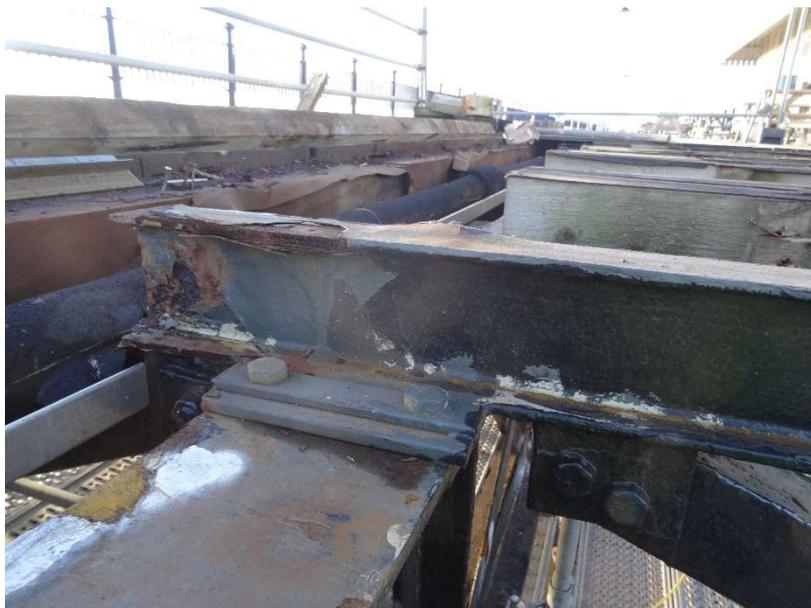
- 4.14 Along the central section of the deck, the transverse frames had evidence of corrosion damaging the paint finish, and surface corrosion was present along the surfaces of the diagonal and horizontal members.
- 4.15 Photograph 37 below indicates typical condition of the North side section of the transverse frames. Along the edges of the steel members evidence of corrosion could be seen damaging the paint finish, and surface corrosion was present along the surfaces of the diagonal and horizontal members.

Photograph 37 – View on North section of TF23, Bay 45, looking seaward

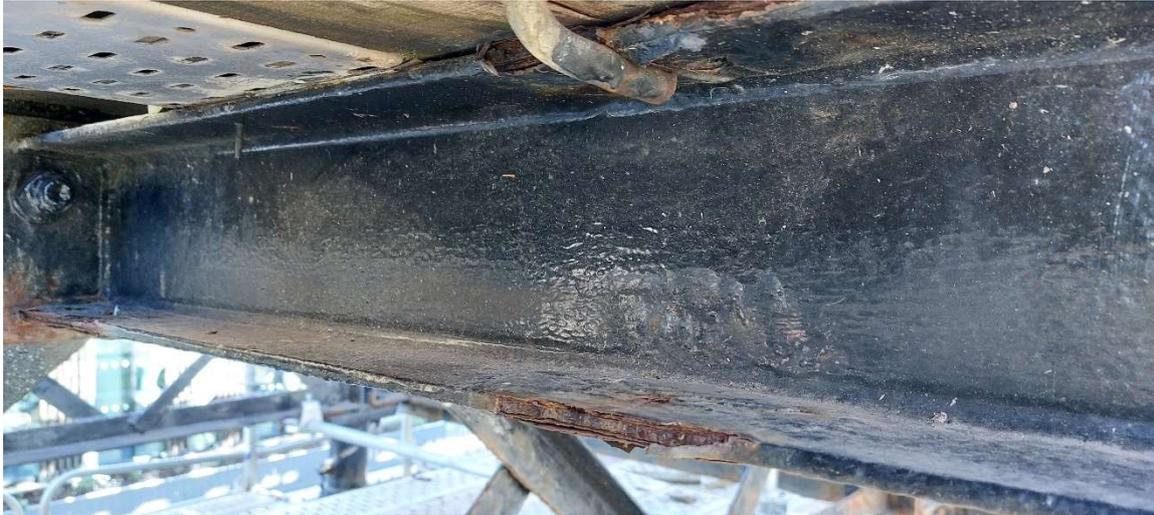
- 5.4 A visual and measured assessment of the central beams was carried out in this area. Notes and commentary have been added to the drawings for clarity.
- 5.5 The condition of the central beams varies, with a significant number requiring replacing. Beam reference 35 is shown in photographs 40 and 41 indicates minor edge delamination to one end, and at the opposite end, severe loss of section to the top and bottom flanges.

Photograph 40 – Central support Beam Ref 35 looking landward adjacent to Mid North truss

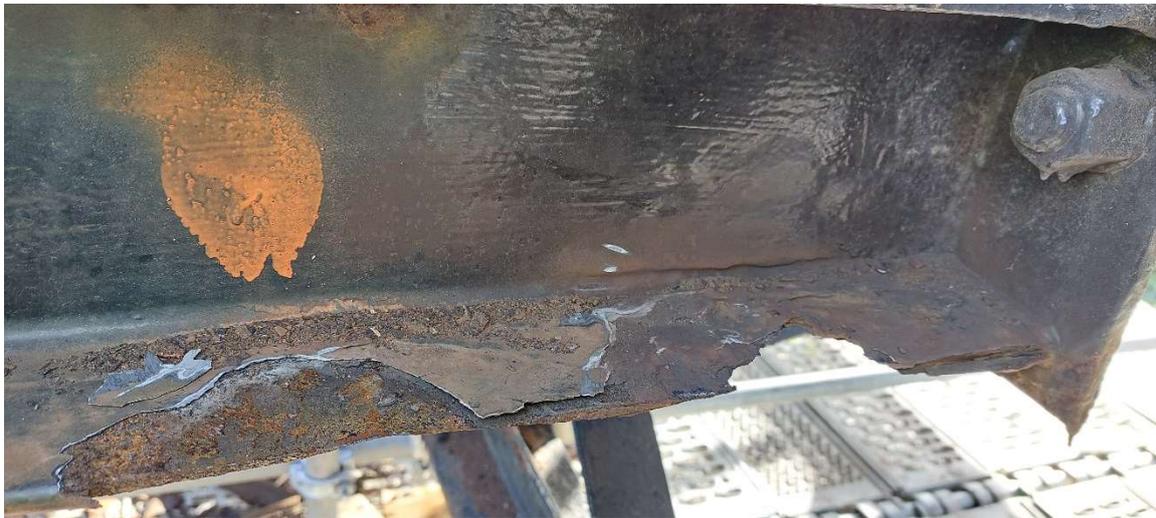
Photograph 43 – Central support Beam Ref 43 looking landward

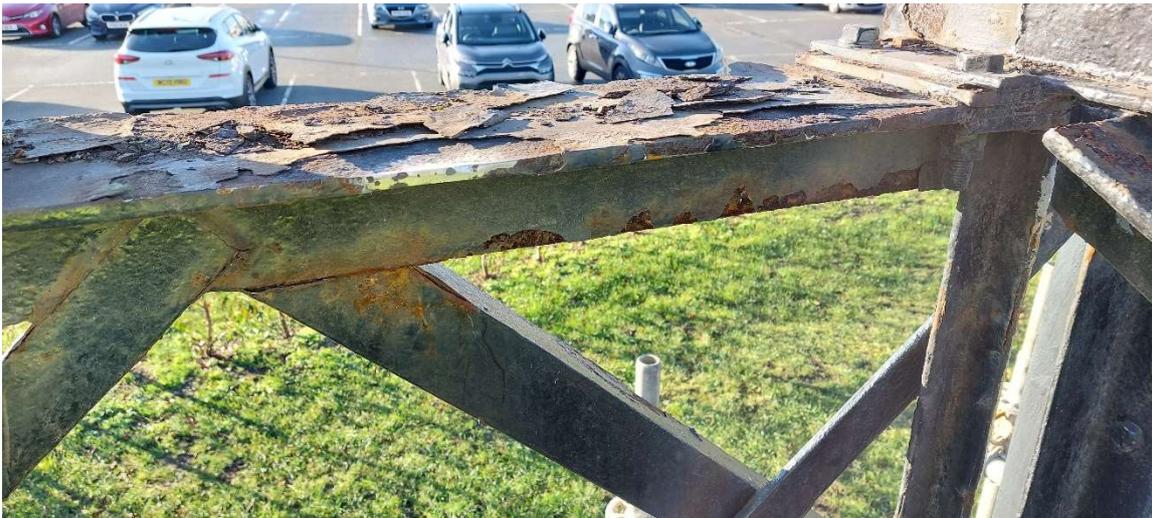
Photograph 44 – View on Outer South truss top chord in Bay 26

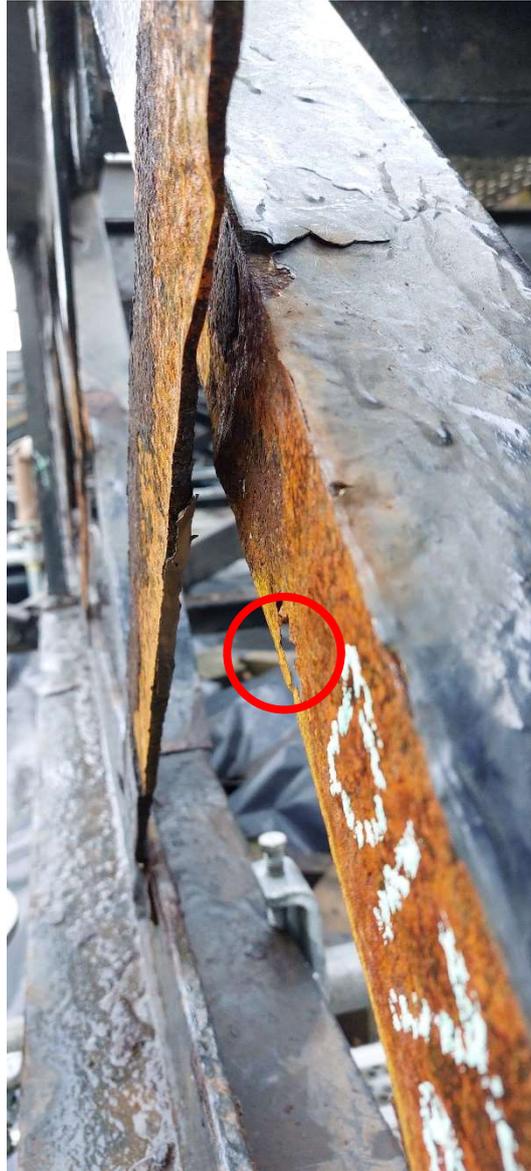
Photograph 47 – Hole in vertical leg of truss angle (highlighted) and loss of section to truss flat of Mid South truss in Bay 27

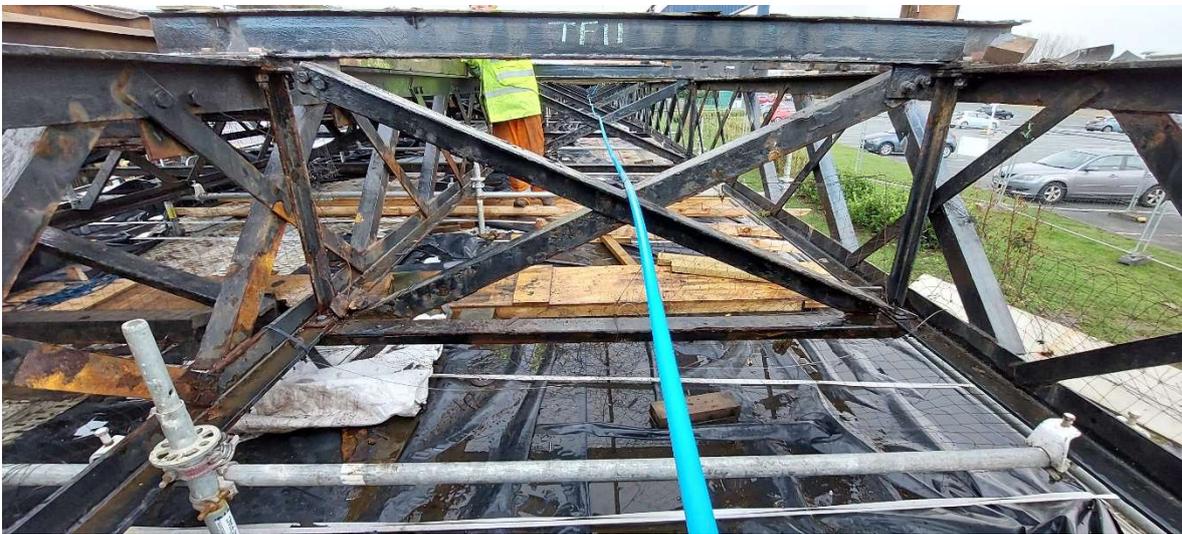
Photograph 48 – View on South section of TF11, Bay 28, looking landwards

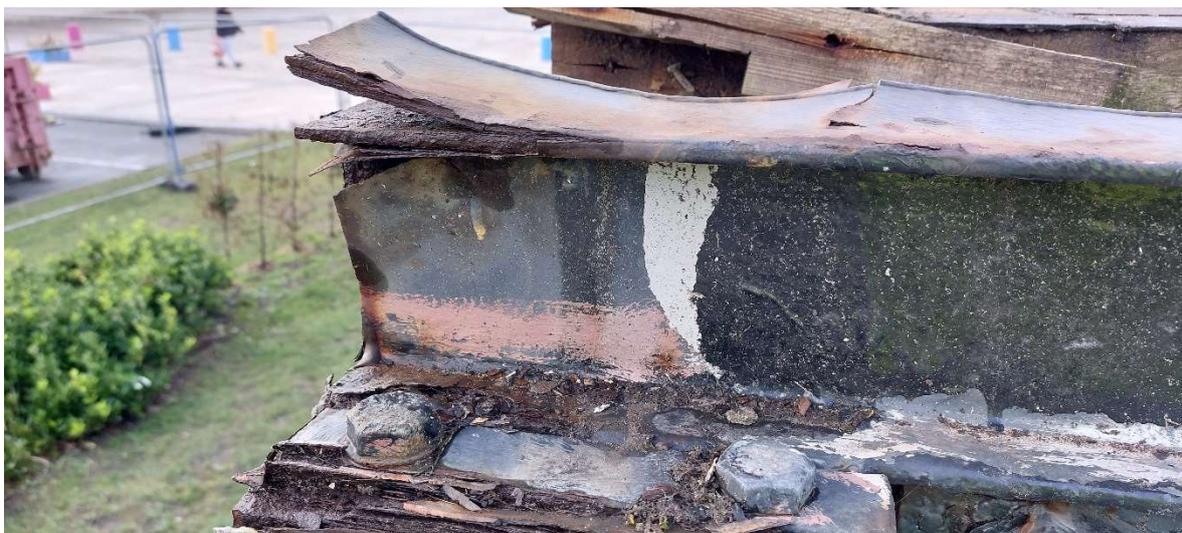
- 5.12 The North and South side trusses were ground back to bare steel and measurements taken, due to restricted access within the central area, a visual inspection was carried out.
- 5.13 Photograph 48 below indicates typical condition of the southern section of the transverse frames. Paint had a bubbling effect due to surface corrosion of the steel underneath. The top members of these trusses typically had evidence of reduced section thickness to the flanges, and at the end's delamination around the full section profile, example of this is shown in photograph 49 below.

Photograph 49 – Example of delamination of top member of TF8

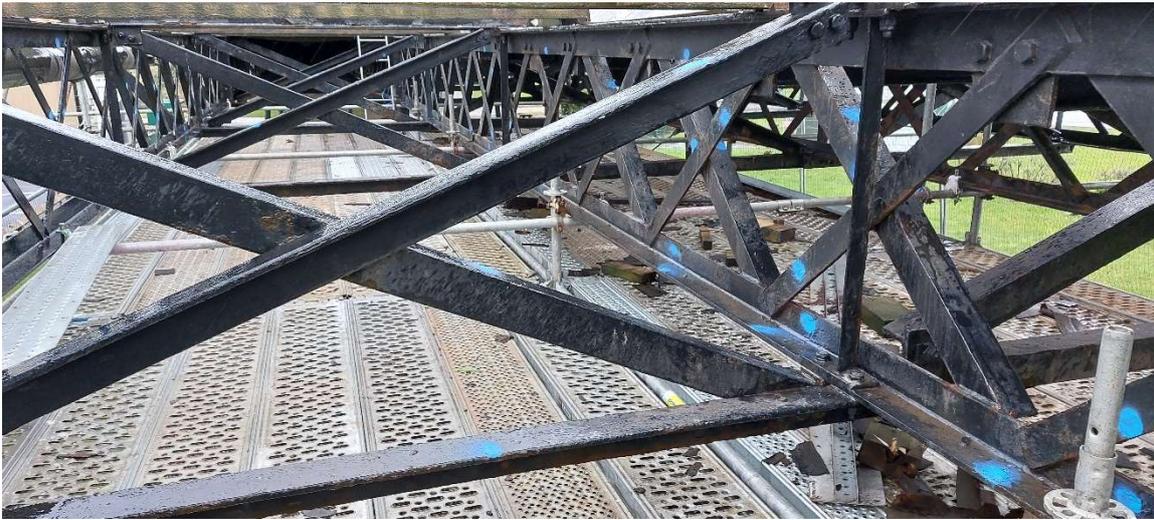
5.15 Photograph 50 below indicates typical condition of the North side section of the transverse frames. Along the edges of the steel members evidence of corrosion could be seen damaging the paint finish, and surface corrosion was present along the surfaces of the diagonal and horizontal members.

Photograph 50 – View on North section of TF03, Bay 25, looking landwards
