Structural Steelwork Inspection

Southport Pier
Promenade
Southport
PR8 1QX

Contract No: LV1255
Dated: March 2024

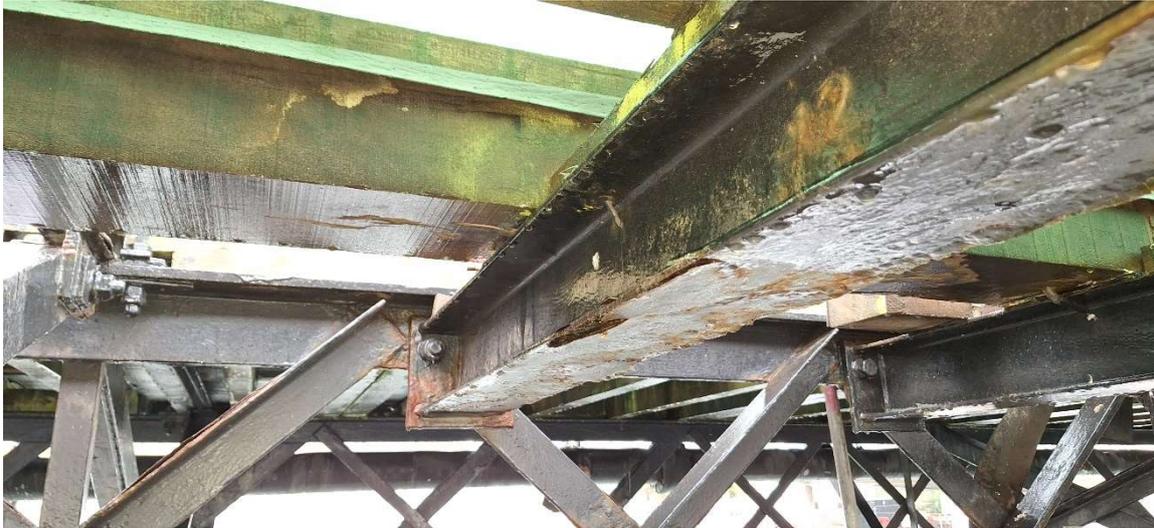
Photograph 53 – Central support Beam Ref 172

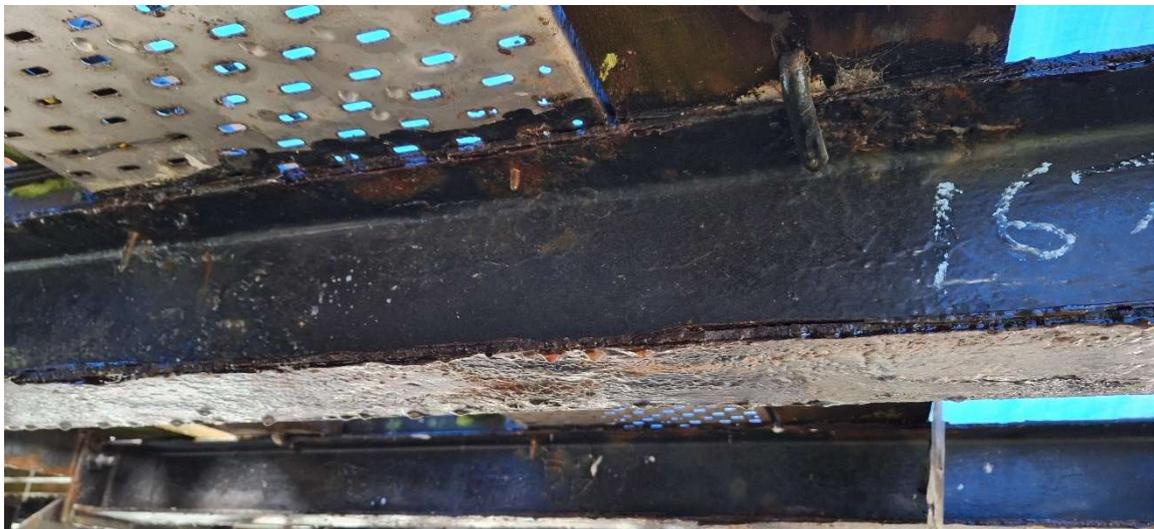
Photograph 54 – Central support Beam Ref 167 indicating delamination and loss of section

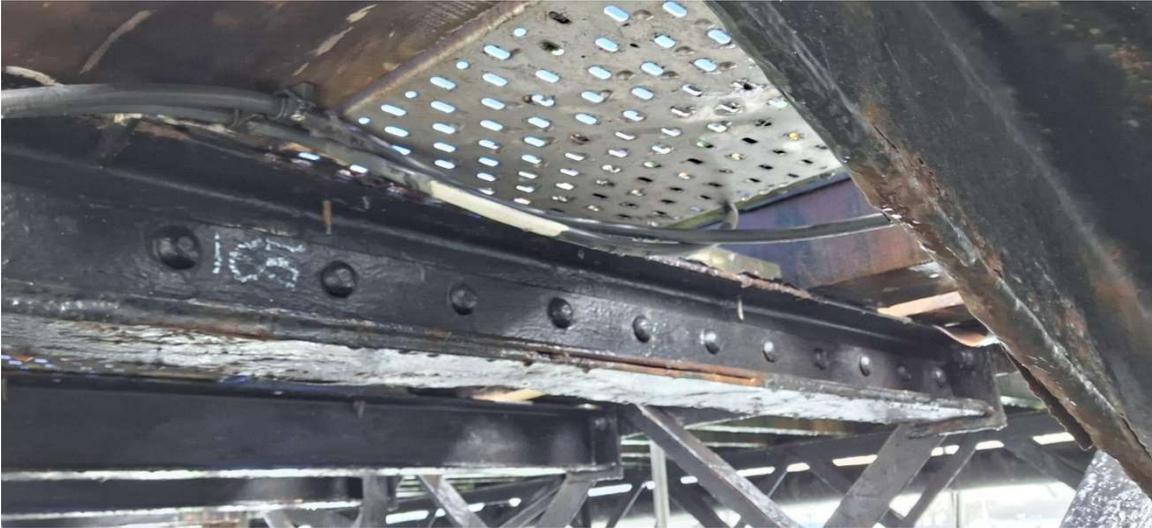
Photograph 56 – Central support Beam Ref 165

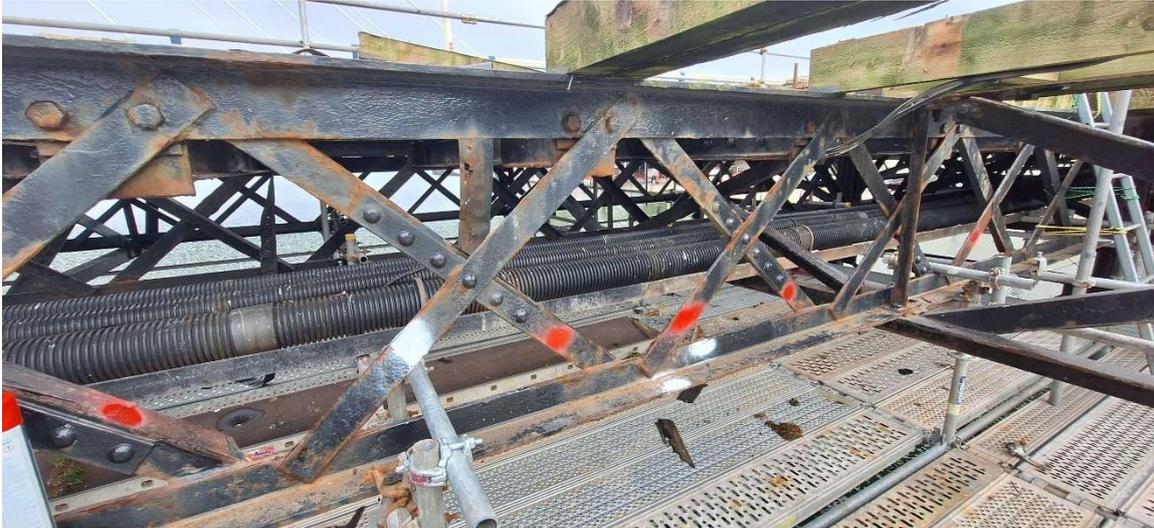
Photograph 57– View on Mid-South truss within Bay 7, indicating corrosion to bottom chord and previous repairs to diagonals

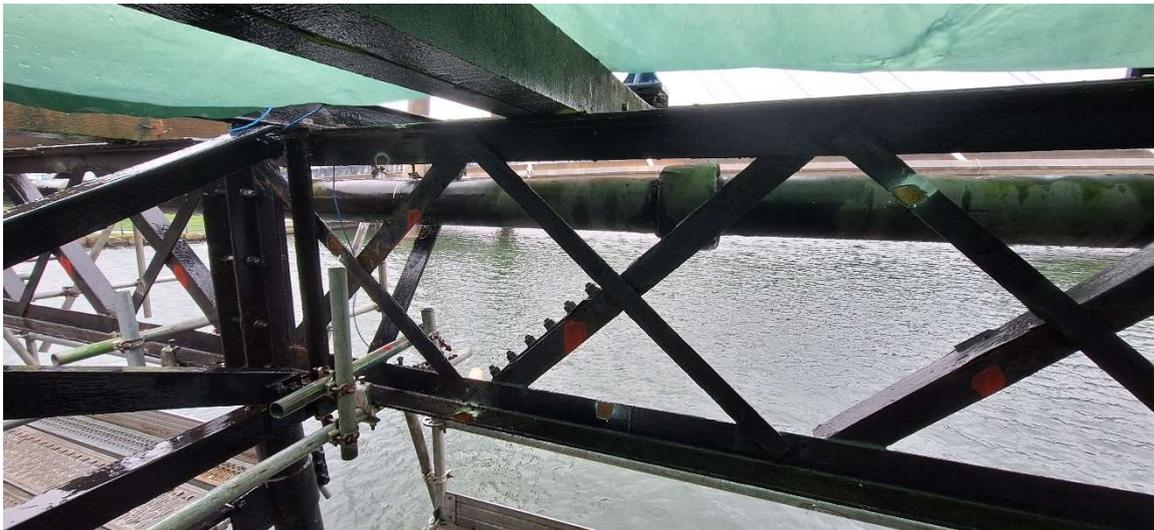
Photograph 58 – Example of previous repair detail to diagonal member in Outer North truss in Bay 7

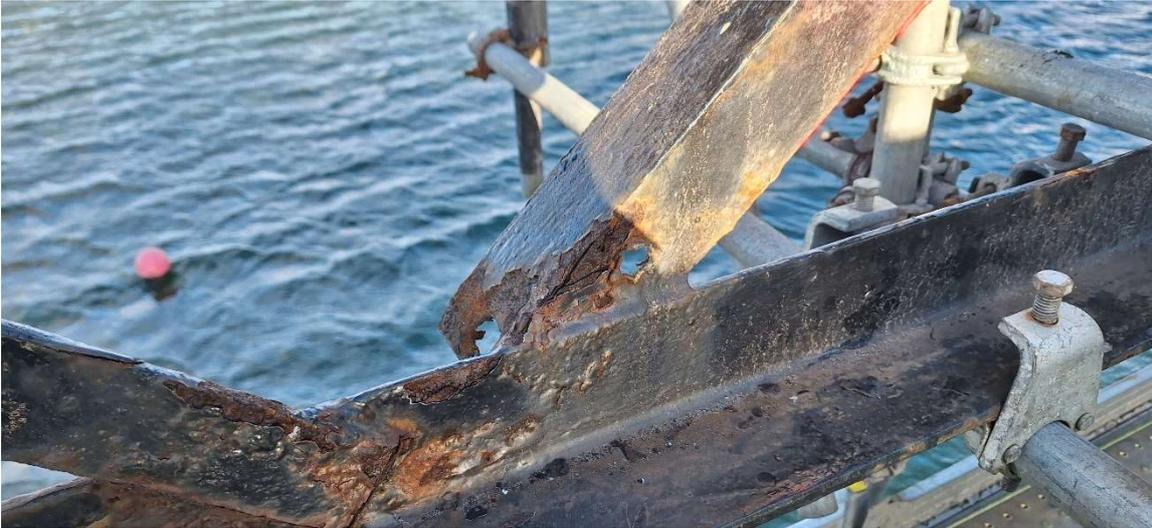
Photograph 59 – Severe loss of section to diagonal member of Outer North truss in Bay 8

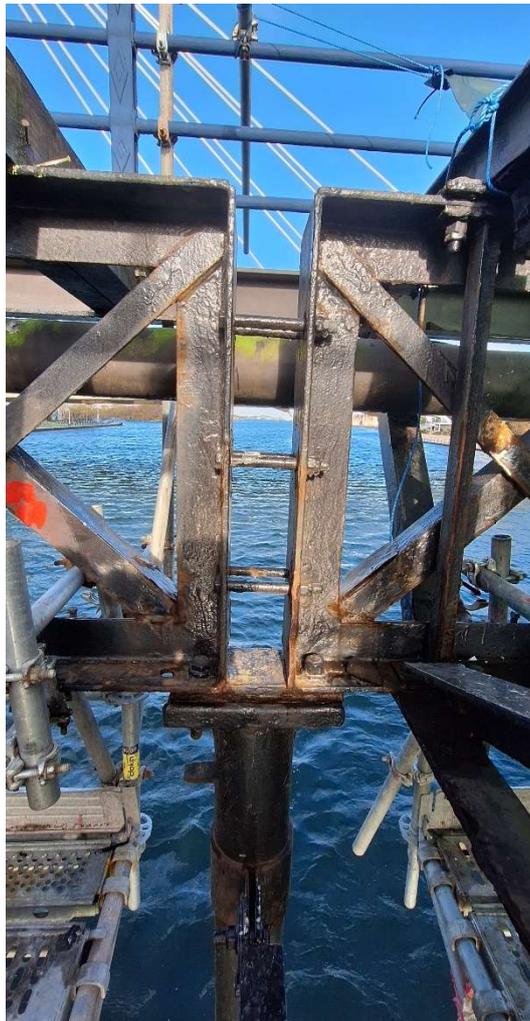
Photograph 60 – Outer North Truss support post on Gridline 7, with noticeable movement in trusses.

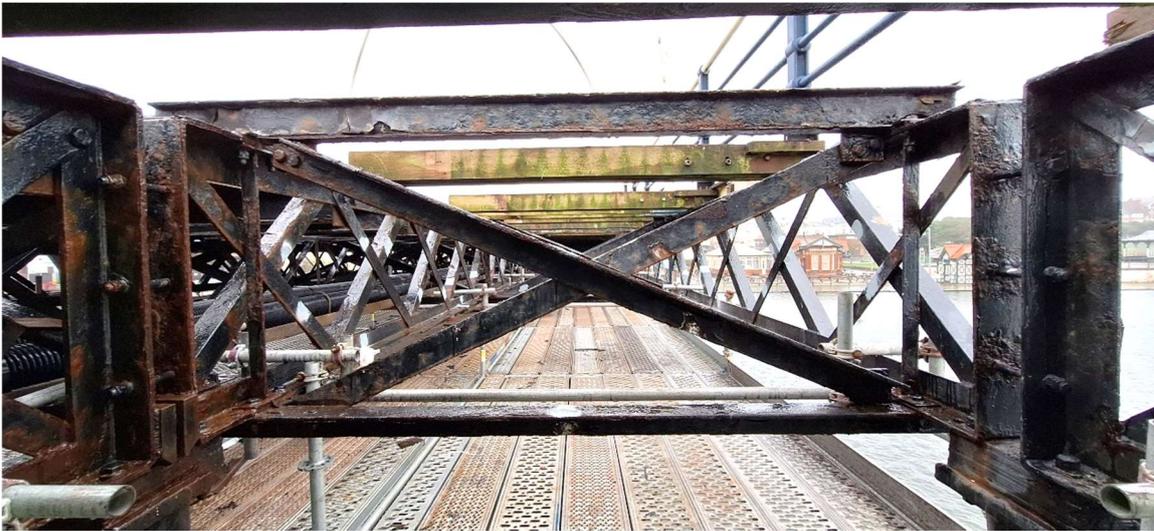
Photograph 61 – View on South section of TF44, Bay 7, looking landwards

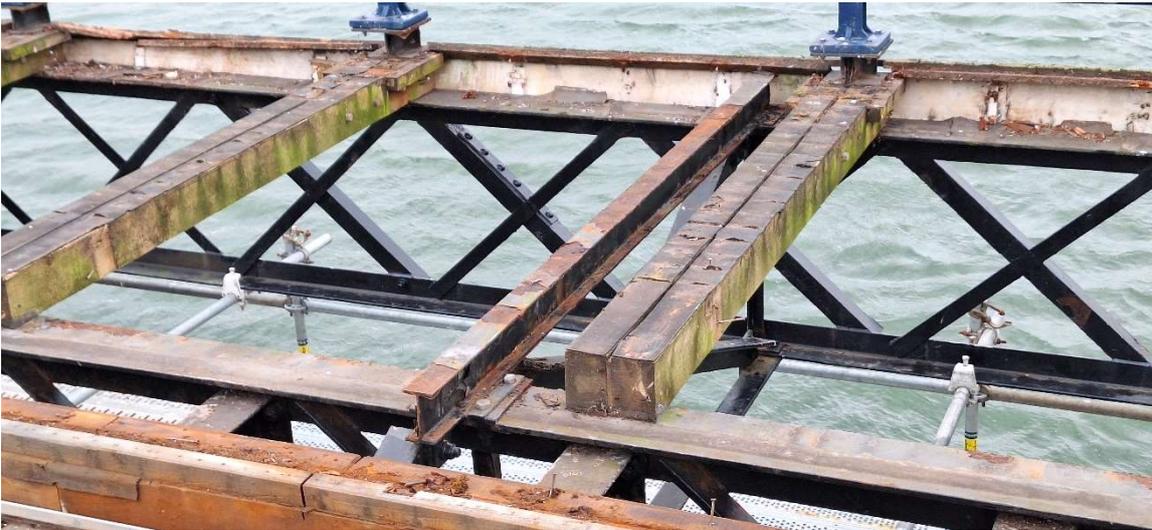
Photograph 63 – View on deteriorated top member of TF47, Bay 8, looking towards outer south truss

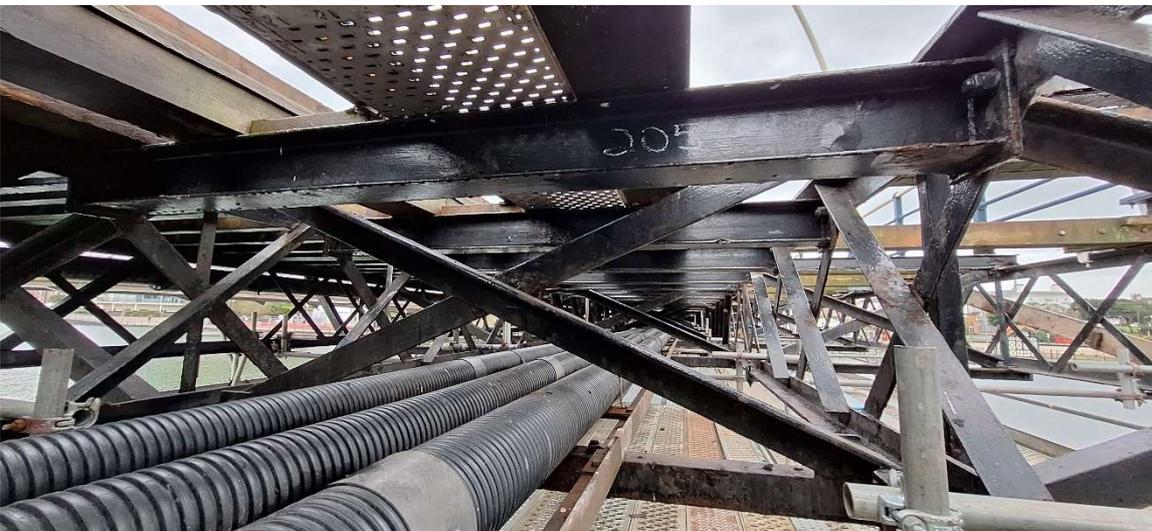
Photograph 64– View on Central section of TF51, Bay 9, looking landwards

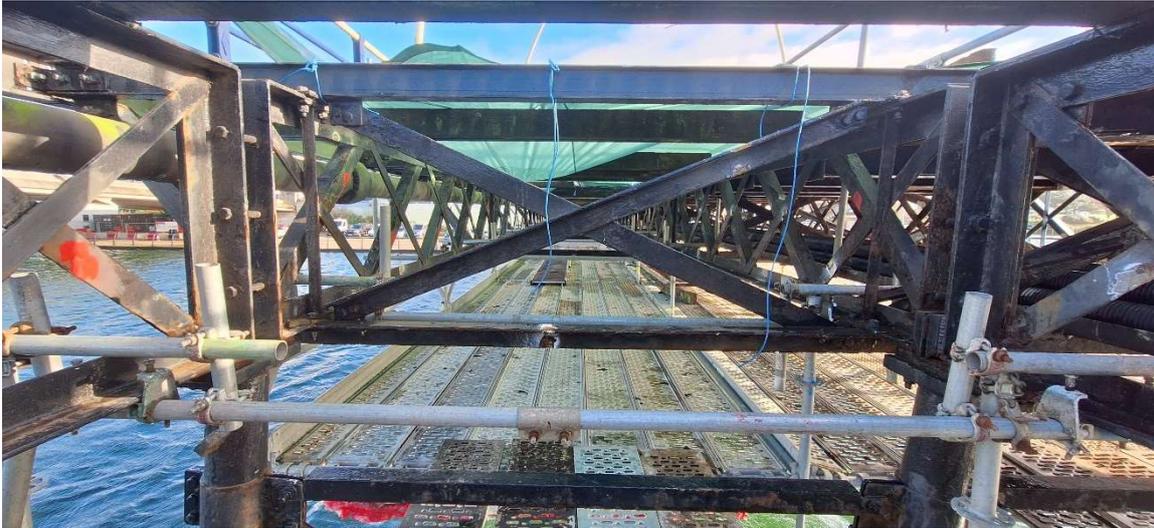
Photograph 65 – View on North section of TF44, Bay 7, looking landwards

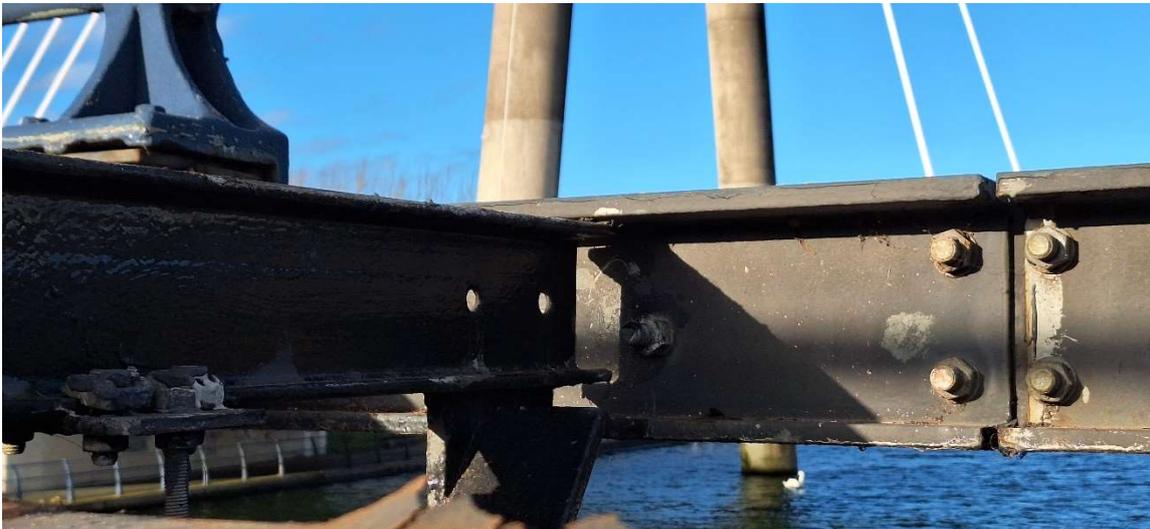
Photograph 66 – No connection between PFC and a transverse member within Area 4

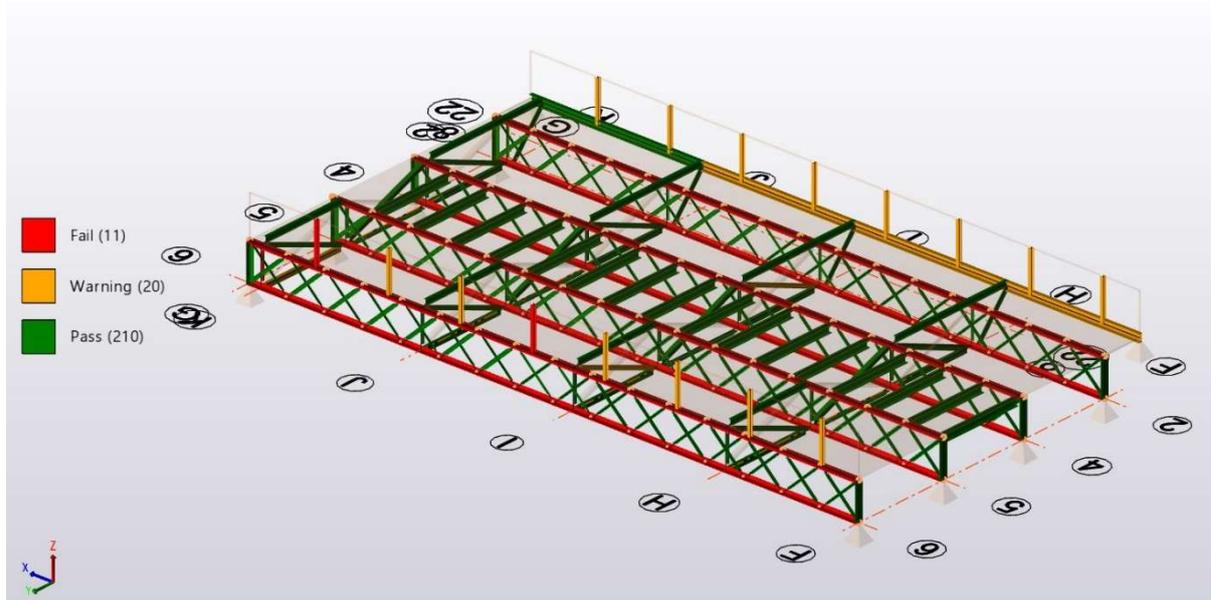
Figure 7 – Output from Tekla Structural Designer Indicating failing members.
