## **6. ARCHITECTURE, DETAILS AND MATERIALS**

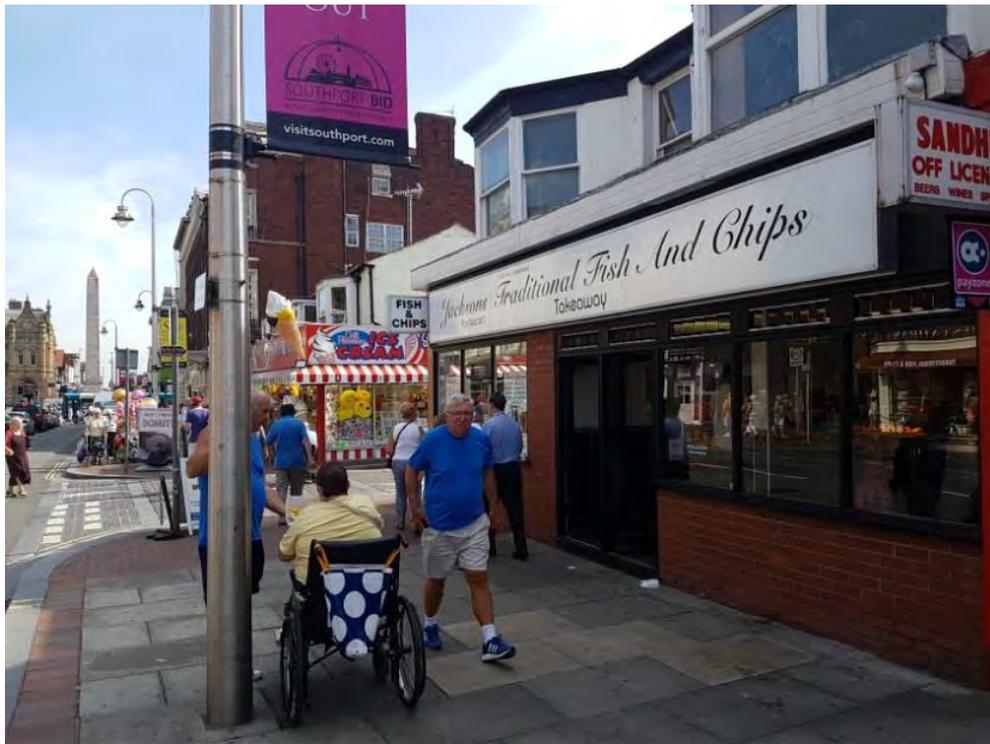
Many properties have been redeveloped to a significant degree, along with the addition of inappropriate and oversized signage

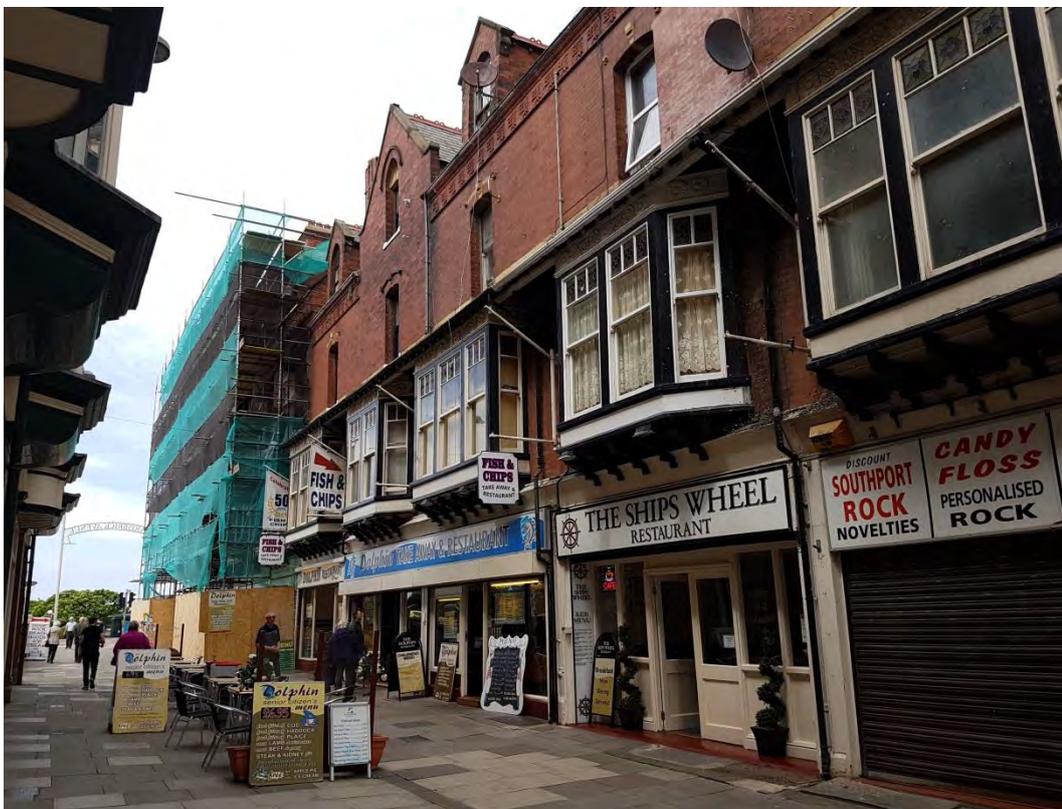
However the installation of roller shutters, A-Board signage and a lack of maintenance has harmed the character and appearance of this key side street

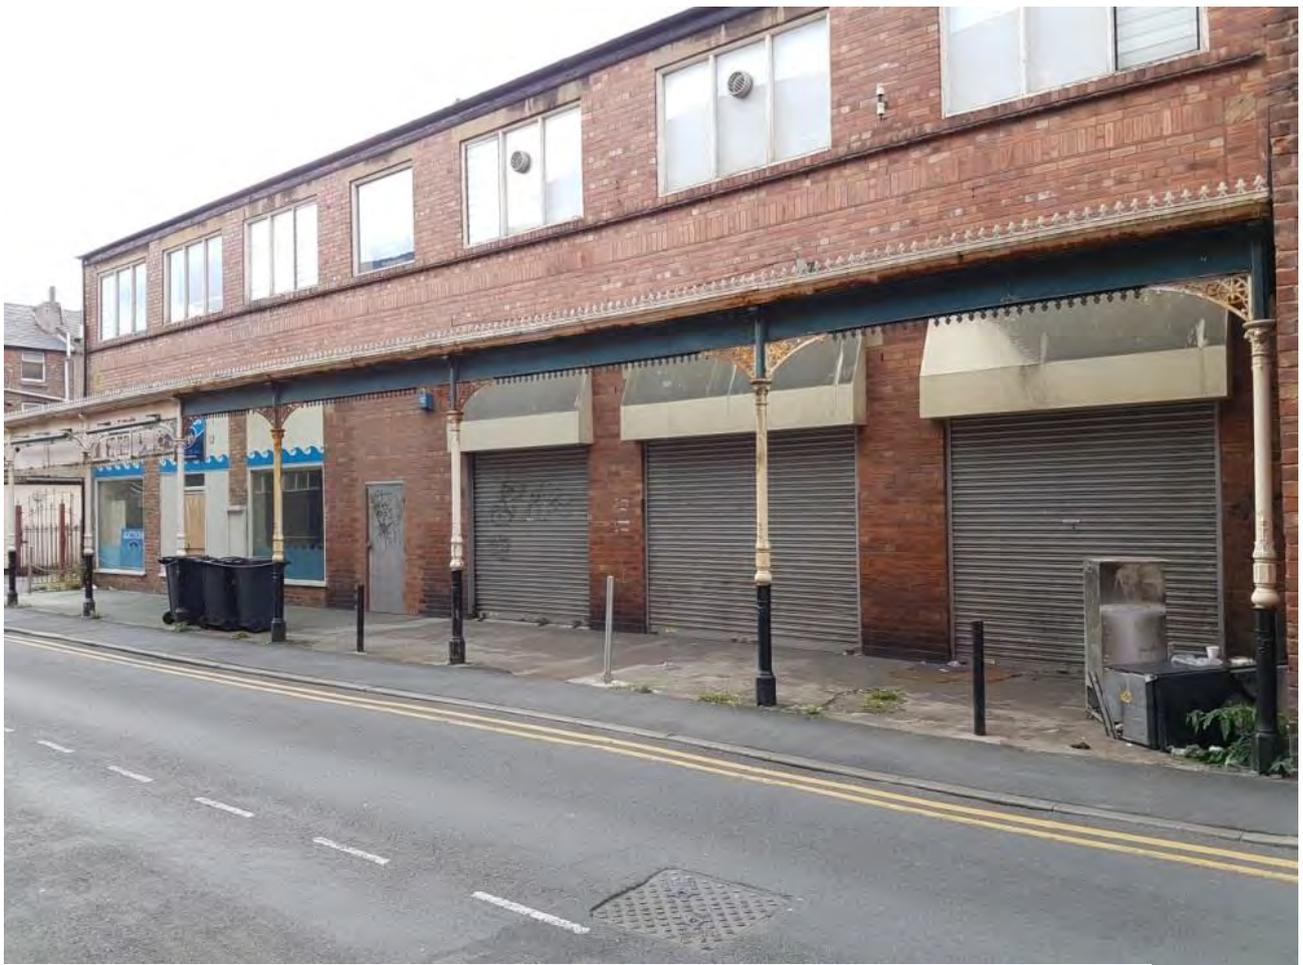
Several shops and hot food takeaways incorporate roller shutters. Where these are external or solid they create a deadening effect in the evening when the shops are closed. External guide rails and projecting boxes are jarring elements which obscure and detract from glazing bars, transoms and fascias. This has a harmful effect on the area.

**Roller shutters often create a hostile effect within their surroundings**

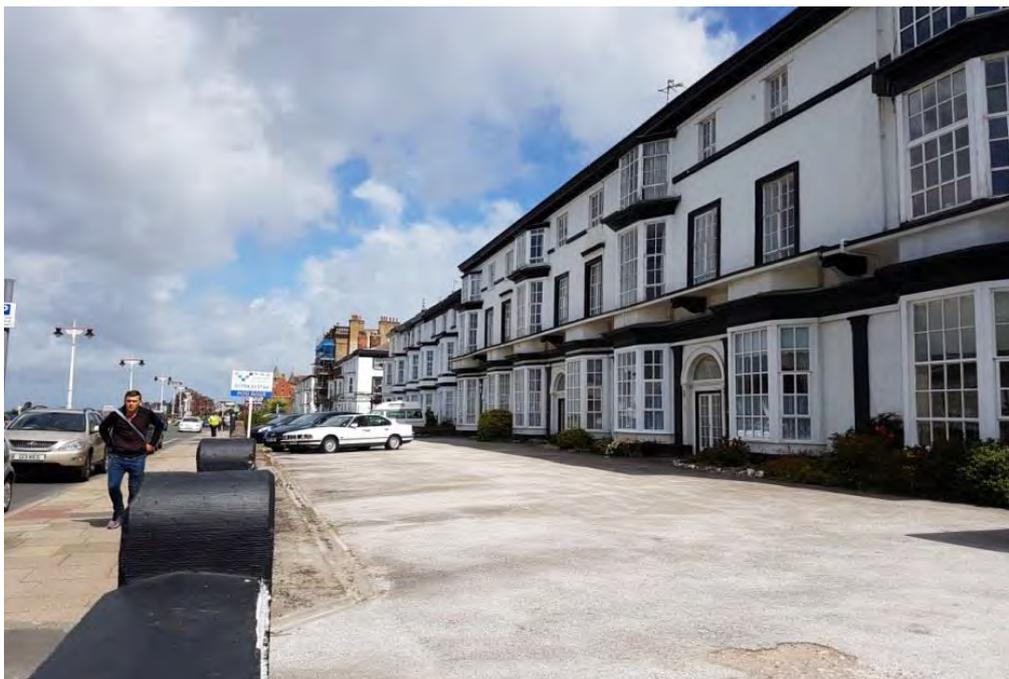
**Changes to accommodate vehicle parking in more recent times have resulted in a loss of boundary distinguishability**

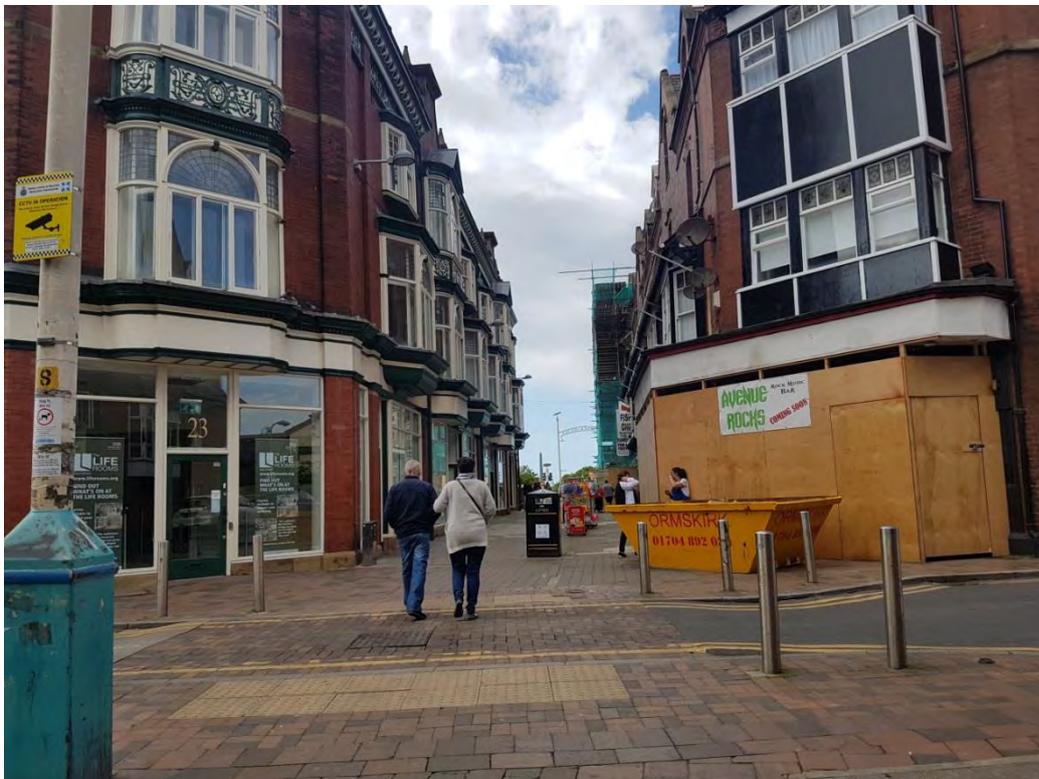
Excessive bollards exist in Scarisbrick Avenue at the junction of West Street. These clutter the streetscape and harm the historic character of this important thoroughfare between the Promenade and Lord Street Conservation Area whilst not deterring vehicles.

**Excessive bollards distract from the architecture of nearby buildings and character of the Conservation Area**

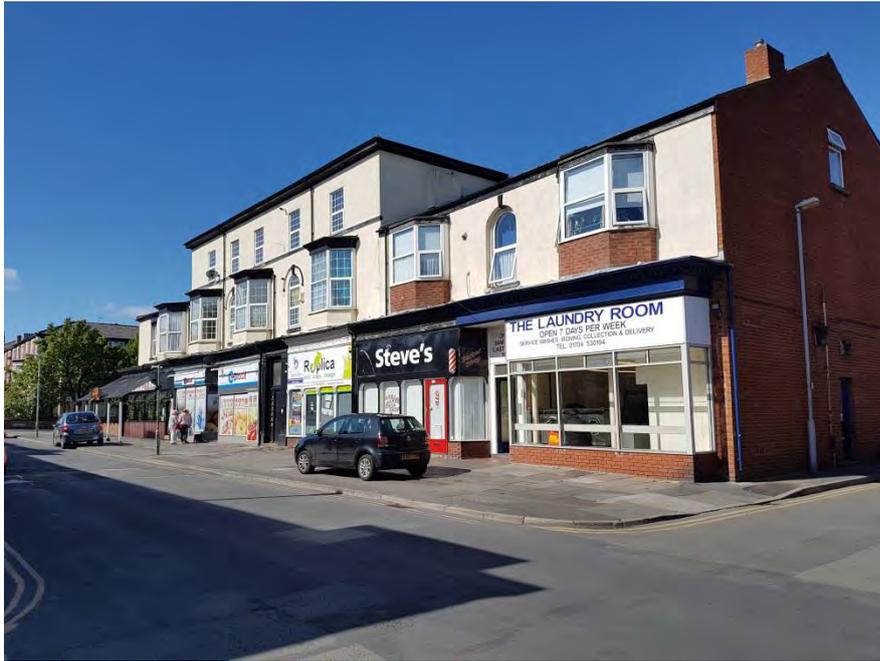
**The design of this Bold Street shopfront does not correspond to more traditional layouts**

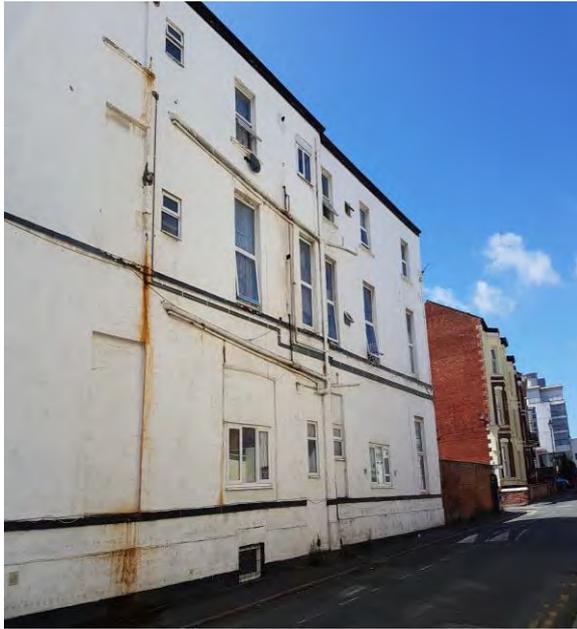
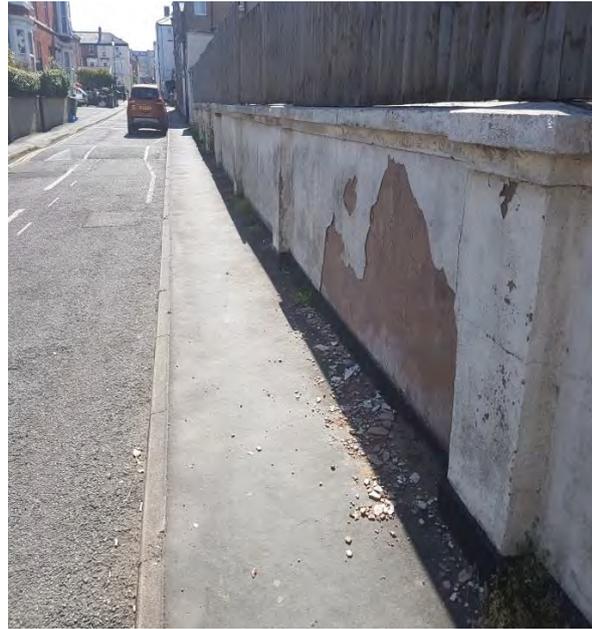
A high number of the historic buildings have visible signs of a lack of maintenance and are in need of some degree of repair. Typical issues include problems such as paint flaking off joinery details, damaged stone work to stringcourses and cills, weeds growing out of gutters and brickwork and dislocated flashings. The declining condition of the historic buildings has a particularly immediate impact on perceptions of the Conservation Area. Notable examples include 22 Promenade and Leo's Bar in Nevill Street which currently harm the character and appearance of the conservation area.

Poorly maintained buildings can significantly harm the appearance on large sections of the streetscape

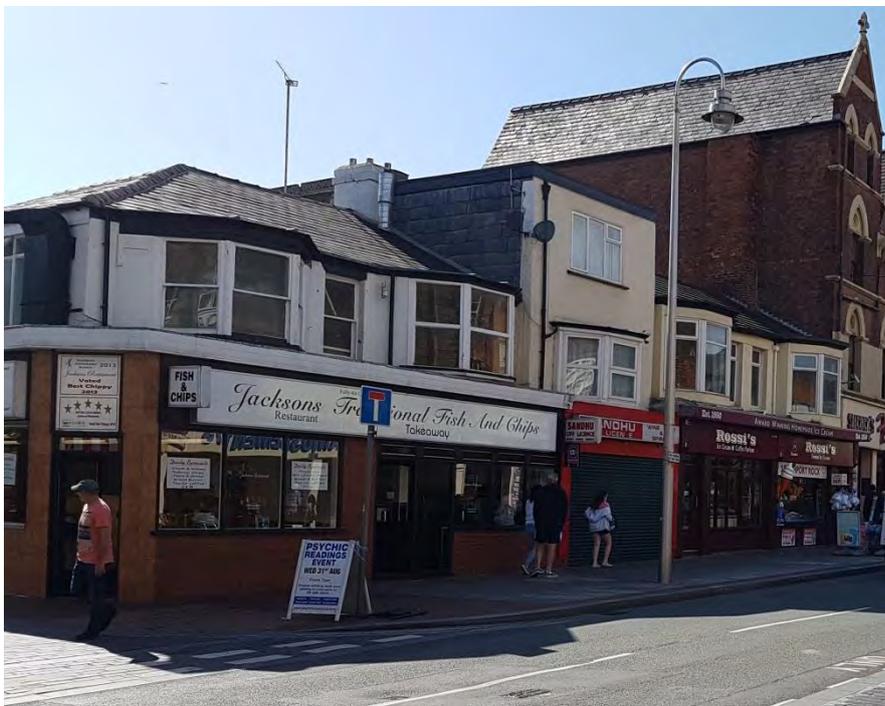
Over-development has affected the legibility of this row of historic properties

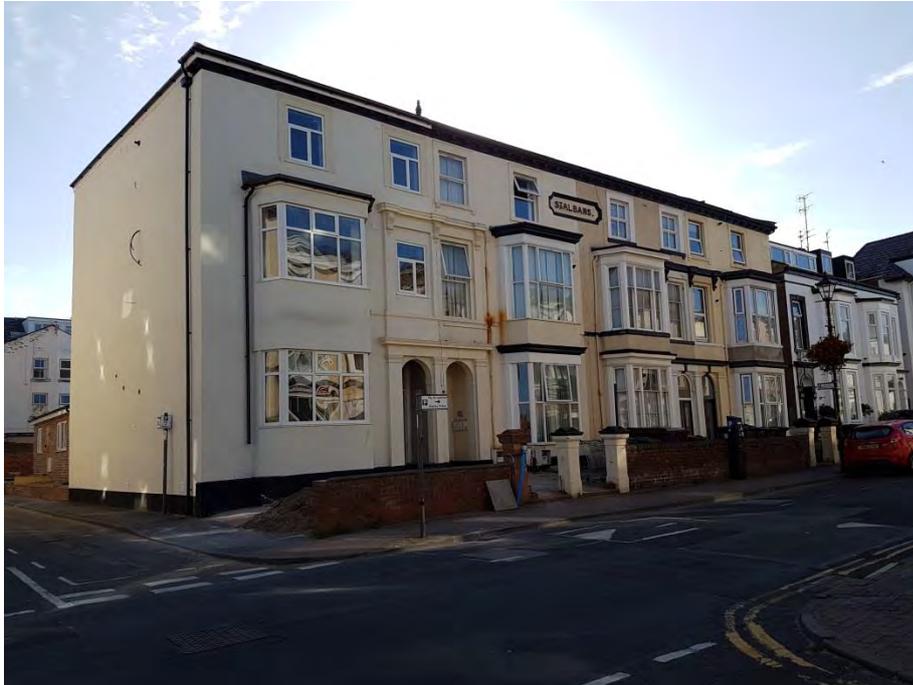
**Inappropriate uPVC windows at St. Albans, Bold Street**

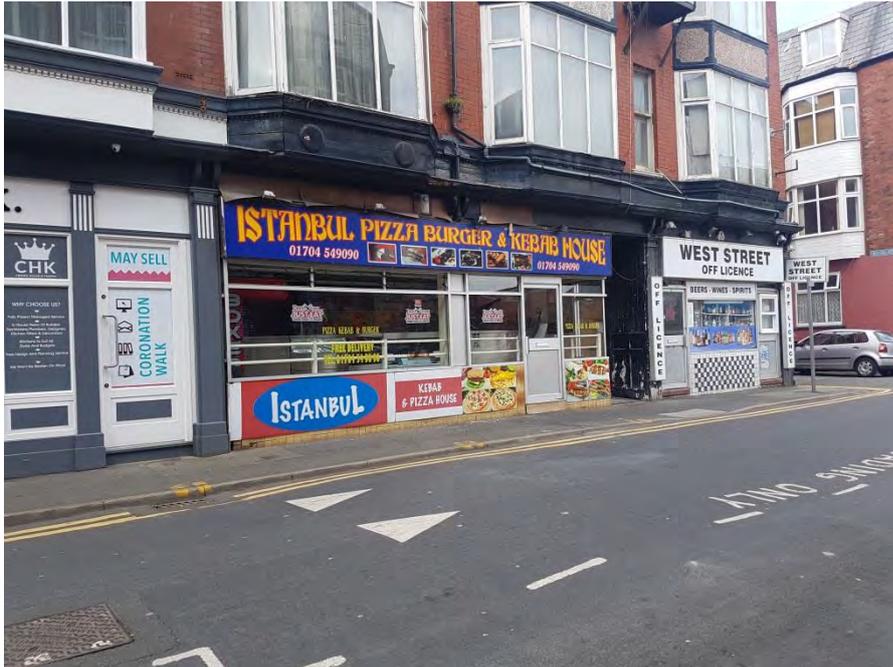
**Bright and oversized signage is not appropriate for the Conservation Area and such changes to shopfronts have harmed their character**

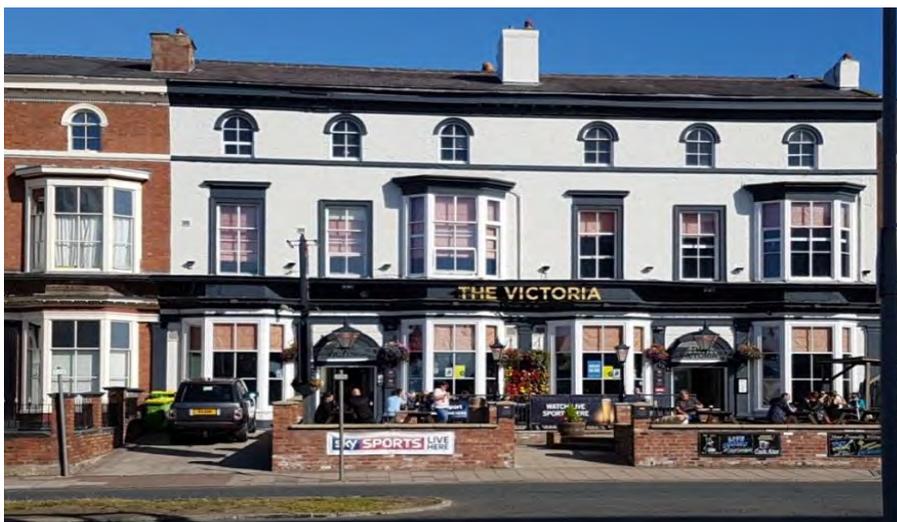
**Lower quality temporary pvc banners are used in a quite permanent fashion and have become tatty and soiled**

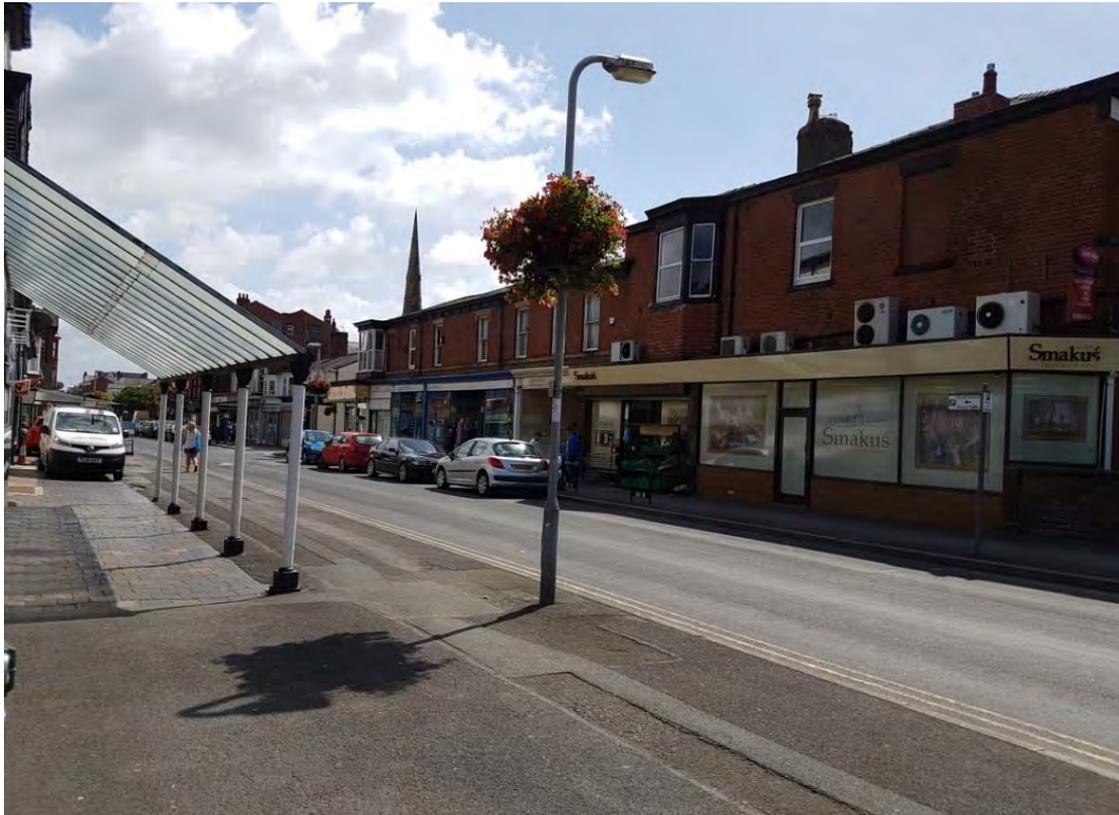
Ventilation and extraction equipment is not an attractive or sympathetic addition to historic buildings. In some cases the vents or external ducting is sited in visually obtrusive locations, the colouring of such units sometimes means they particularly stand out against the brickwork. A high number of units or significantly sized ducting increases the degree of harm. Such units can be noisy and vent unpleasant odours. The above issues mean that the locations of vents often become less desirable places. A particularly poor example of several air conditioning units attached at first floor level to a front elevation occurs at 25 Bold Street.

**Visible ventilation units strongly detract from the aesthetic appeal of historic properties such as 25 Bold Street**

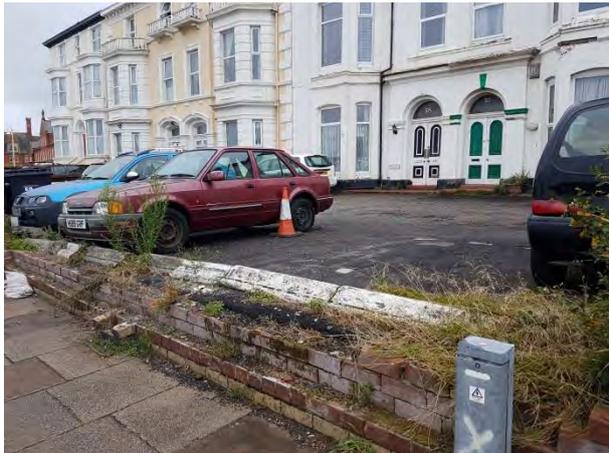
**Repairs are needed to this boundary wall on the Promenade**

The character and appearance of a number of buildings and structures would benefit from repairs and maintenance works. Repairs to render, painting of joinery details, repairs to roofs and rainwater goods, and the use of more long lasting and traditional

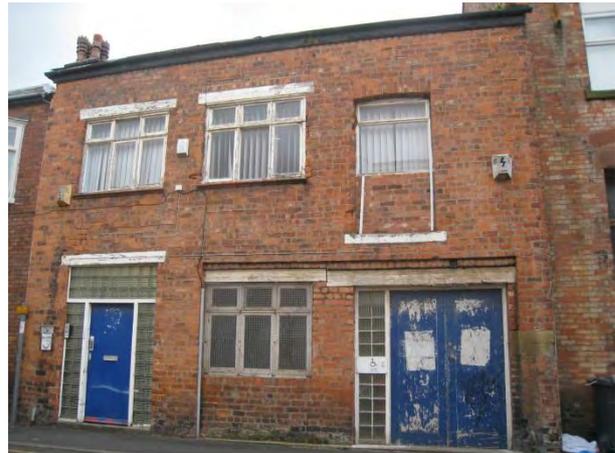
**An example of poorly executed brick infills and structural amendments**

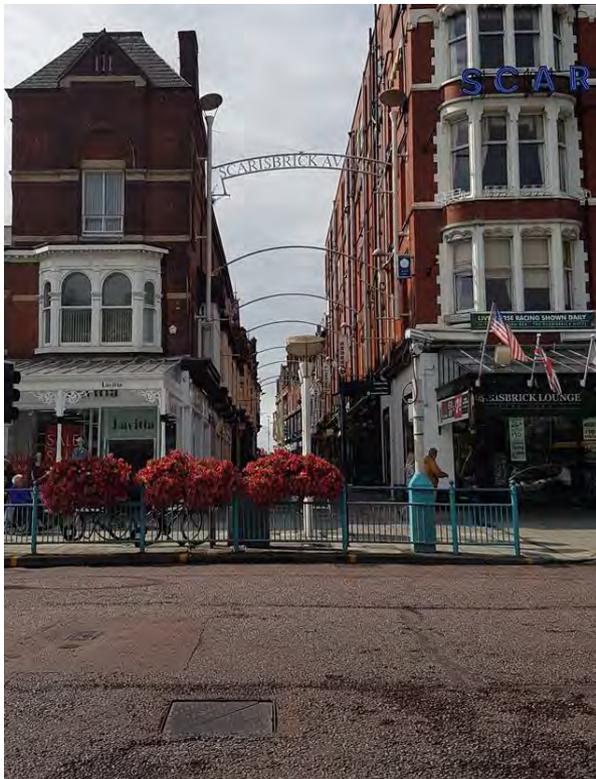
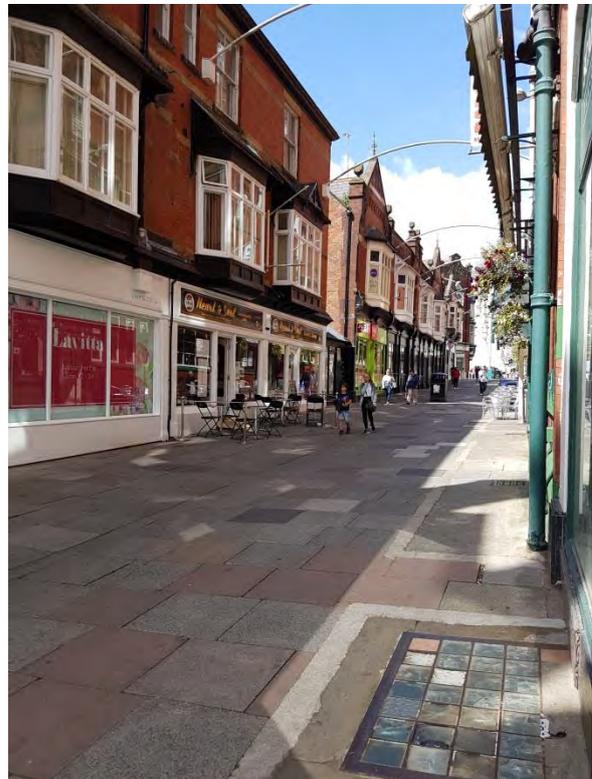
**Scarisbrick Avenue has the potential to be a key gateway between Lord Street and The Promenade and would benefit from a high standard regeneration scheme**

Large metal arches have previously been installed along Scarisbrick Avenue along with a series of banner fixtures. These have been partially removed and it would be beneficial if the remaining fixings could also be removed. There are no streetlights along this narrow street an enhanced scheme of lighting at night would help to improve the perception of the street, though it is recommended that any additional lighting be affixed to the buildings, rather than crowding the already narrow pedestrian route.

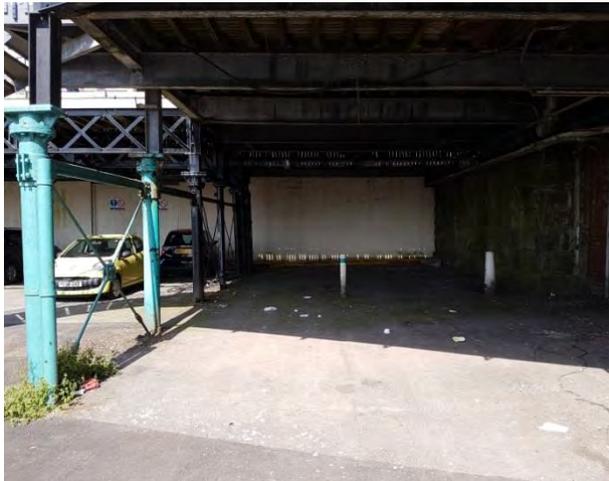
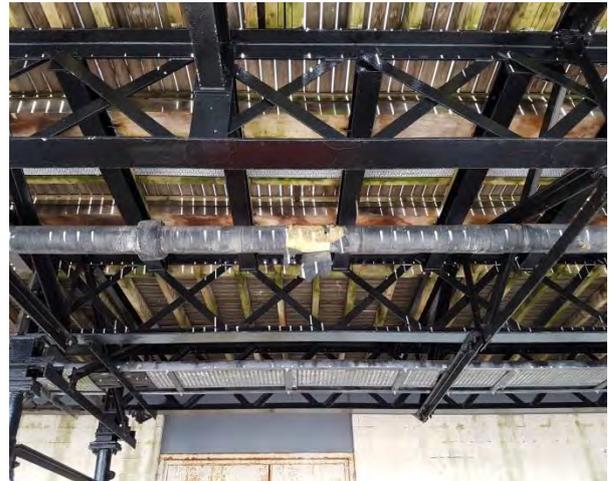
The area beneath the pier is very dark and suffering from pigeon damage

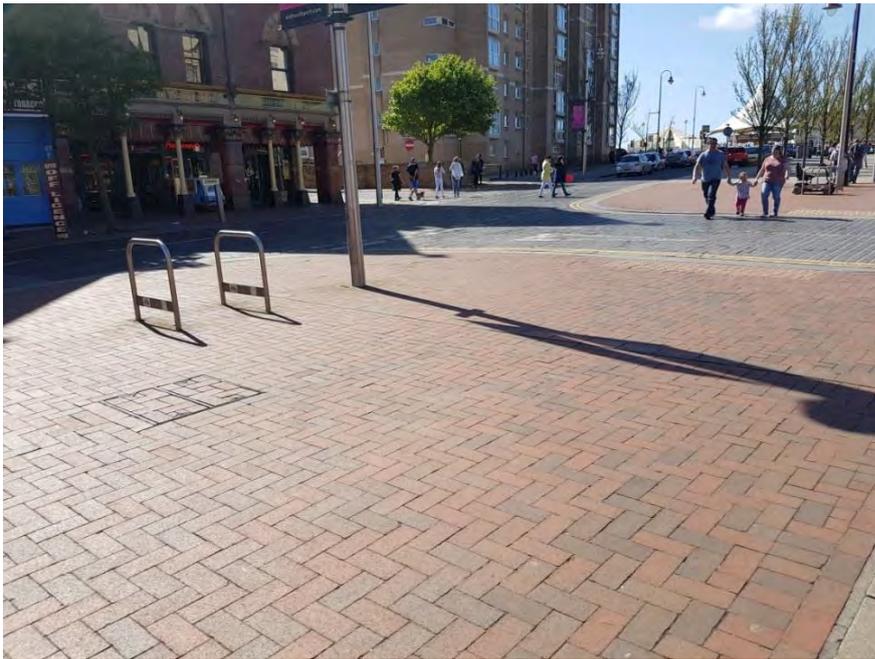
**Inconsistent paving styles should be rectified with more appropriate and unifying materials**

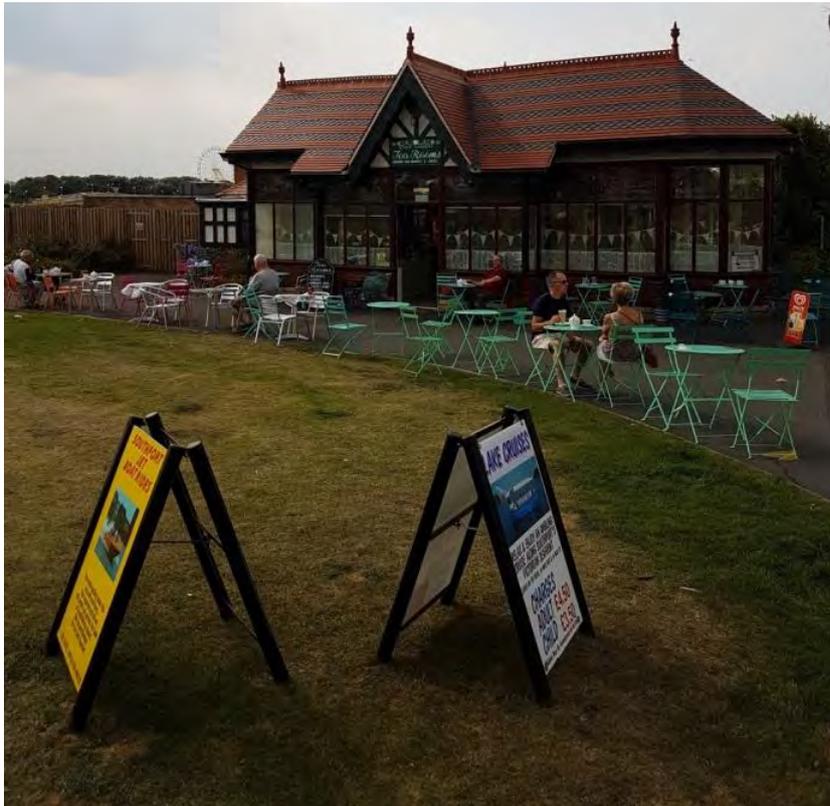
**Pavement cafes and the use of A-boards should be carefully reviewed**
