Waterloo Park Conservation Area Appraisal Adopted April 2016

This Conservation Area Appraisal was prepared by Sefton Council in 2015 and amended following public consultation between January and March 2016 and was fully adopted including the suggested boundary changes shown below by Sefton Council on 27th April 2016. For more information on boundary changes please see Section 9.0

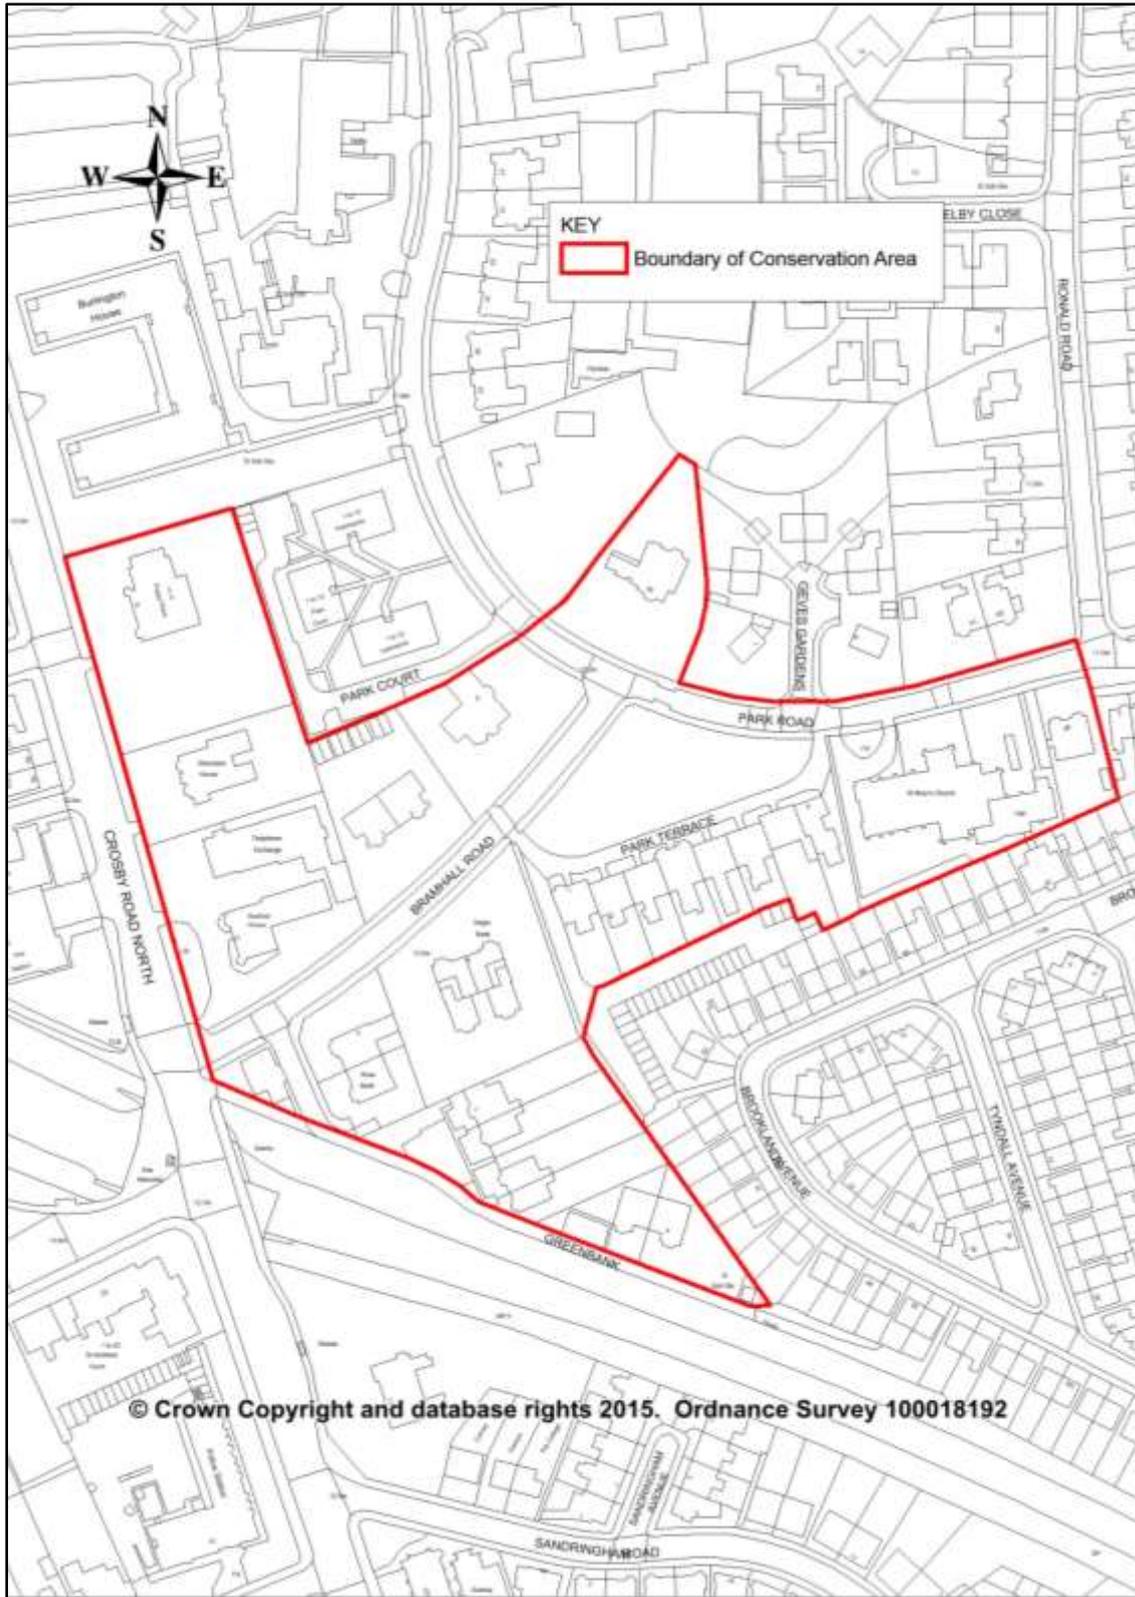
Plan 4: Boundary of Waterloo Park Conservation Area

Waterloo Park Conservation Area was designated by Sefton Council in October 1991. The area comprises important elements of a late 19th Century planned housing development and is considered an attractive combination of architectural, townscape and historical interest. It is the combination of these factors which makes the area special and justifies efforts to preserve and enhance its character and appearance. The Conservation Area Boundary is largely arrow-shaped and focuses on Park Terrace and Bramhall Road. To the south-east it abuts the Christ Church Conservation Area where it overlooks the Southport to Hunts Cross Mersey Rail Railway line. As part of the review of the Waterloo Park Conservation Area, it is necessary to investigate if there is any scope for boundary changes since the appraisal was adopted. Any amendments to the existing boundary will reflect an up-to-date and comprehensive survey and analysis of the area. Chapter 9 provides a detailed review of the Conservation Area boundary with suggested changes.

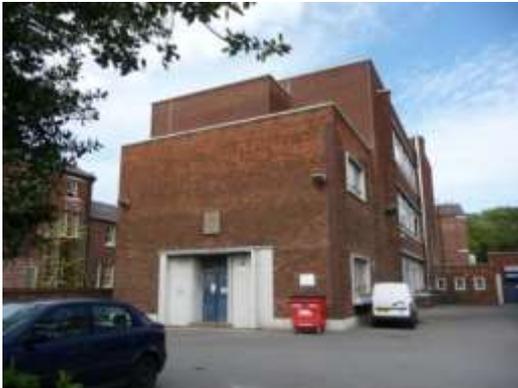
All properties within the Waterloo Park Conservation Area, apart from St. Mary's Church on Park Road, the Telephone Exchange building and Seafield House (offices) on Crosby Road North, have been converted into flats. The properties in multi-occupancy have resulted in some alterations to the building fabric and original layout of the grounds, but their condition is generally good. Four properties on Greenbank (numbers 1-4 inclusive) are owned by Riverside, which is a social housing provider, and are well-maintained residencies, as are Numbers 5 and 6 Greenbank which are in private ownership. Properties along Crosby Road North are in good condition and are well-maintained office and residential premises. Apart from Park Terrace, the majority of all other properties in the Conservation Area are generally well-maintained.

Photo 35: Telephone Exchange, Crosby Road North

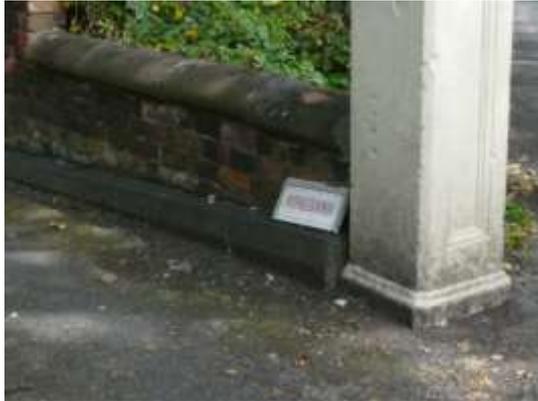
Boundaries – stone and brick walls with stone copings form the principal boundary treatments within the Conservation Area. Not all materials are original and some repair works have been undertaken using modern bricks. Although gate piers still exist to most properties, their gates and ironwork have been lost. There is evidence of former railings to the original boundary walls in evenly spaced shallow recesses with iron stumps. Original wrought iron railings and handrails to the steps at 1-4 Greenbank exist.

Photo 39: Boundary wall to Rosebank

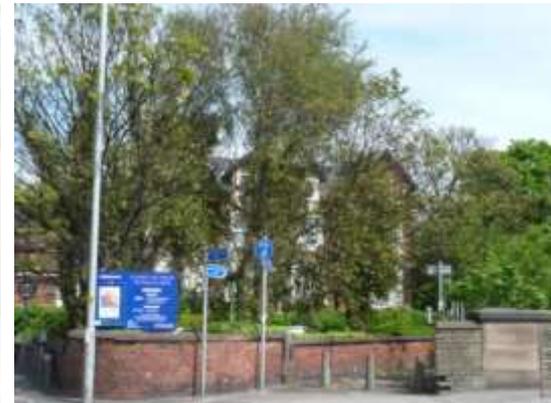
Photo 42: Brick Boundary wall to Greenbank and Stone Railway bridge on Crosby Road North

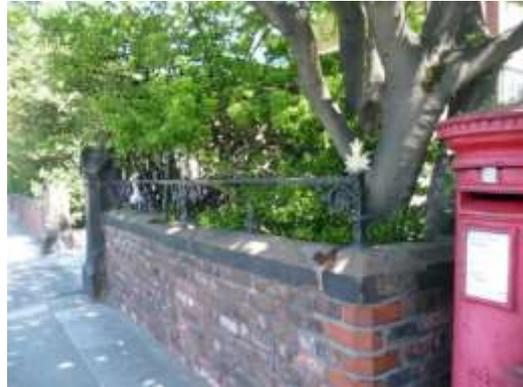
Of interest is the detailing to the external boundary wall enclosing Seafield House, where the wall forms a recess for the post box. This interesting design feature makes an important contribution to the Conservation Area through attention to detail. Every effort should be made to preserve this feature should the structure become de-commissioned.

Photo 46: Boundary wall to Seafield House

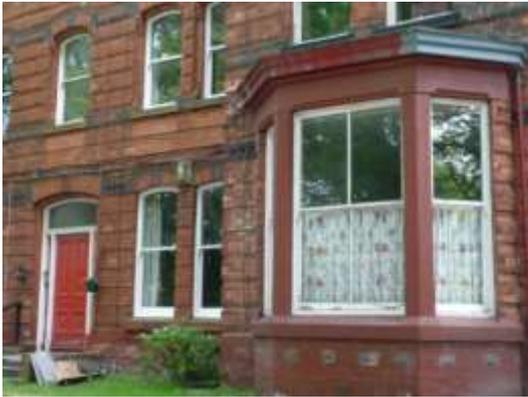
Although many properties have had their windows replaced, original timber sliding sash windows (typical of the period) can be found in the Conservation Area, particularly Park Terrace. Where properties have retained this original feature, they make a significant positive contribution to the overall character of the area.

Photo 77: Timber sash bay to Park Terrace

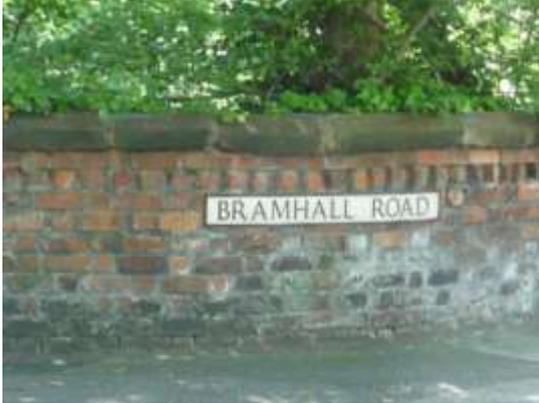
Boundary walls form an important feature throughout the Conservation Area, and many properties retain their original boundaries. Park Terrace has a particularly attractive boundary wall in brick, with a decorative band of arris detailing with a saddleback stone coping. Stone copings are a particularly important feature of the area, and even where original walls have been replaced with more modern boundary walls, the original stone copings have been re-used.

Photo 83: Boundary wall to Park Terrace

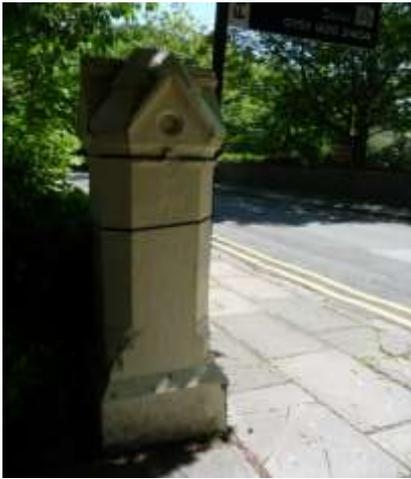
Sandstone gate piers are a typical feature throughout the Conservation Area. Their size and design vary with the grandeur and scale of the property to which they relate. It has become common practice for the piers to be painted. Their contribution to the rhythm and dynamic of the street scene is significant, even though some have been lost, or when the related property has been lost or replaced by more modern development.

Photo 87: Gate pier

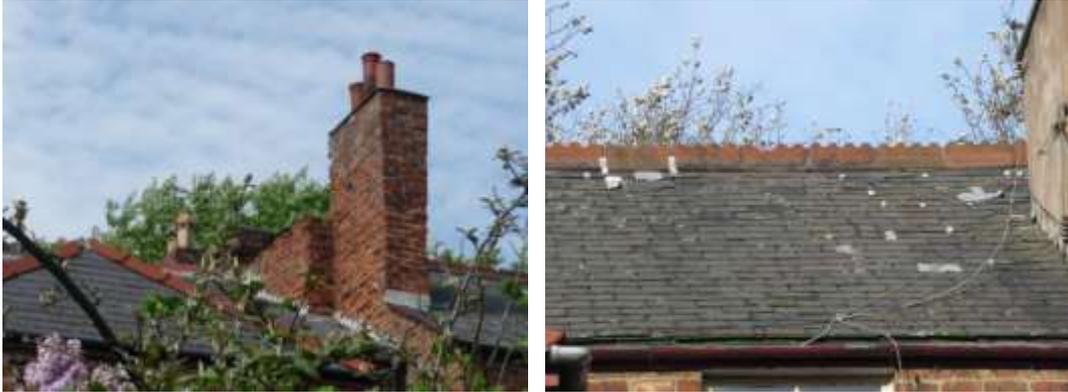
These are not a prominent feature across the Conservation Area. Park Terrace is the only group of properties, which retains decorative terracotta ridge tiles.

Photos 93 and 94 - Decorative terracotta ridge tiles to Park Terrace

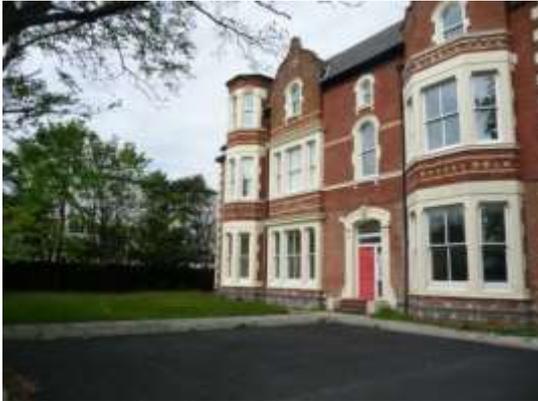
the area. In the main, there are timber replacements with modern door furniture not in keeping with the character of the Victorian property. It is noted that the front doors to both Poppy Place and Ellesmere House are not original to the buildings and the door to Poppy Place is out of scale with the property. Although they are of timber construction, they have modern door furniture and the recessed panels are not a traditional design.

Photo 105: Poppy Place with modern door furniture

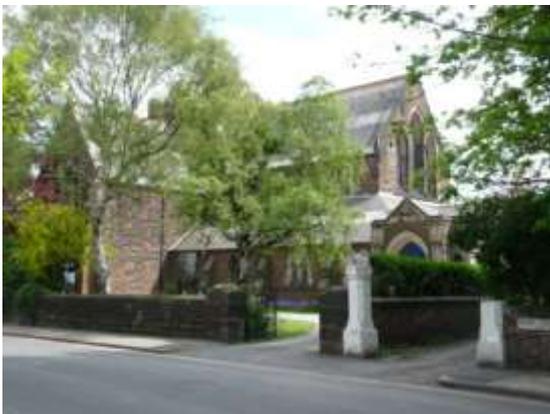
As identified in Section 5.3, front boundary walls are an important feature of the street scene within Waterloo Park Conservation Area. They contribute to the rhythm of the street and clearly define public and private space. Their loss, or alteration is, therefore, detrimental and particularly damaging where this has occurred in conjunction with the hard-surfacing of front gardens for car parking.

Photo 107: Damaged gate pier to Park Terrace, Park Road

It is noted that some of gate piers have been removed, damaged or altered over time. It would greatly enhance the Conservation Area if they could be repaired or reinstated as appropriate. Paired entrance piers complement the grandeur and status of the Victorian villas within their parkland setting.

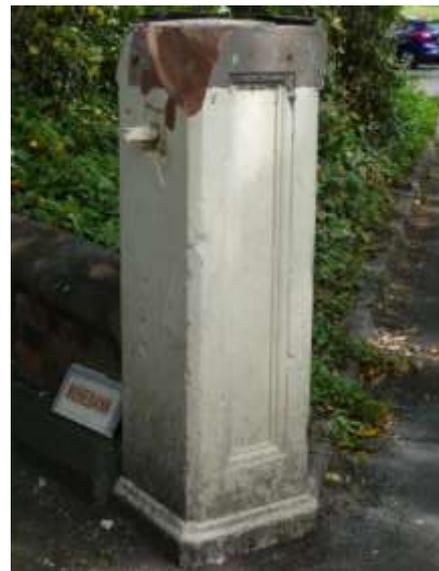
Photo 108: Damaged gate pier to Rosebank

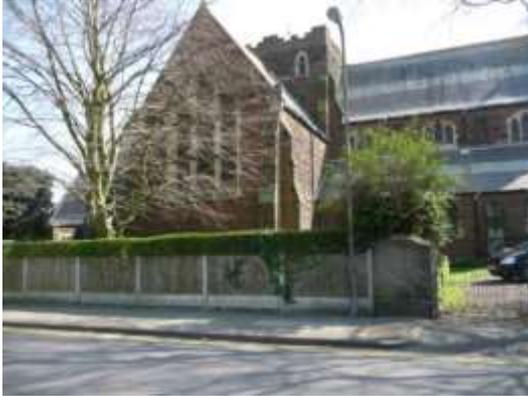
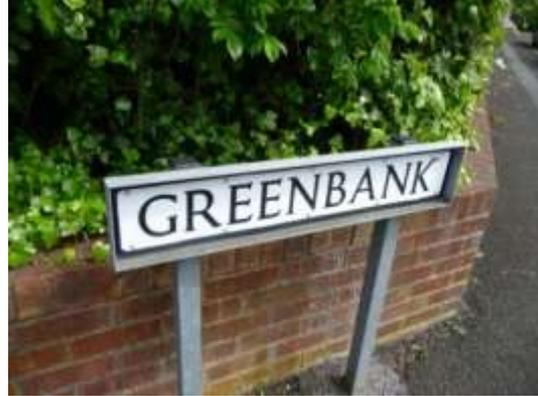
As with the removal of boundary walls, their replacement with inappropriate materials has had an equally damaging effect on the street scene, destroying continuity and uniformity. It is particularly detrimental when it occurs along a row of detached properties.

Photo109: Loss of original boundary wall, St. Mary's Church Photo 110: Replaced boundary wall at Greenbank

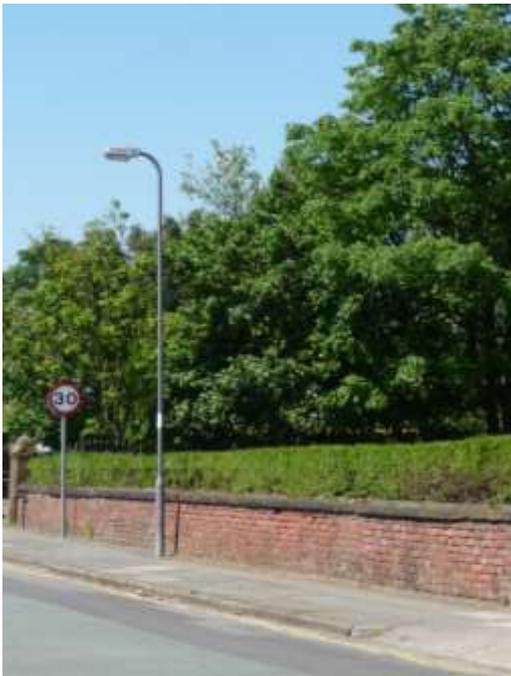
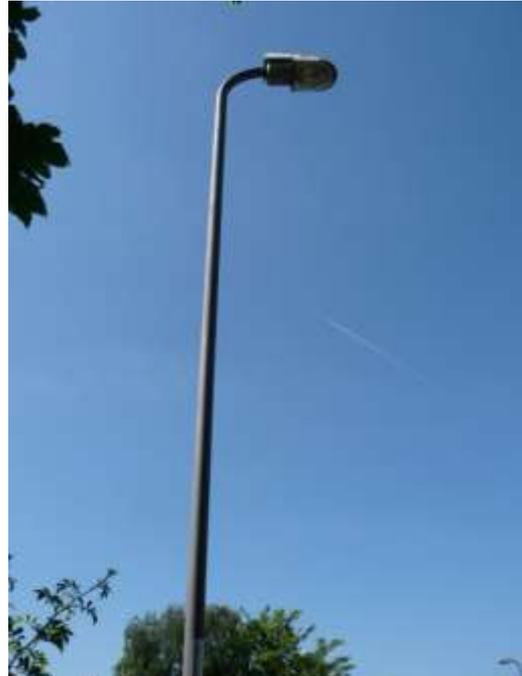
Photo 115: Poor quality modern lampposts

Photo 116: Poor quality modern lampposts

It would greatly improve the Conservation Area if the lampposts could be replaced with a heritage style design and painted finish to complement the Victorian villas and thereby, contribute towards enhancing the character of the area.

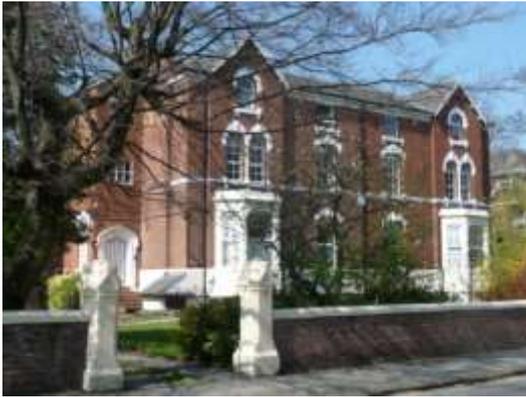
Photo 117: Gate piers at 1-3 Bramhall Road

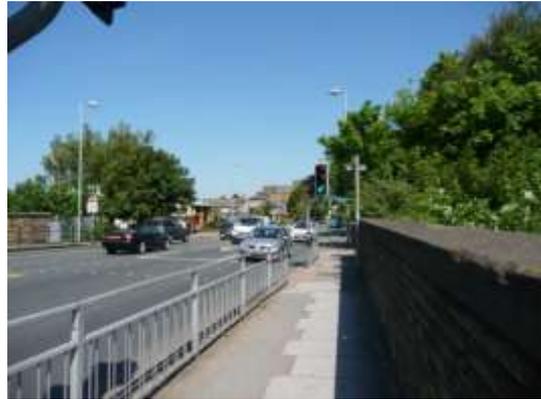
Photo 122: Barrier fencing abutting Crosby Road

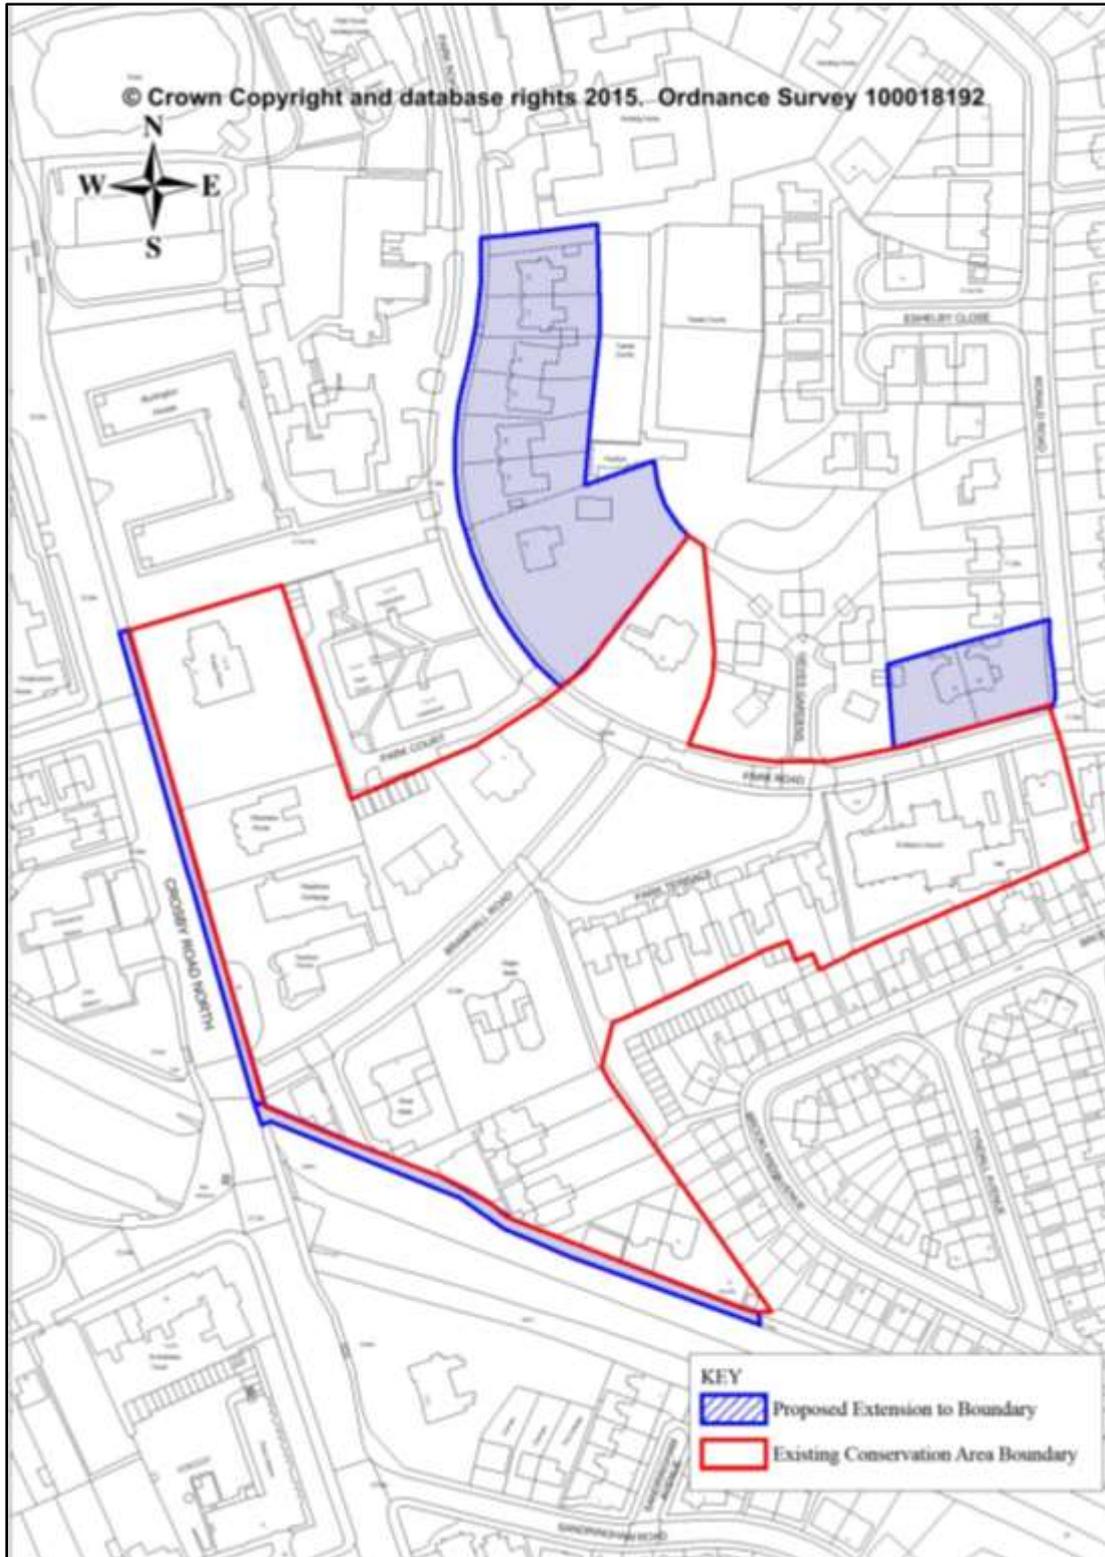
Plan 12: Proposed alterations to the existing Conservation Area boundary

In general, there appears to be some small anomalies where the boundary is set either at the back of pavement line or kerb line. It is recommended that, in all situations where the boundary runs in front of buildings, it should be consistently drawn at kerb line. This will help to protect any historic paving and kerbs, and thereby protect the setting of the buildings and their boundaries. Furthermore, it would enable any future enhancement schemes to address the public realm works in a meaningful way. The Conservation Area boundary has been amended to reflect this. (Plan 12).
