## **6. ARCHITECTURE, DETAILS AND MATERIALS**

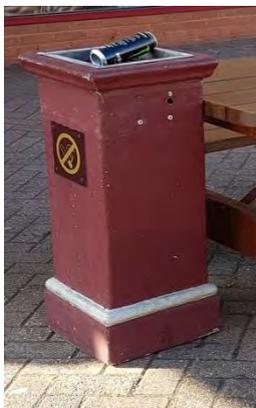
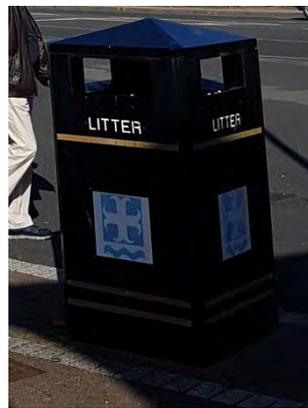
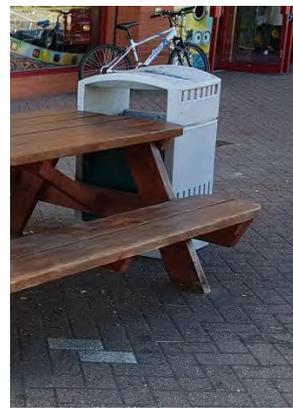
Due to various landlords and ownerships, there are a multitude of different styles of litter bin within the area. These include square black metal bins, red metal bins, freestanding round stainless steel bins, beige plastic bins and grey plastic bins. It would be beneficial if bins were designed to a consistent scheme, ideally of cast iron to complement the existing character and appearance of the Promenade Conservation Area.

**There is a variety of differing bin designs throughout the Conservation Area**

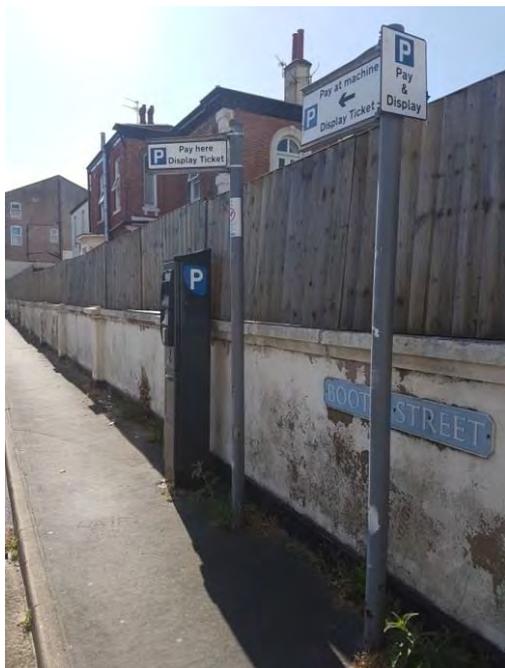
There is a proliferation of traffic signs, particularly in relation to parking restrictions and the pay and display machines.

**An unnecessary amount of signage makes parts of the Conservation Area appear cluttered**

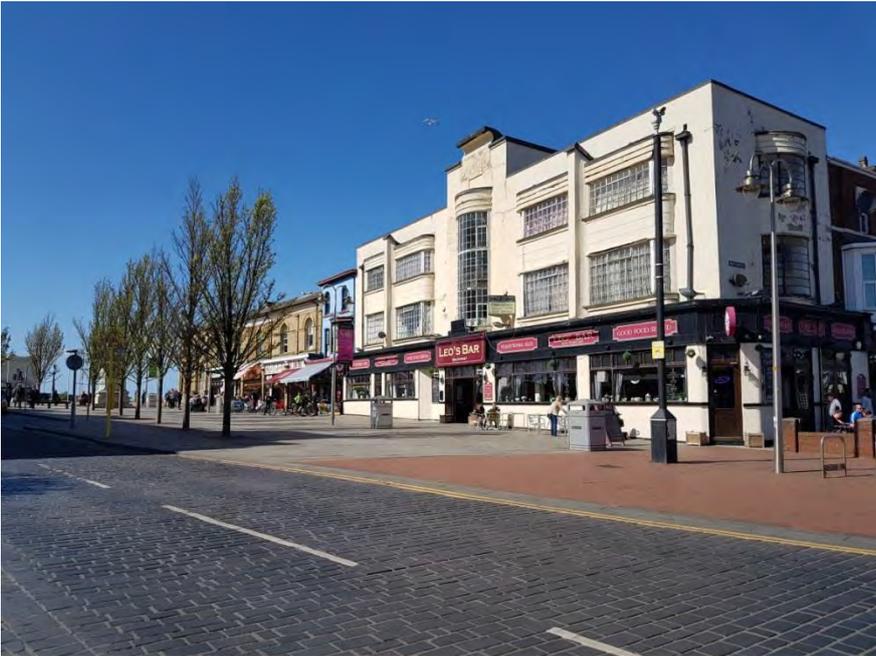
### **Leo's Bar**

Though its fenestration and ground floor frontage has been altered unattractively, its overall symmetrical shape and central tower are unmistakably Art Deco, which marks it out from surrounding buildings.

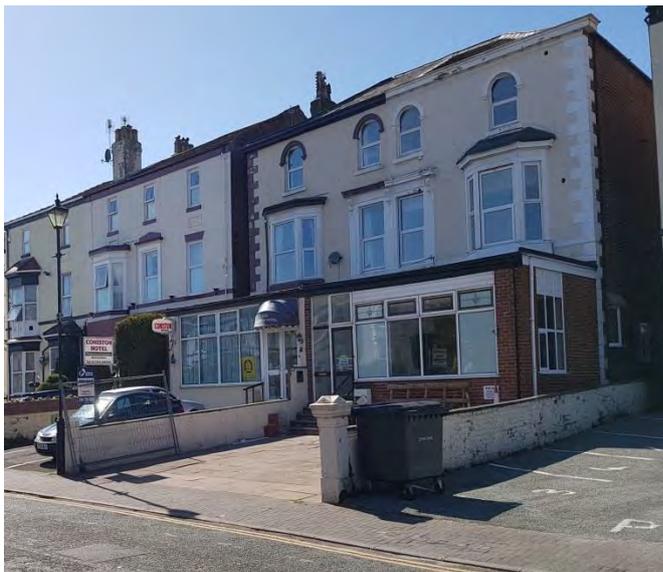
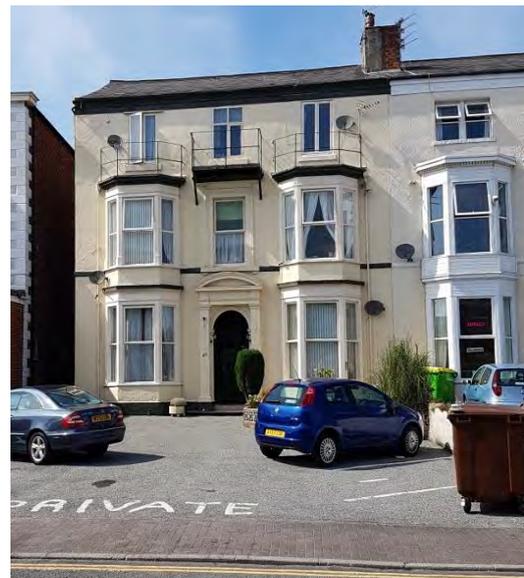
Disproportionately sized and poorly designed extensions disfigure some properties. This is particularly prevalent along Bath Street, where modern single storey front extensions have been added to the Victorian villas. These additions have a negative impact on the buildings and the Conservation Area as a whole by disrupting the traditional layout and rhythm of the street and obscuring architectural detailing at ground floor.

A substantial number of properties in Bath Street show signs of inappropriate alterations

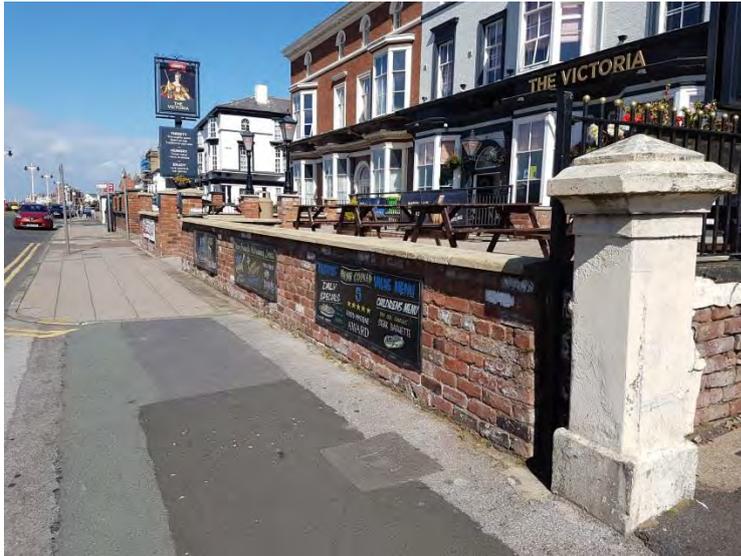
**Wooden boards detract from this historic brick boundary**

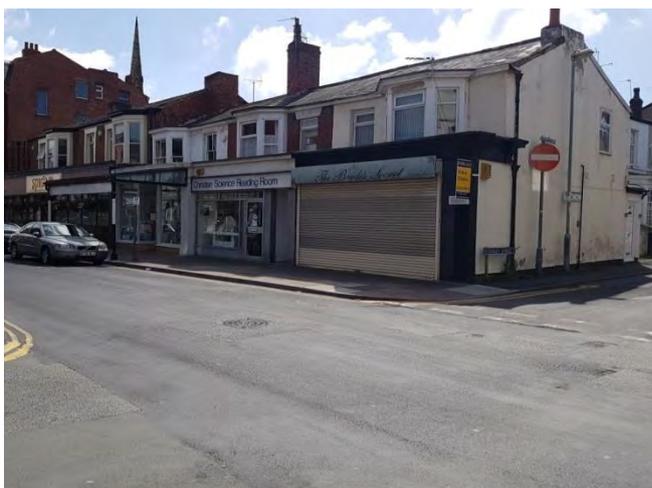
**Shopfronts would benefit from the removal of inappropriate roller shutters, signage and regular maintenance**

Commercial buildings would benefit from the removal of overlarge signs, roller shutters and installation of shop fronts and signs which better reflect the age, materials, style and decorative detail of the upper floors. Ideally these should be based on the original designs. Such an approach would allow the architectural diversity and interest of the Conservation Area to be more easily recognised and therefore better enjoyed by visitors.

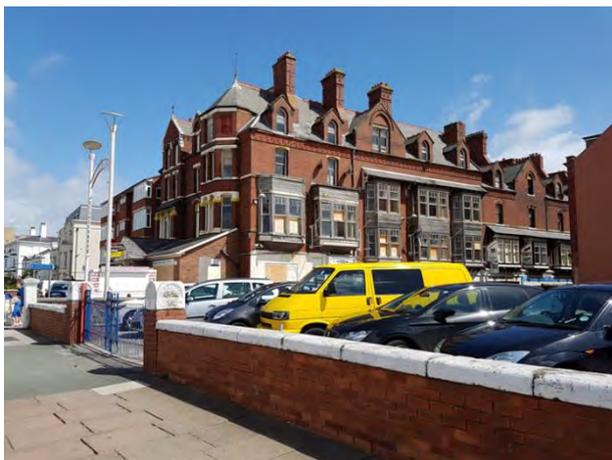
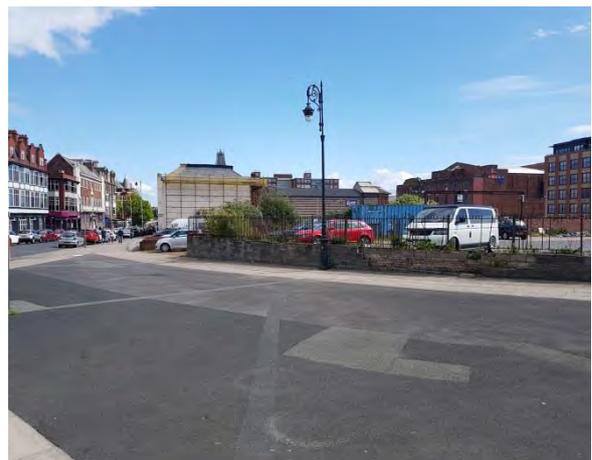
**Appropriate development would benefit the small number of gap sites within the Promenade Conservation Area**

The sympathetic redevelopment of the car park site at the junction of Scarisbrick Avenue with the Promenade would be beneficial. To enhance the Conservation Area, development should be set on the established building line, be of a height, scale and massing which correlates with the historic character of the Promenade and recreate a sense of enclosure, while ensuring vertical divisions break up the facade.

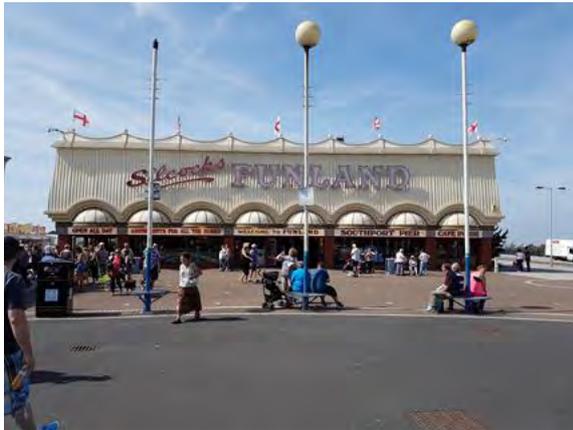
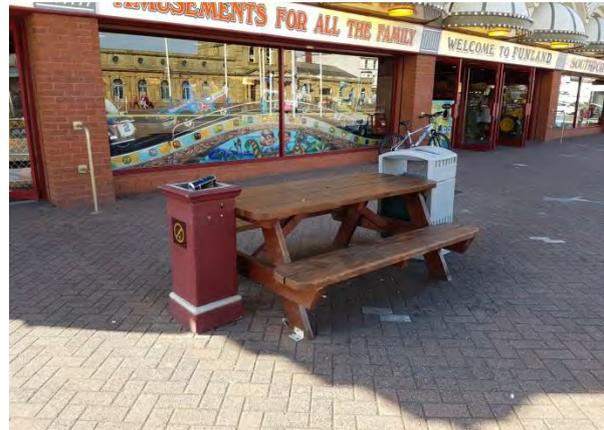
Funland and the Pier forecourt would benefit from a comprehensive scheme of redevelopment to improve the legibility of the space and enhance its character as the central focus of the Conservation Area. The existing features and paving are starting to appear tired and unbecoming of Southport's wider heritage.

The popular area around Silcocks Funland is in need of refurbishment

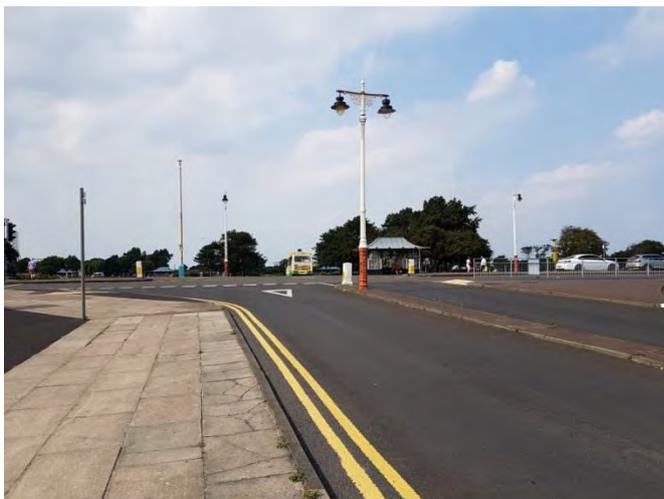
The junction between West Street and the Promenade lacks individuality and interest

Improvement to the definition and visual appearance of the road junction with the Promenade would be beneficial. A scheme to rationalise and improve the appearance of the existing complicated hard landscaped arrangement should aim to improve the pedestrian experience of this space. Such a scheme could potentially be developed in connection with redevelopment of the vacant former 'Kingsway' site.

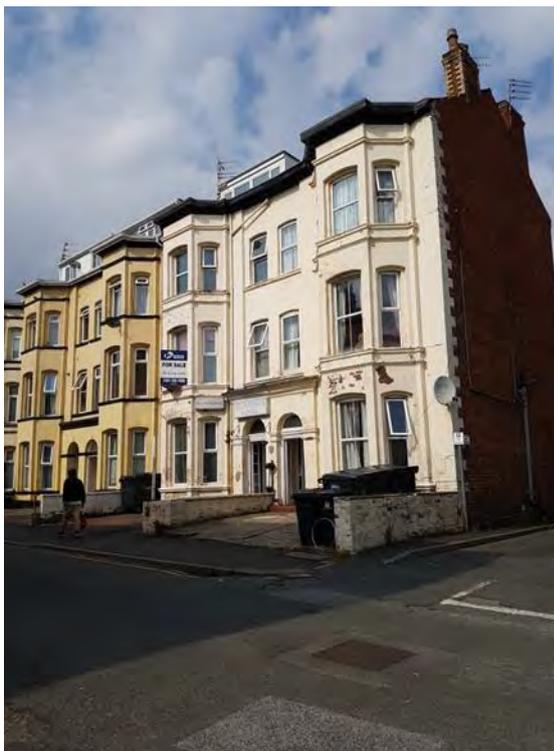
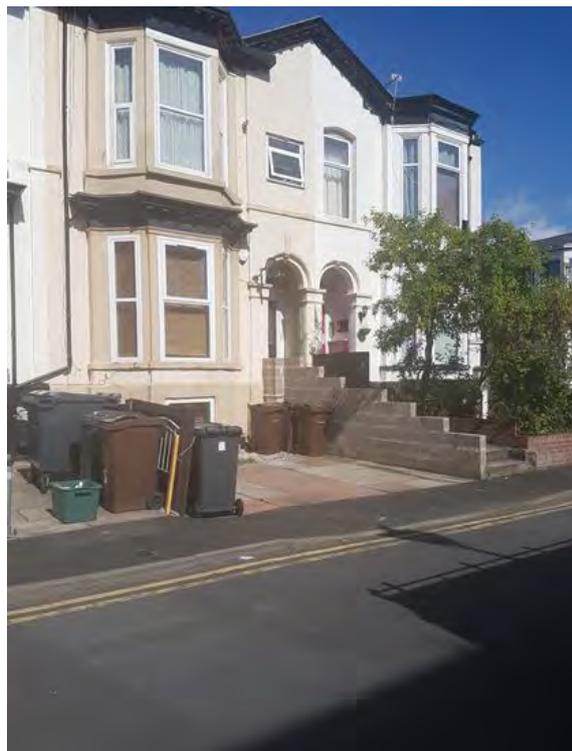
**Several guest houses and houses of multiple occupation have fallen into a state of disrepair**

The guest house and hotel uses are essential contributors to the resort area's historic character and appearance, though many have a dated appearance. In refurbishing such premises many of the frontages would benefit from more appropriate signage, removal of inappropriate additions and reinstatement of historic features and to add to their unique appeal.
