Structural Steelwork Inspection

Southport Pier
Promenade
Southport
PR8 1QX

Contract No: LV1255

Dated: June 2023

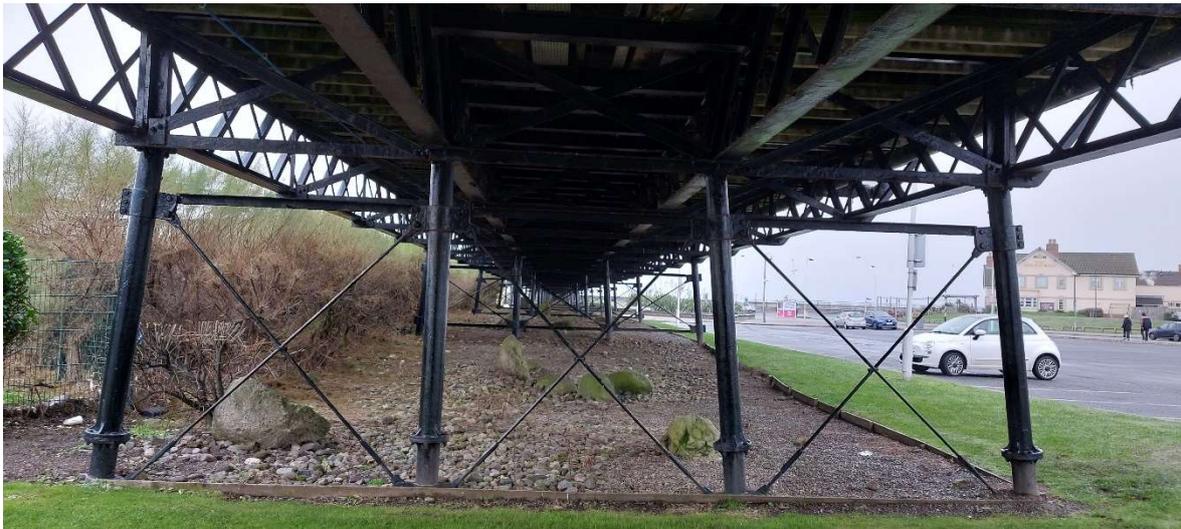
2.6 No intrusive or destructive testing has been carried out on the steelwork to determine the grade or composition of the materials used, there has been localised removal of loose paint and corrosion only. Photograph 4 below shows a typical support frame (as Figure 4) adjacent to the access road into the leisure park. Further investigation is required for the existing cast iron columns to determine if any cracking is present and depth of installation, foundation size, form and bearing strata to allow comment on the frame's capacity.

Photograph 4 – Typical support frame.

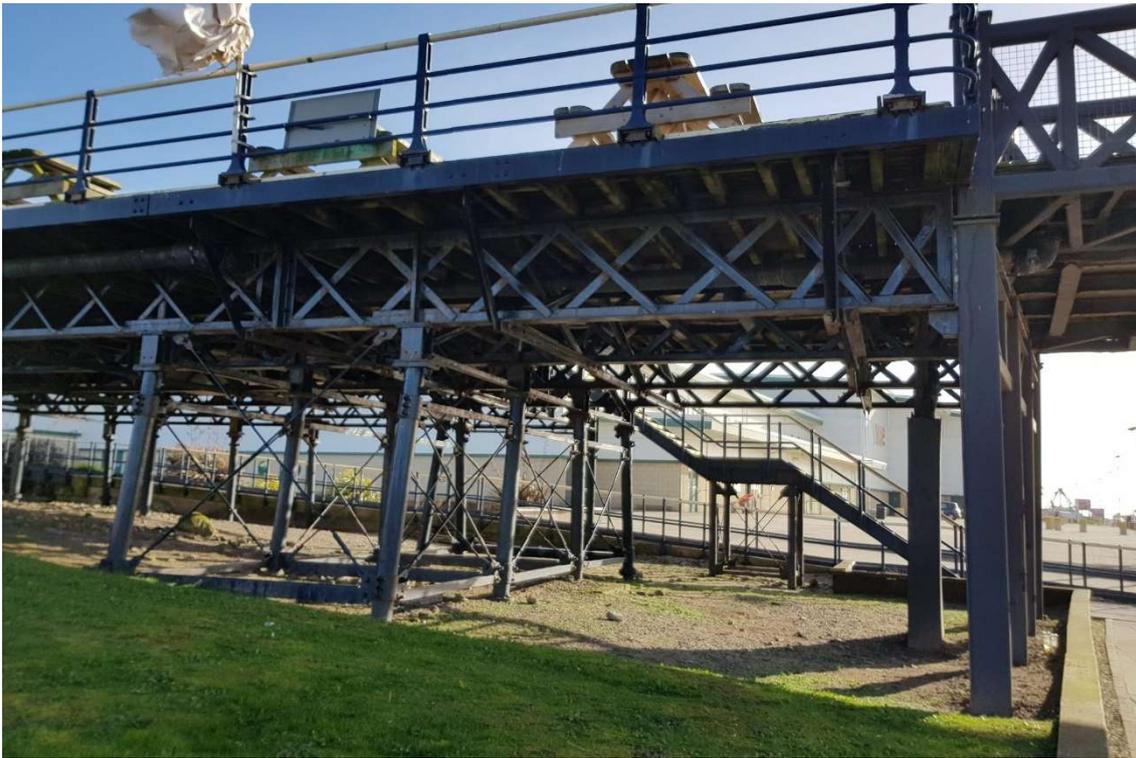
2.26 To the underside of the Donut shop, at approximately the midpoint along the pier, there is a double frame configuration. This provides cross bracing between the support frame posts in two directions, and horizontal cross bracing to the underside of the trusses. Photograph 19 provides a view from the side of this braced configuration.

Photograph 19 – View Braced Double Support Frame on left hand side

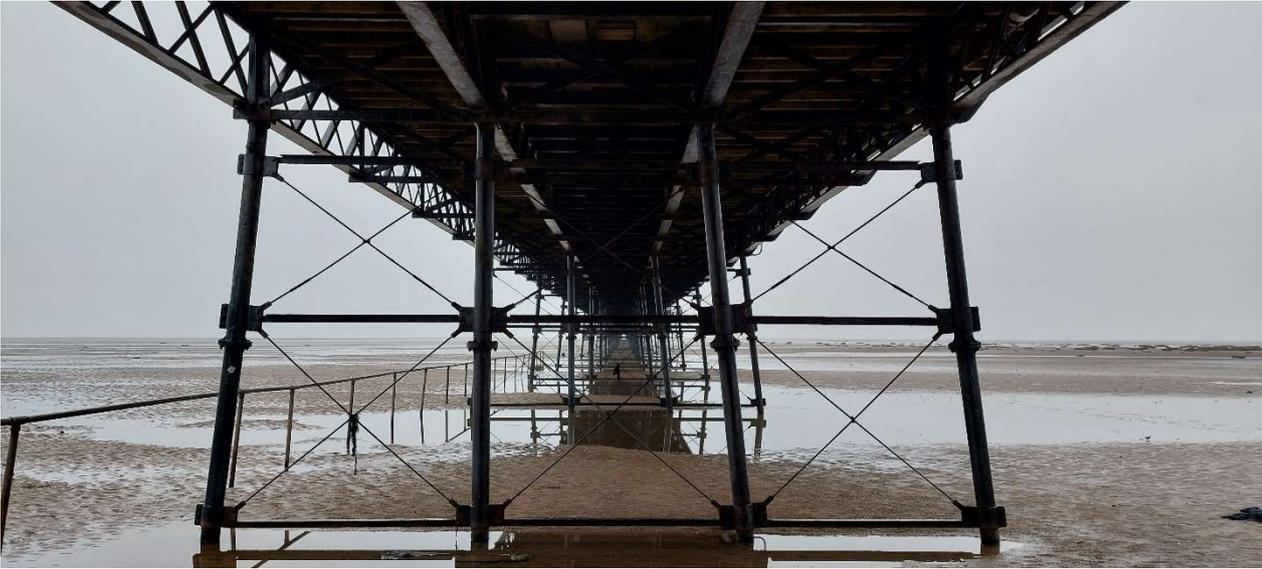
2.43 On the beach side of the pier, the support frames are naturally higher and thus require a double braced configuration shown in Photograph 34 and Figure 5.

Photograph 34 – View on typical support frame along the beach
