## Structural Inspection

Southport Pier  
Promenade  
Southport  
PR8 1QX

Sefton Metropolitan Borough Council  
Magdalen House  
Trinity Road  
Bootle  
L20 3NJ

Dated: April 2023

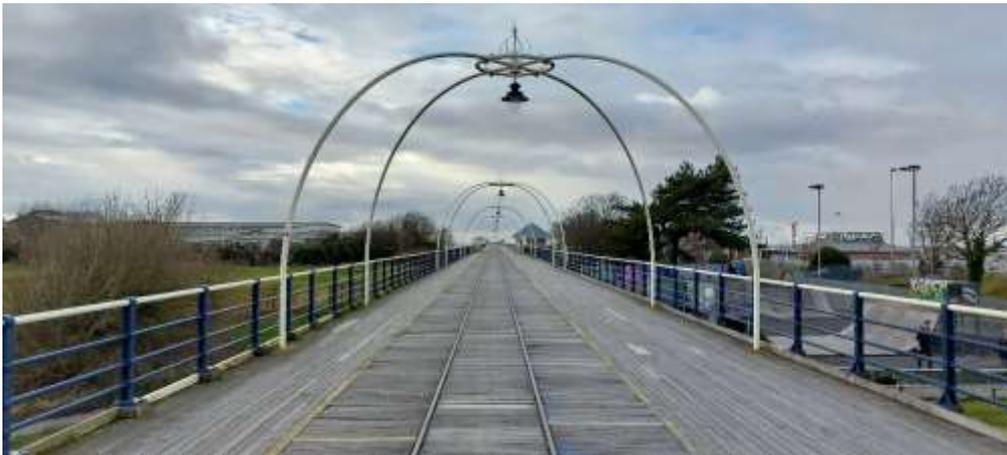
- 2.1 Along the pier, there are a number of overhead light frames that are numbered, see photograph 2, in co-ordination with Formby Surveys topographical survey. Thomasons commenced the survey adjacent to light frame 2, which was noted as the extent of the Phase 1 deck refurbishment.

Photograph 2 – Indicating light frame numbers (No. 4 shown)

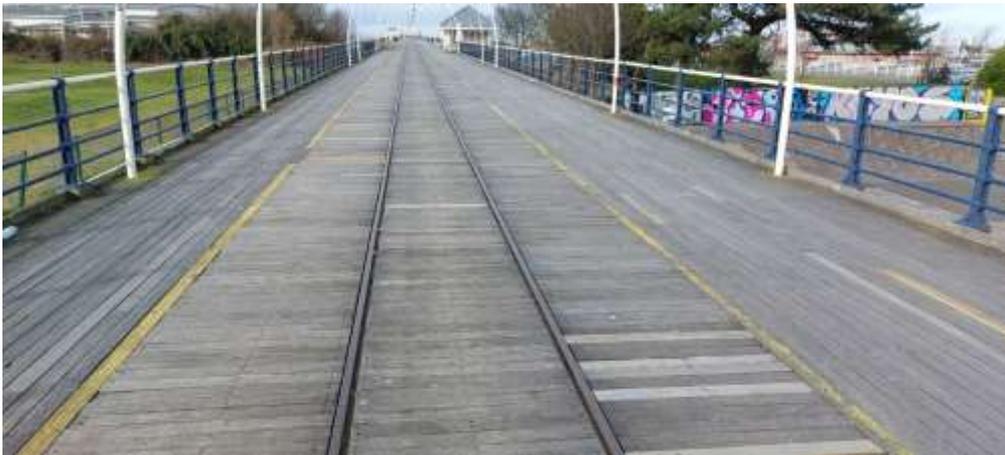
- 2.4 Photograph 3 indicates the orientation of the decking boards along the pier. This is the typical configuration, except at the entrance to the pier and at the pier head due to the widening of the deck. At the pier entrance the boards have been replaced as part of a previous phase of works and the rails removed. Based on the typical layout of the pier, descriptions for locations and positions are: the pier head to the west, the pier entrance to the east, and the sides of the deck labelled north and south respectively.

Photograph 3 – View along pier looking west towards the sea.

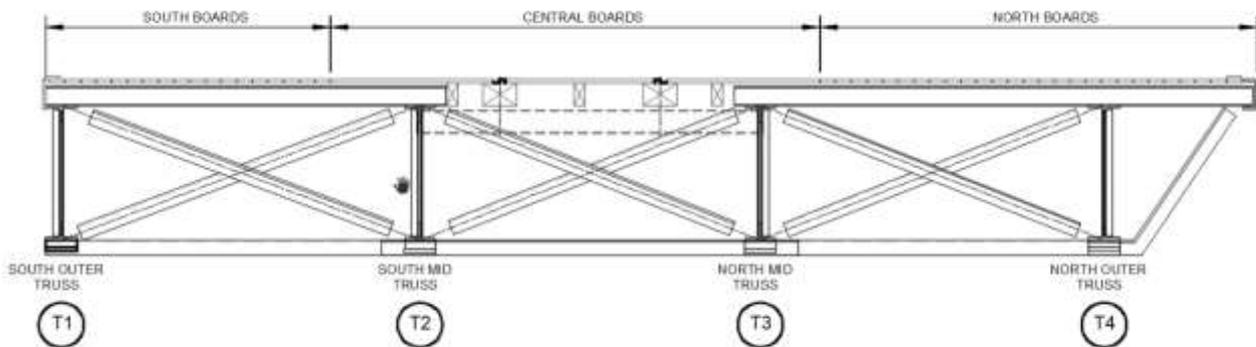
- 2.5 Reviewing the deck boarding, the referencing was split across the pier into three sections, north, south, and central boards. The north and south sections run longitudinally along the pier, and the central boards span perpendicular across the pier. The longitudinal boards span between timber joists, and the central boards span between noggins at joist edges and the timber rail supports. Refer to typical section in figure 1 below.

Figure 1 – Typical section through deck

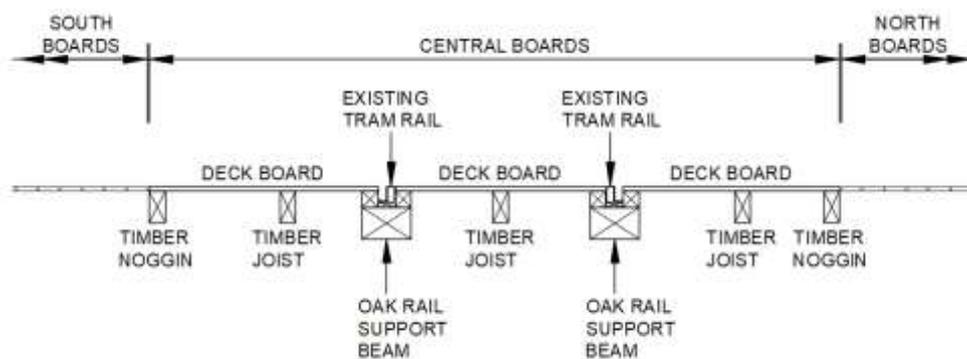
2.10 The three sections of central boards span perpendicular either side of the existing tram rails, as shown in figure 2 below. To the underside of each rail is an oak beam, the boards span between these on the central section, and between the beams and noggins to the outer edge of the section. The noggins are fixed between the joists supporting the north and south decking boards.

Figure 2 – Central board supports.

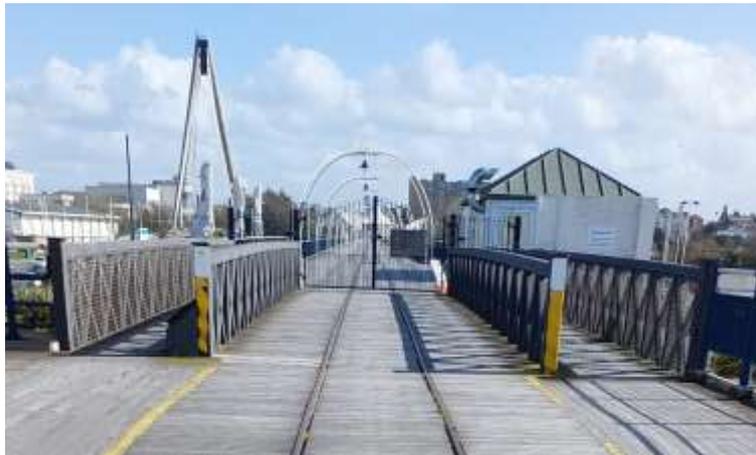
2.25 Access onto the bridge is via gates on the eastern side of the bridge. Due to the construction of the bridge, the trusses spanning over Marine Drive create walkways along the sides of the bridge, see photograph 17 below, the central section utilised for the train tracks to cross the bridge. The deck boards over the bridge are short span members, similar to the central section of the rest of the pier, and all five sections span perpendicular to the span of the bridge.

Photograph 17 – View looking East over Marine Drive Bridge

- 2.26 Due to the narrower width of the pier across the road bridge and the single route for the train the decking in this area is more concentrated than other open, wider areas of the pier. Whilst the original train utilised the existing rails, the wheels wouldn't have transferred any load onto the deck boards, since the train now runs along the top of the deck, a travelling load is now applied to the boards. This loading will not have been allowed for as part of the original design and will have caused a more detrimental effect on the boards, causing bouncing, which has lifted fixings and loosened boards.

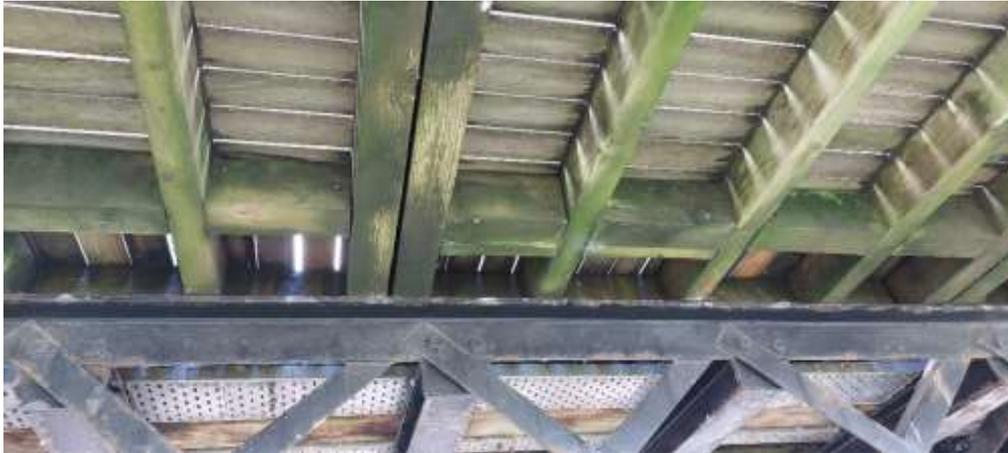
- 2.30 Area 1 – Underside of Pier adjacent to Marine Drive:
- 2.31 Timber joists to the underside of the decking are tanalised softwood timber, and span between steel trusses on the south side of the deck, and between the steel trusses and a channel section along the cantilevering deck edge on the north side. Photograph 18 below indicates the typical layout of the joists and noggins in relation to the pier steelwork trusses.

Noggins are typically located over the steel trusses. Additional noggins have been installed between the joists to support the outer edges of the central decking boards. In the cantilevered section of the north deck, there is a line of noggins set back approximately 300mm from the edge member.

Photograph 18 – Indicating typical joist and noggin configuration to underside of deck.

- 2.32 Fixing of noggins was with skewed nails through the ends of the noggins into the joists. Where the noggins sat between joists and steel beams, the noggins were seated into the web of the beam, and skew nailed into the joist at the opposite end. The skew nail fixing is not a controllable structural fixing, penetration depths and edge and spacing distances are erratic and can cause failure in the supported and supporting members which is generally observed throughout the deck.

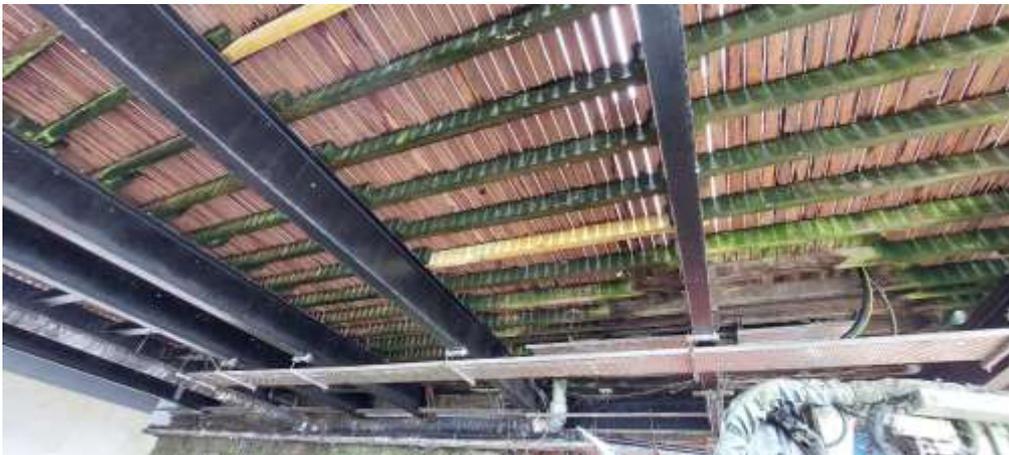
2.39 Initial inspection from ground level looking up at the underside of the pier noted some timber joists had been replaced previously and could be distinguished by their colouring, as indicated in photograph 24 below. Upon closer inspection, these were noted to be softwood timber and appeared to be untreated.

Photograph 24 – Indicating typical steelwork and joist configuration to pier entrance.
