Structural Steelwork Inspection

Southport Pier
Promenade
Southport
PR8 1QX

Contract No: LV1255
Dated: March 2024

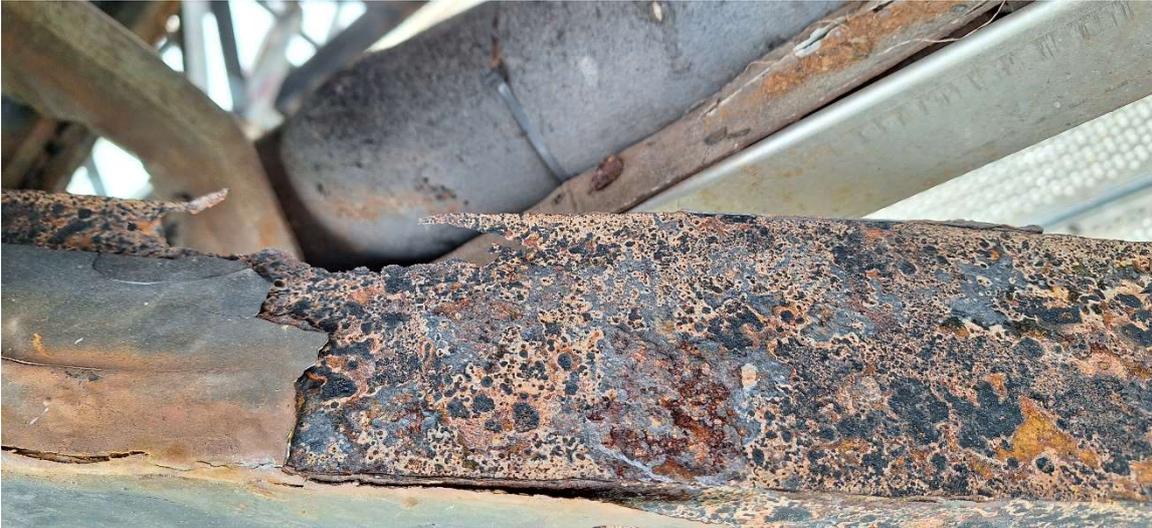
Photograph 09 – Horizontal leg of angle brace within Mid North truss in Bay 62

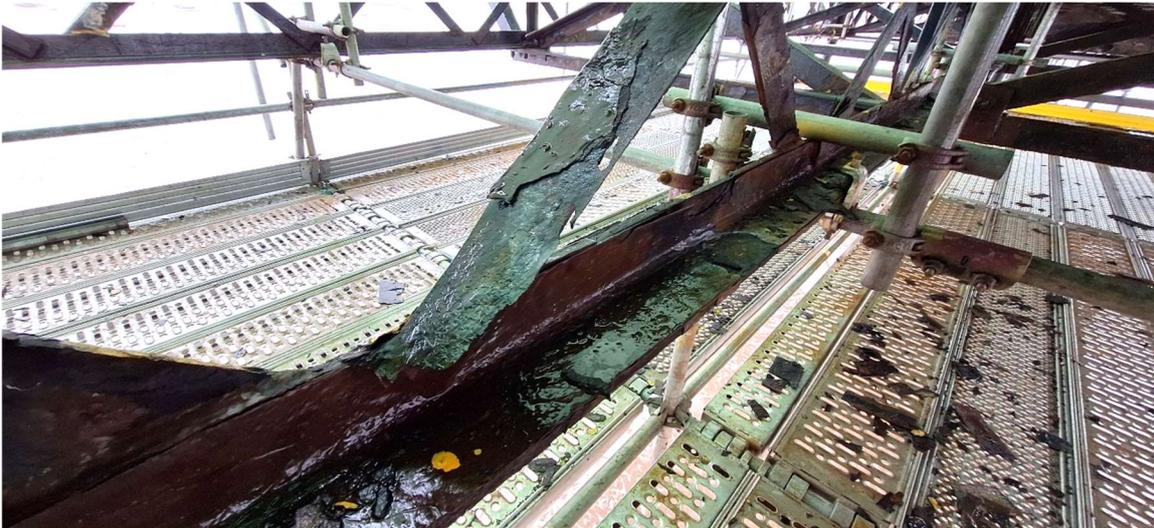
Photograph 14 – Loss of section to horizontal leg of bracing angle within the mid North truss in Bay 60

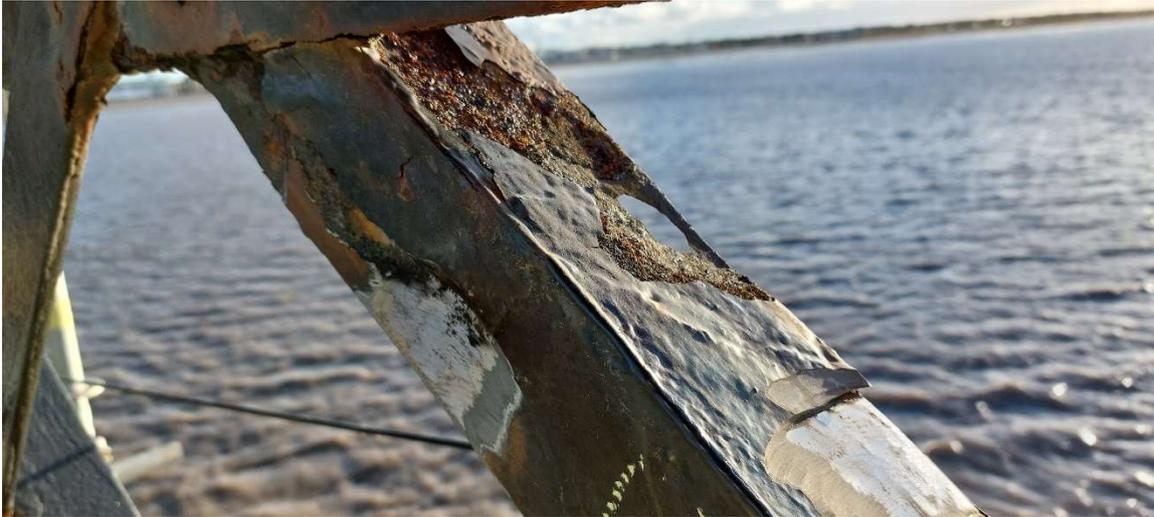
Photograph 17 – Pitting and hole in horizontal leg of diagonal brace within Outer South truss in Bay 63

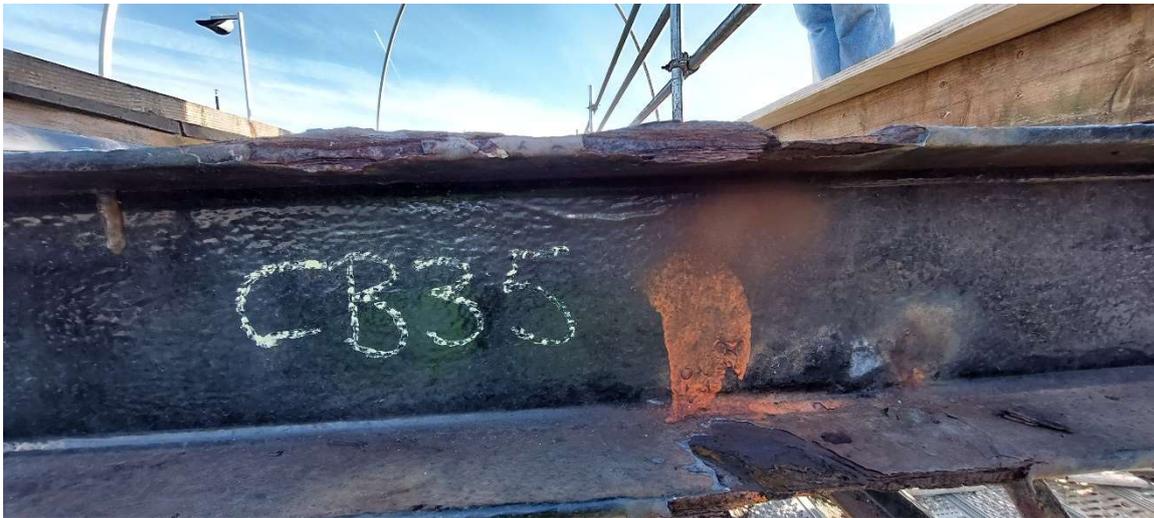
- 5.4 A visual and measured assessment of the central beams was carried out in this area. Notes and commentary have been added to the drawings for clarity.
- 5.5 The condition of the central beams varies, with a significant number requiring replacing. Beam reference 35 is shown in photographs 40 and 41 indicates minor edge delamination to one end, and at the opposite end, severe loss of section to the top and bottom flanges.

Photograph 41 – Central support Beam Ref 35 looking landward adjacent to Mid South truss

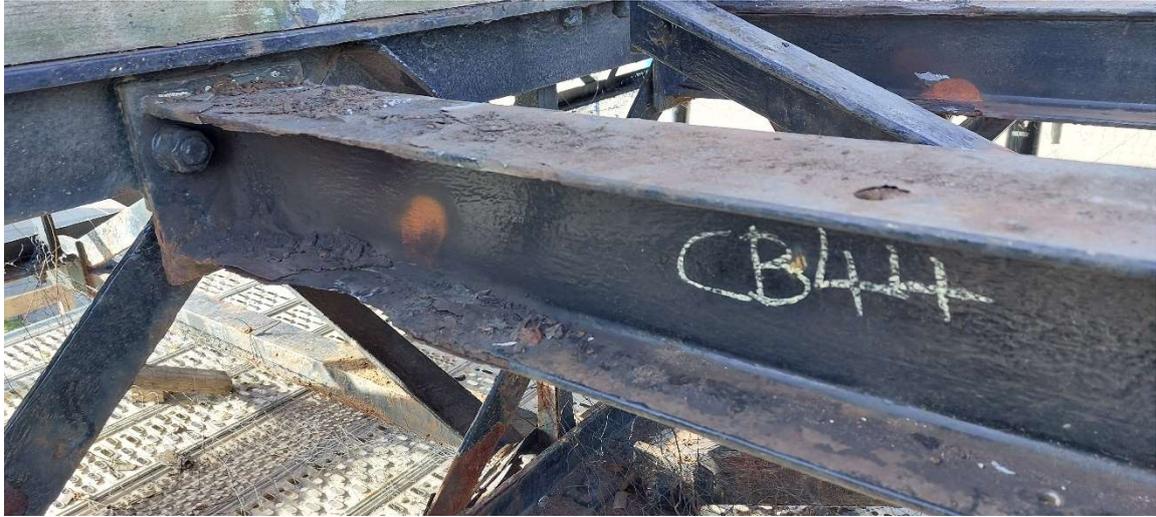
5.6 Photographs 42 and 43 below shows two central support beams that have severe loss of section to the top and bottom flanges on Mid South truss end of the beam.

Photograph 42 – Central support Beam Ref 44 looking seaward

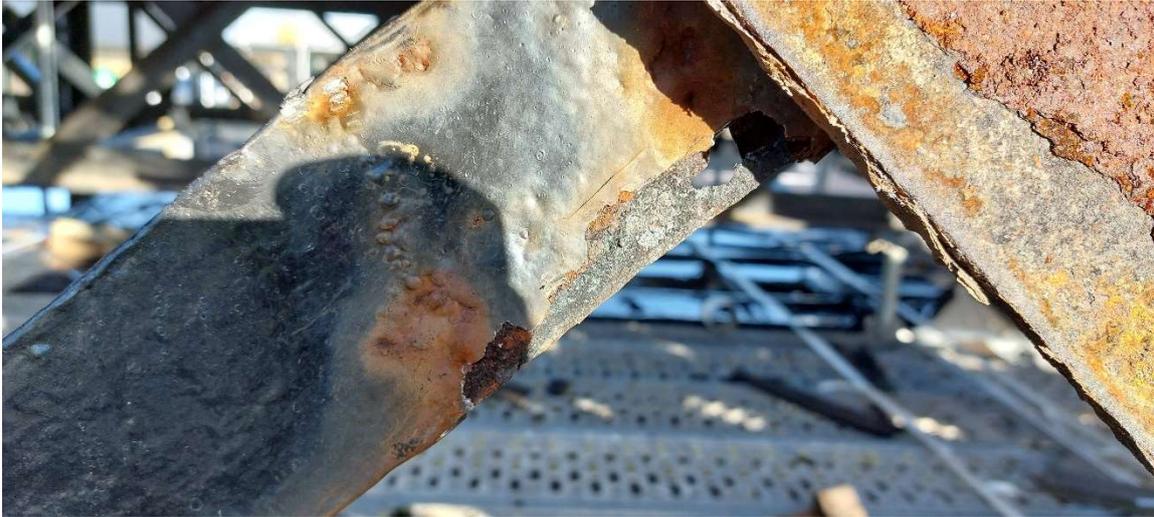
Photograph 45 – Loss of section to vertical leg of bracing angle within the mid North truss in Bay 26

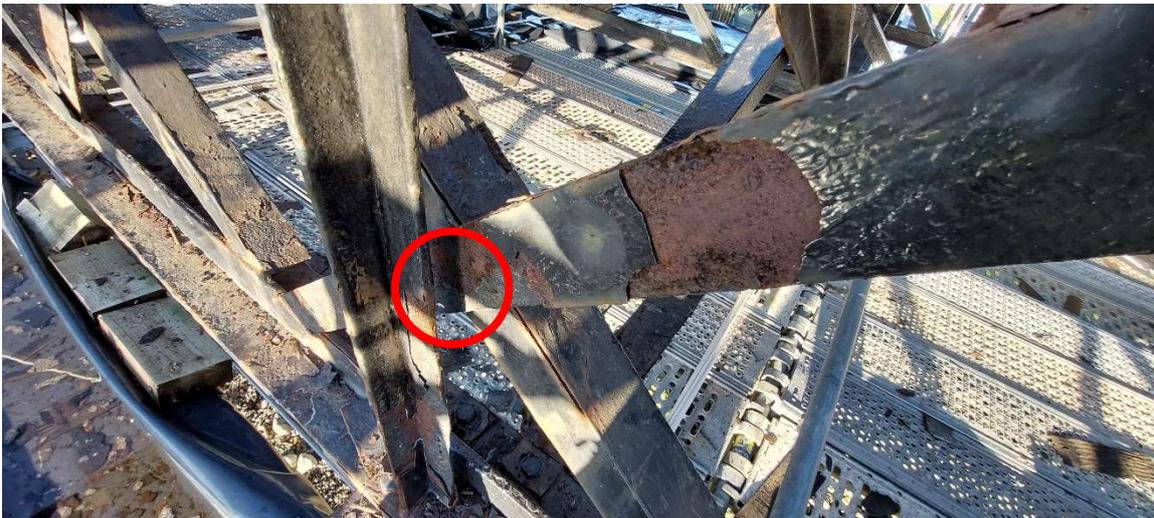
Photograph 46 – Loss of section adjacent to truss diagonals within Mid South truss adjacent to TF6 of Bay 27

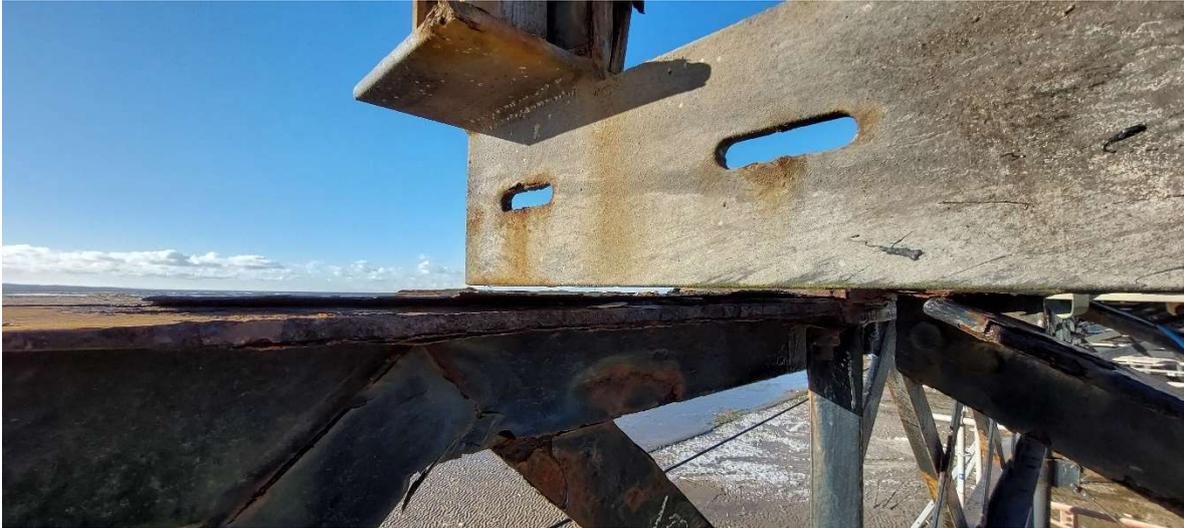
Photograph 73 – Typical handrail base detail along South side of pier

- 7.4 Photograph 73 above, indicates the vertical plate that fixes directly to the timber and has no positive fixing to the top chord of the outer south truss. It appears the design philosophy adopted during the major refurbishment circa 2000, utilizes the timber joists and decking boards dead load to provide sufficient counteraction for any load applied to, and from, the handrails.

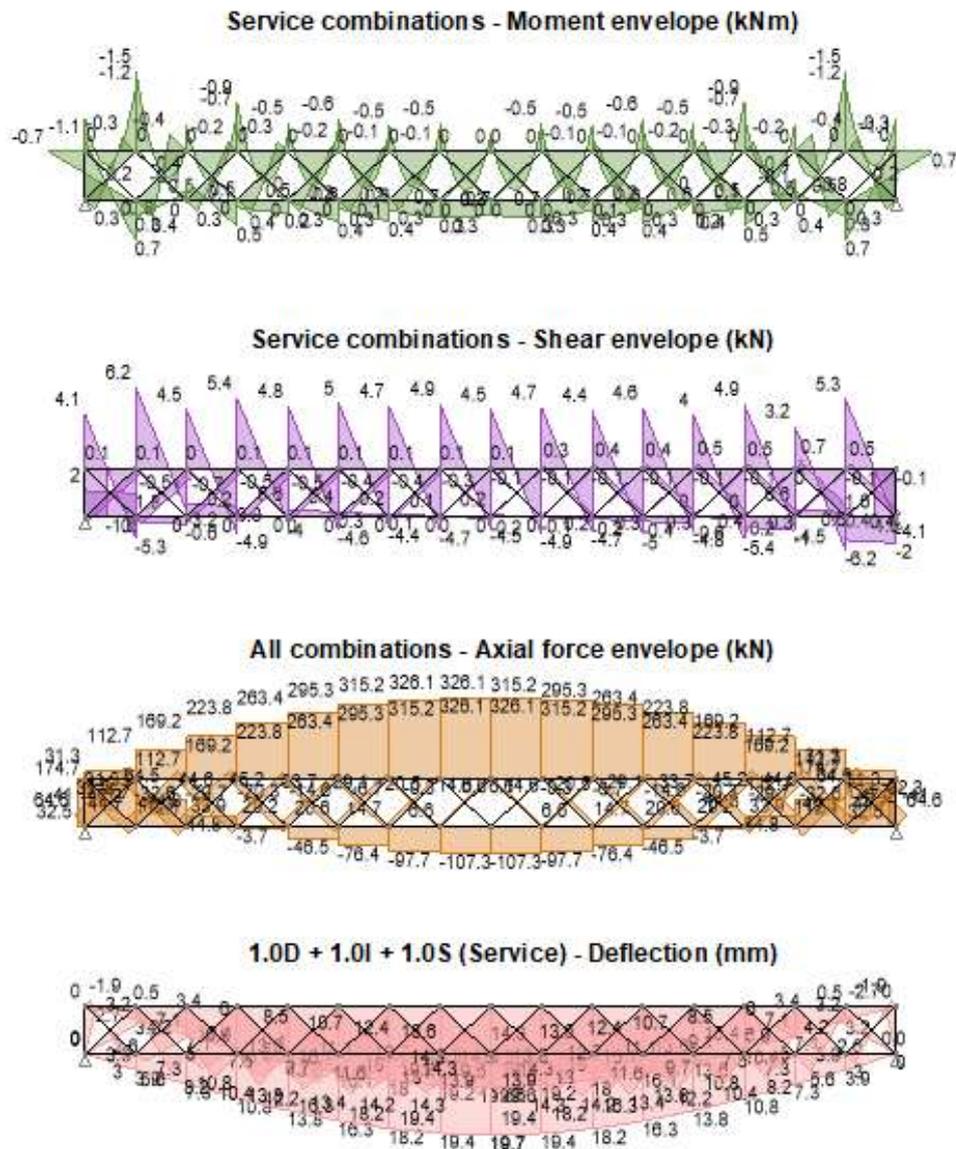
Figure 9 – Output from Tekla TEDD's diagrammatically indicating forces to Outer South Truss.

9.7 A spreadsheet was used to determine the utilisation of each member under full load with the original section properties, the outer trusses have been assessed with top chord lateral restraint at 3.8m and the inner trusses with restraints at 0.95m centres. The assessment of the outer trusses revealed the top chord to fail in compression and bending, reiterative assessments were undertaken to determine the distance between restraints to achieve a utilisation ratio less than 1.0, this was determined to be @ 1.80m coinciding with the distance between handrail standards. Due to the general poor condition of the former tram rail support members between the inner trusses Thomasons are recommending these are removed, therefore these trusses have been reassessed with the top chord restraints @ 1.8m to reflect those required to the outer trusses.

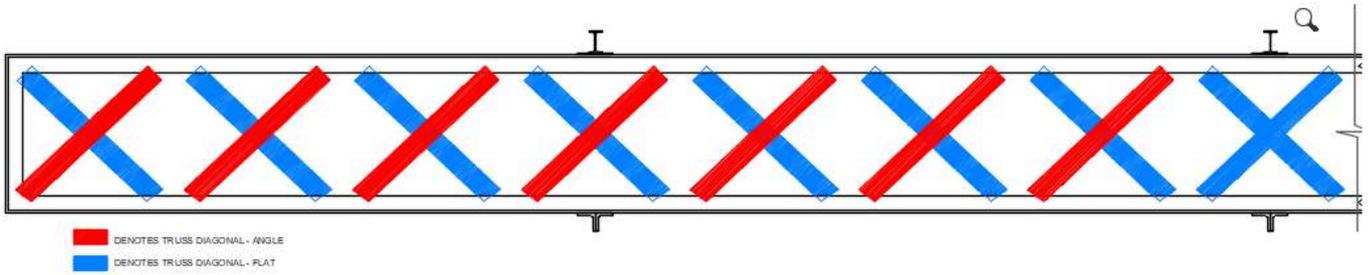
- d. Compression check: Assessment of the frame determined, with no section loss of the members, all diagonal angles passed. Further assessment determined that the first five angle members from the left-hand side of figure 10 below achieved a utilisation of >90% when the loss of section reached between 80-90% of its original area. Two of the flat members at the centre of the truss in compression are exceeding their capacity and will require replacing with suitable angle members.

- e. Tensile check: Assessment of the frame determined, with no section loss of the members, all diagonals passed. Further assessment determined that the first six flat members from the left-hand side of figure 10 below achieved a utilisation of >90% when the loss of section reached between 60% at the left-hand member, and 90% on the members closer to the middle of the frame.

- e. Tensile check: Assessment of the frame determined similar results to the south outer truss, but with the first six flat members varying between 40% and 90% section loss to achieve a utilisation of >90%.

Figure 10 – Part elevation on frame indicating the internal elements (Frame mirrors about centerline of truss).
